Easton Park Community Development District

May 21, 2026

Agenda Package

Easton Park CDD Waterway Inspection Report

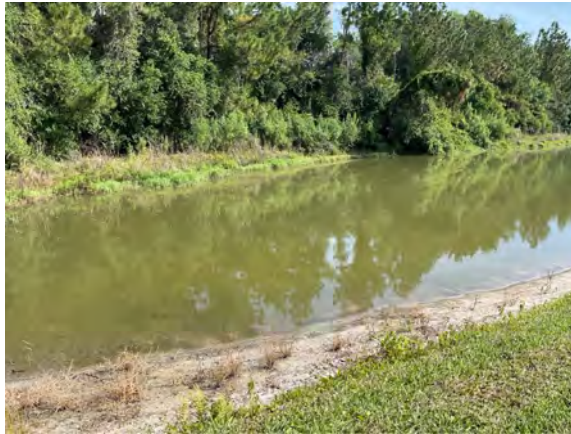
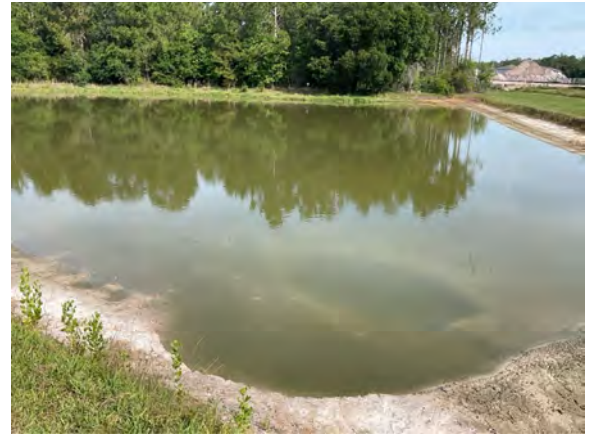
Site looks good
This site is looking good.
Shorelines are clear of nuisance growth.

Routine maintenance next visit

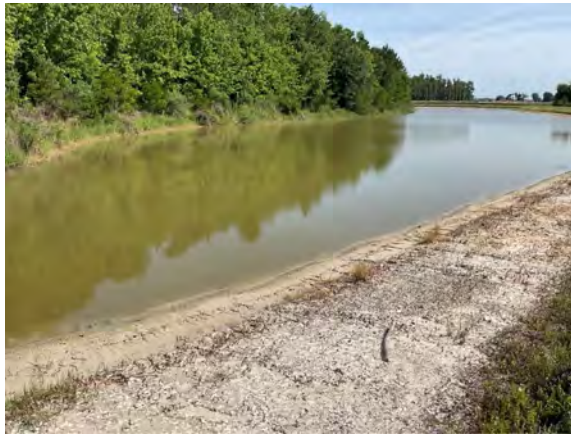
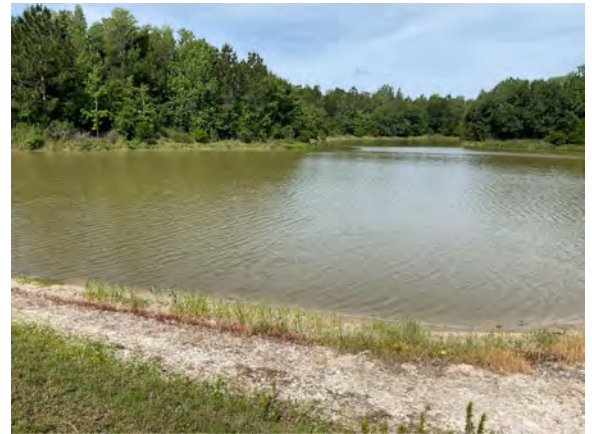
Normal growth observed
Minor shoreline weeds but overall site looks good.

Routine maintenance next visit

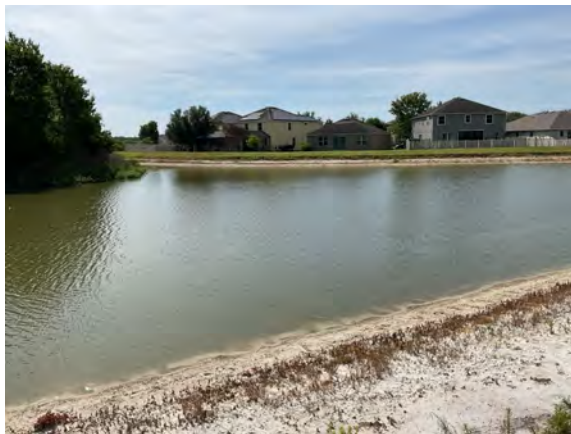
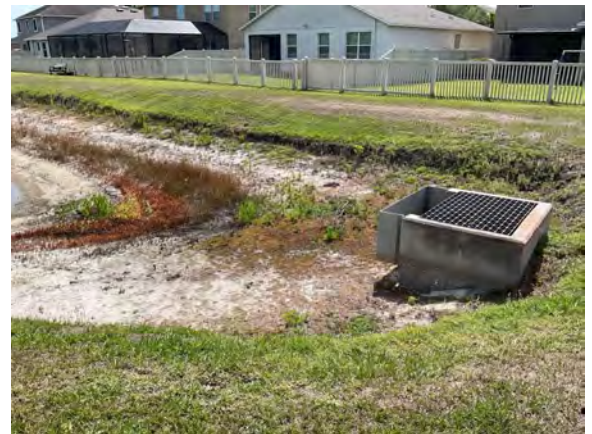
Normal growth observed
Site has shoreline grasses but overall is doing well.

Routine maintenance next visit

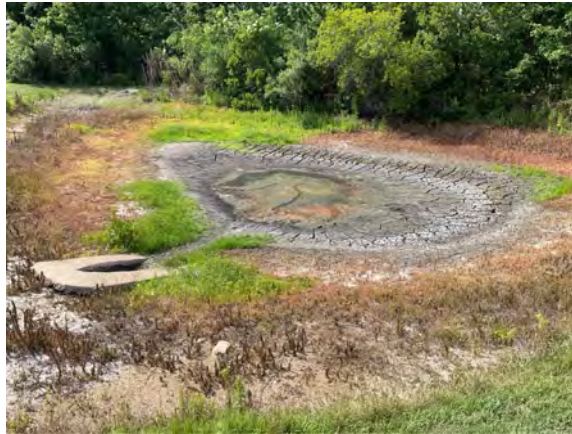
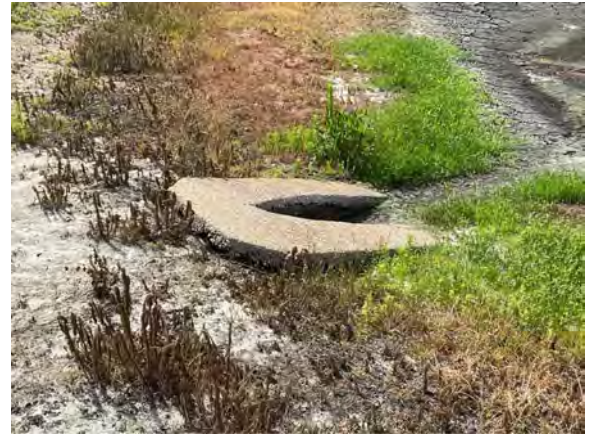
Site looks good
This site is completely dry.

Routine maintenance next visit

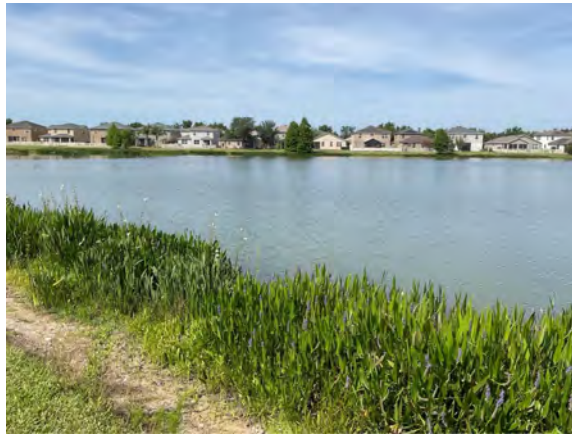
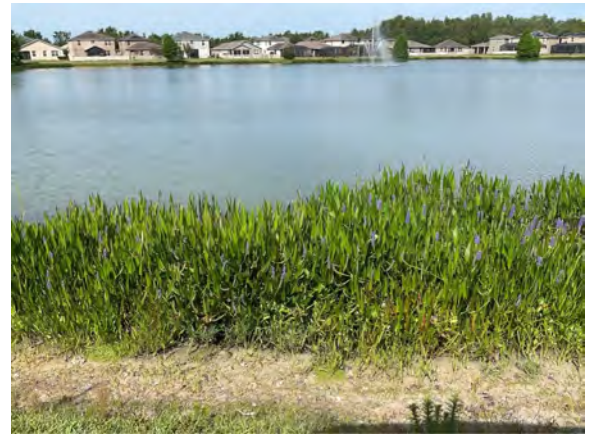
Site looks good
This site is doing well with a full perimeter of beneficial plants.

Routine maintenance next visit

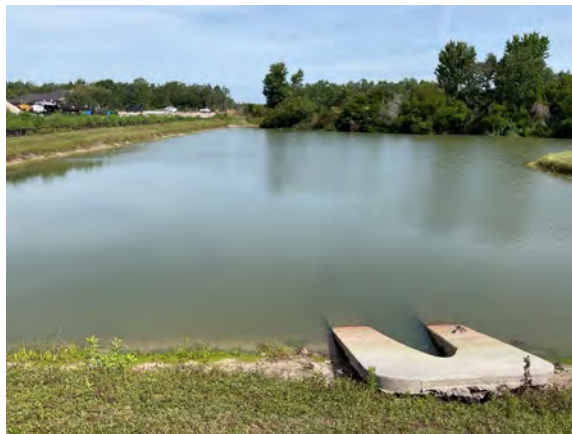
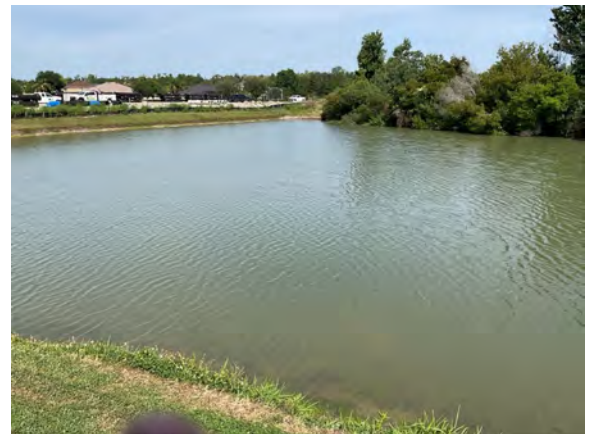
Normal growth observed
Shoreline grasses present. Flow structure has erosion along the sides of it.

Routine maintenance next visit

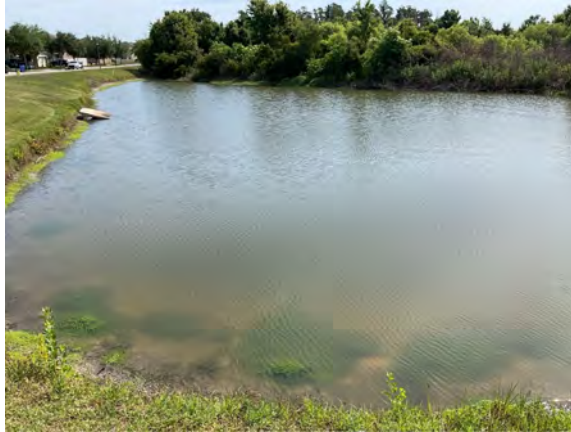
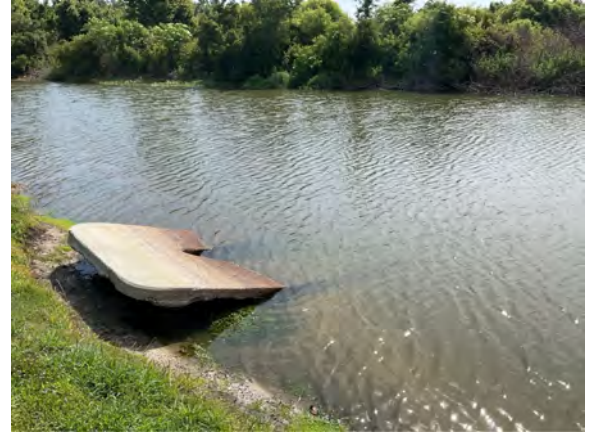
Normal growth observed
Flow structure has no support underneath it. Site has some submersed vegetation present.

Routine maintenance next visit

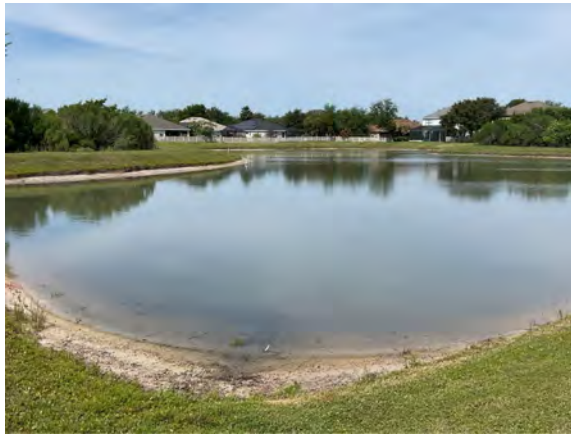
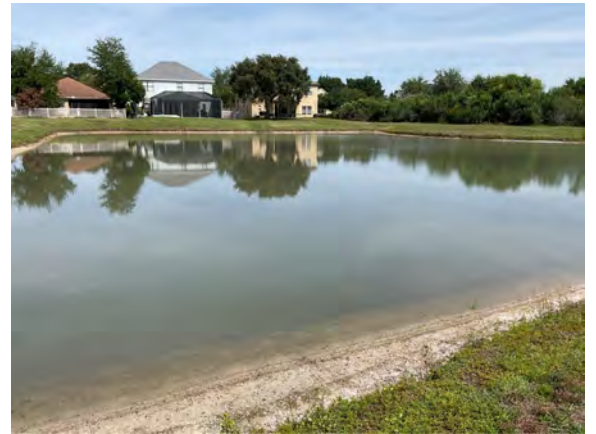
Site looks good
This site is in good condition. Shorelines are free of growth.

Routine maintenance next visit

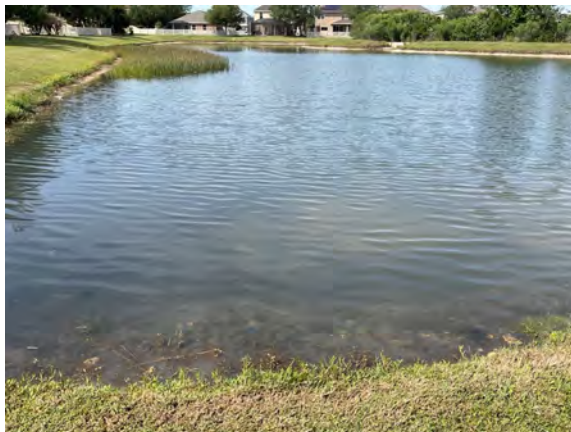
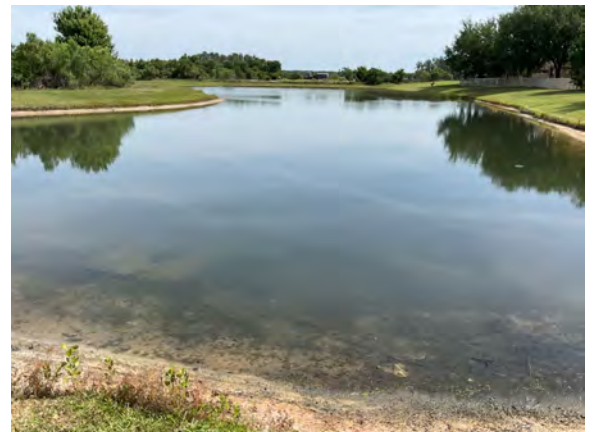
Site looks good
Overall site is doing well. There is a small group of beneficial GSR present. Shorelines are looking good.

Routine maintenance next visit

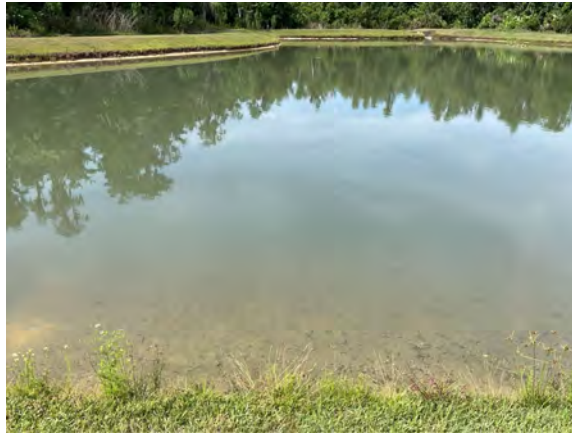
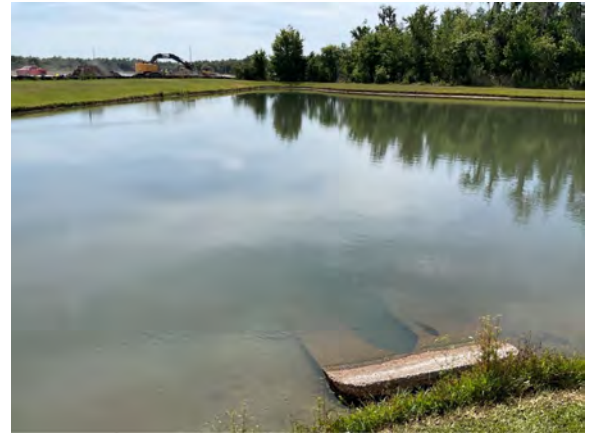
Site looks good

This site is in good condition overall. Flow structures look good.

Routine maintenance next visit

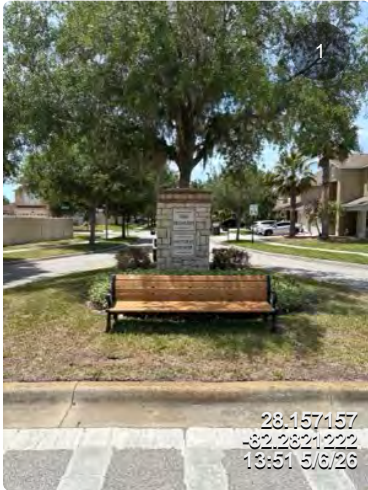
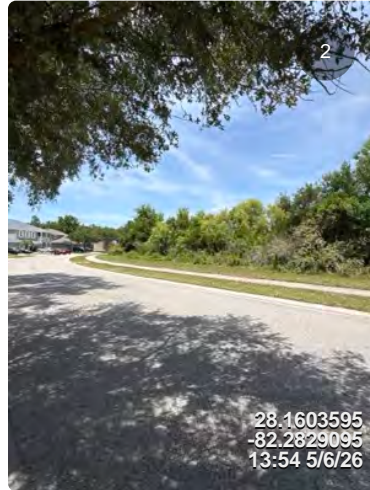
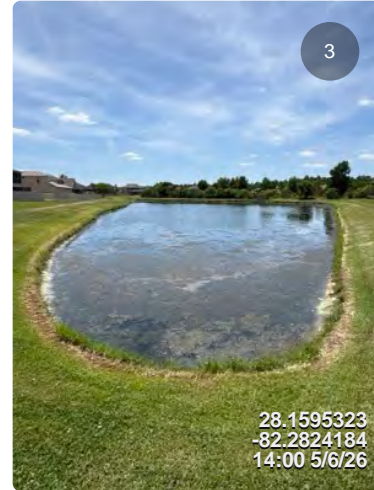
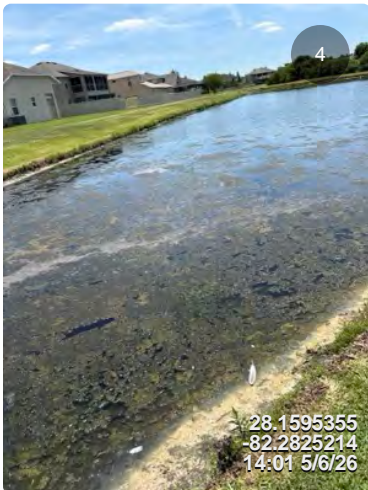
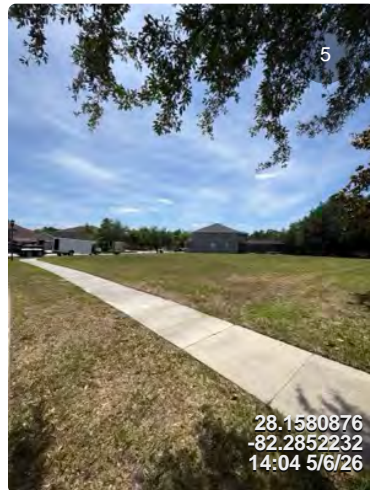
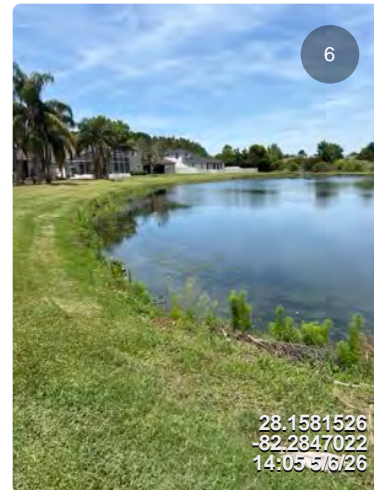
Items 4 - Natures Corner

Natures Corner is generally well maintained. Proper mowing around the pond banks and pocket parks are being performed. It appears the pond banks are being missed by line trimming. Observed evidence of algae bloom at the middle pond.

- Please line trim the pond banks at next service.
- Please treat for algae at next service.

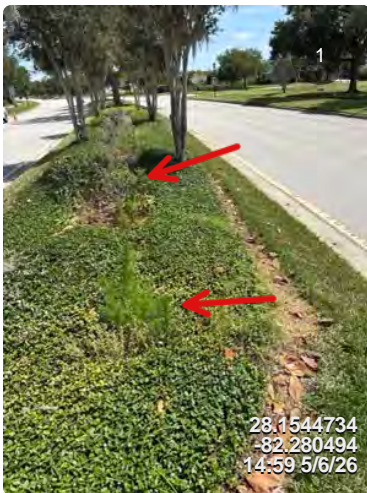
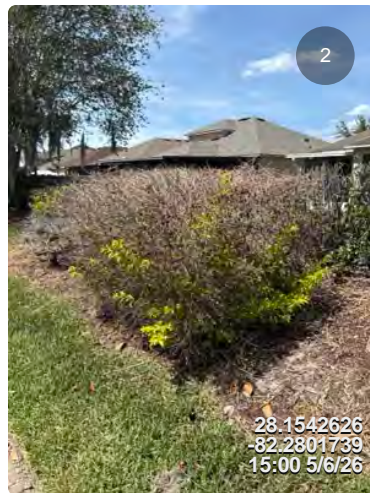
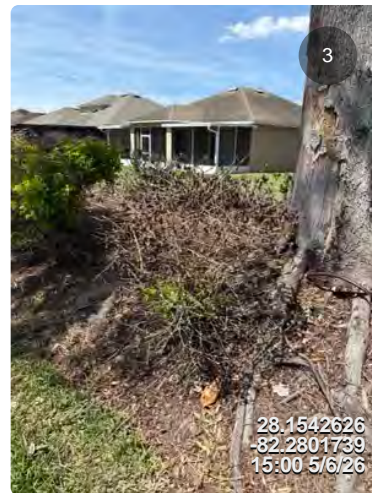
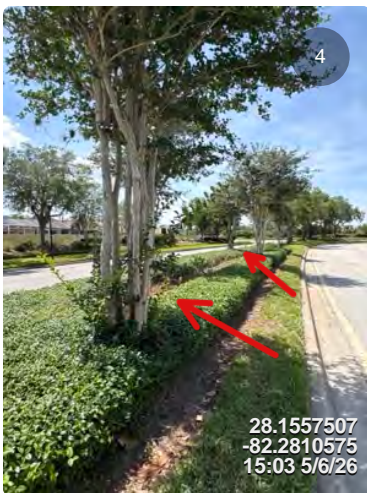
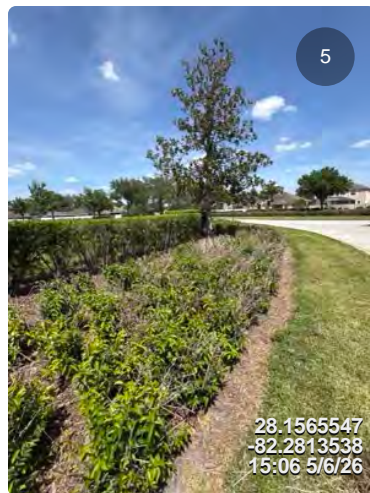
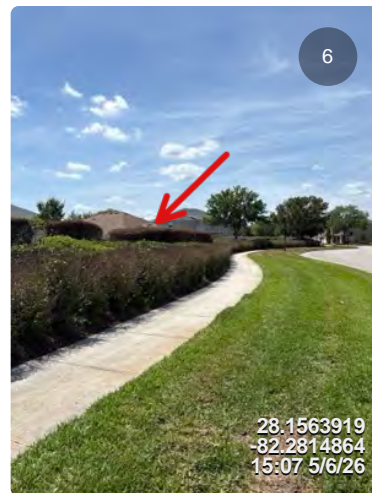
Landscape throughout the main boulevard appears well maintained but in struggling condition. It is evident that landscape is still recovering from previous cold snap. Suggesting a rejuvenation cut-back to encourage healthy growth in the struggling plants. Some garden beds in the median appear to have overgrown weeds and sucker growth on the Crape Myrtles.

- Please service the median garden beds and treat for weeds.
- Please cut the sucker growth from Crape Myrtles at next service.
- Please trim the Cordyline Red Sister of dead plant material.

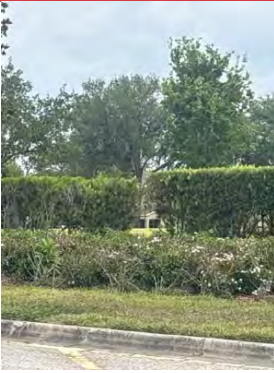
OBSERVATION 5

A good portion of freeze damaged plants are slowly recovering

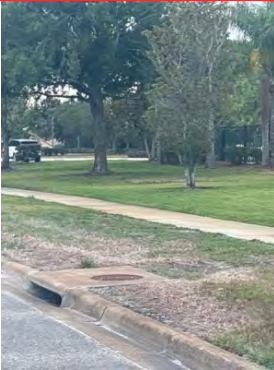
OBSERVATION 14

Turf damage near clubhouse maybe be damage from tree removal on other side of sidewalk
