**Traditional Reserve Study
For
VillaSol Community Development District
Kissimmee, Florida
February 26, 2024**

Report Number: 2024.02.26.205

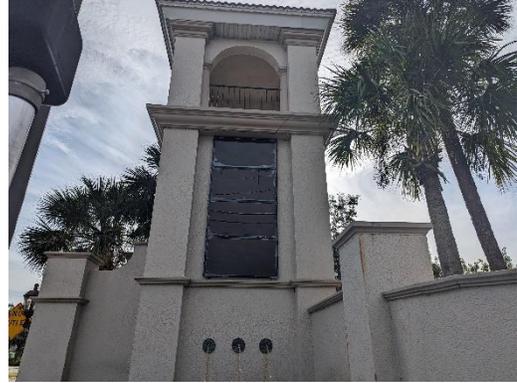
ID: 001

- **Entrance Signage. Monuments, Partial** – This provides for the replacement of all entrance signage monuments. The estimated remaining useful life is 65 years and so the total replacement cost is excluded from the study. A periodic failure rate of 5% every 3 years is included in the study as the estimated costs are significant.

Item Description:
Entrance Monument

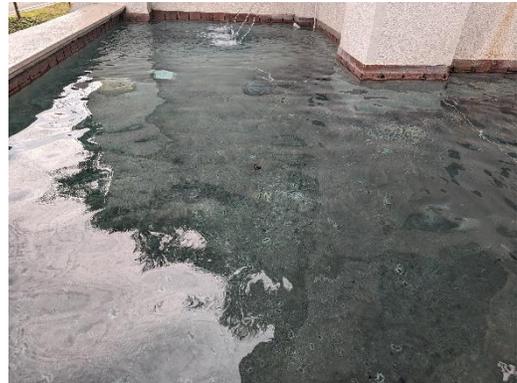
ID: 002

- **Entrance Signage, Fountain Resurfacing** – The fountain is approximately 459 square feet. It is in poor condition.
- **Entrance Signage, Paint** – There is approximately 3,764 square feet of paint between the entrance signage and irrigation enclosure. It is running, stained and in poor condition.

Item Description:
Fountain

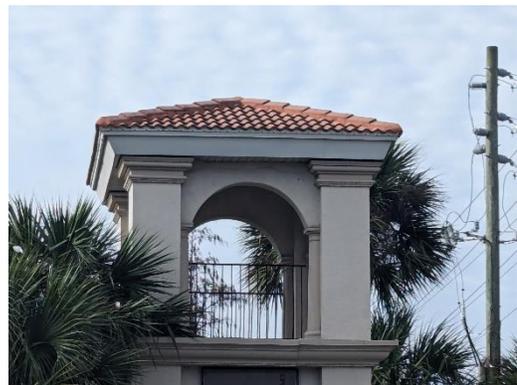
ID: 003

- **Entrance Signage, Roof, Terracotta** – There are approximately 2 squares of terracotta roof. Did not have access. No condition assessment is available.

Item Description:
Entrance Signage, Terracotta Roof

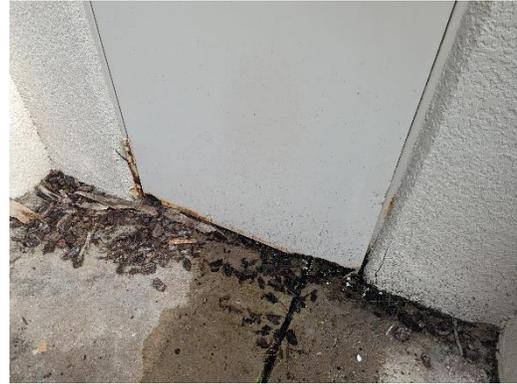
ID: 004

- **Entrance Gates** – There are 3 aluminum entrance gates. One is missing. They appear to be in very good condition.
- **Entrance Signage, Fountain Pump** – Did not have access to the pump room. No condition assessment is available.

Item Description:
Fountain Pump

Note:
Door in poor condition. Considered operational Did not have access.

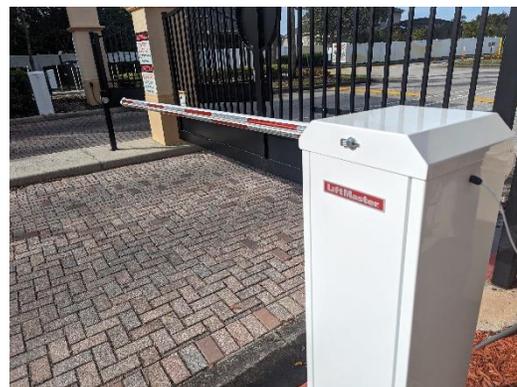
ID: 006

- **Entrance Gate Motors** – There are 4 entrance gate motors. They appear to be in very good condition.
- **Entrance Gate Motors with Barrier Arms** – There are 4 entrance gate motors with barrier arms. Two of the arms have been removed and one was laying on the ground during the time of the inspection. Other than the arms, they are in very good condition.

Item Description:
Entrance Gate Motor with Barrier Arm

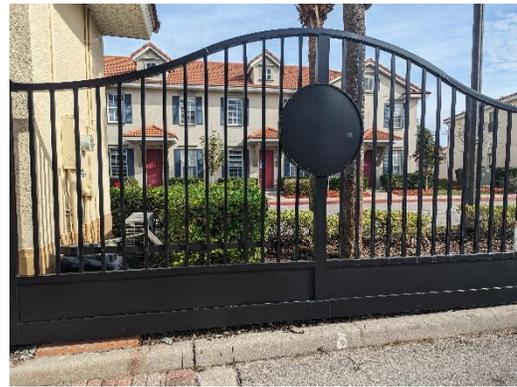
ID: 008

Item Description:
Entrance Gate

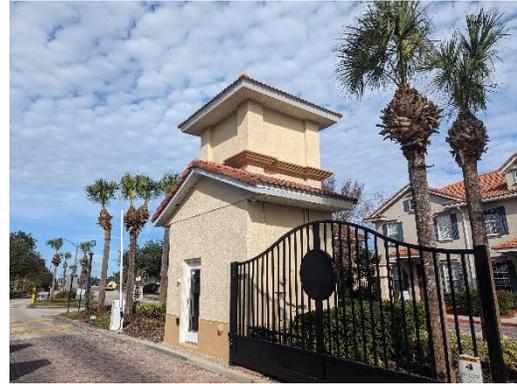
ID: 010

- **Exterior Paint and Waterproofing** – There is approximately 1,100 square feet of exterior painting and waterproofing on the guardhouse. It is in fair condition.
- **Roof, Terracotta** – There are approximately 5 squares of terracotta roof. It appears to be in good condition.

Item Description:
Guardhouse Exterior Paint

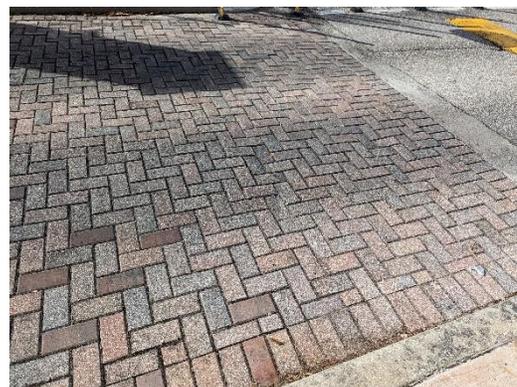
ID: 012

- **Road Pavers** – There are approximately 1,904 brick pavers by the security building. There are uneven pavers by the inside entrance area, however, the rest appear to be in good condition.

Item Description:
Road Pavers

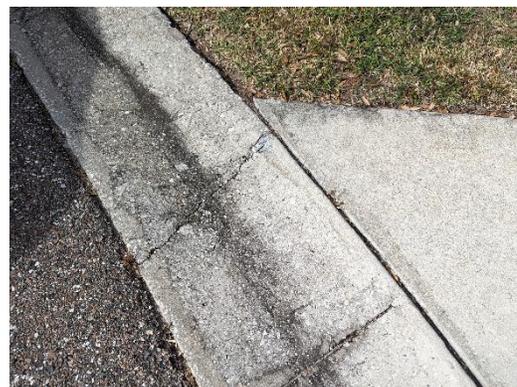
ID: 015

- **Curbs and Road Gutters** – There are approximately 27,200 linear feet of curbs and road gutters. There are damaged areas throughout the property, but overall, it is in good condition.

Item Description:
Curbs and Road Gutters

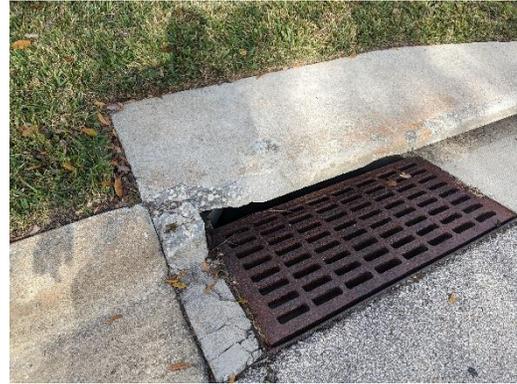
ID: 022

Item Description:
Stormwater System

Note: Damaged catch basins.

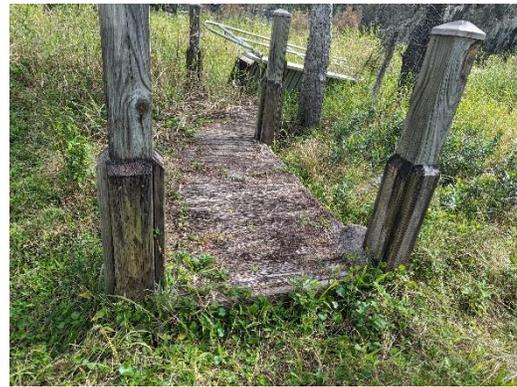
ID: 023

- **Dock** – Dock has been damaged by hurricane. Unable to determine length. Due to the condition, we recommend getting a quote from a third-party vendor.

Item Description:
Dock/Boat Area

Note:
Unable to measure.

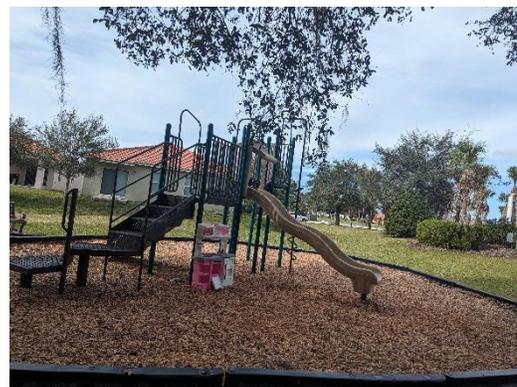
ID: 024

- **Playground** – There is one playground. It is considered to be in poor condition based on its age.
- **Small Basketball Court, rebuild** – The small tennis court is approximately 1,600 square feet. It is showing cracking throughout. It is in fair condition.

Item Description:
Playground

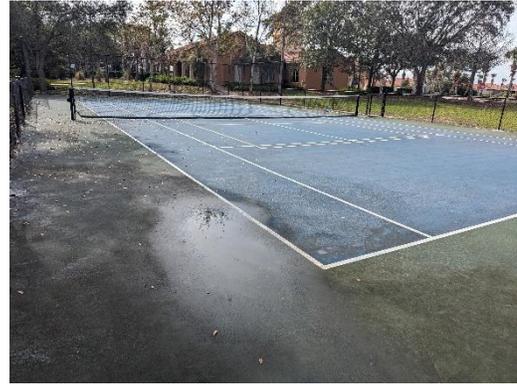
ID: 025

- **Tennis Court, rebuild** – The tennis court is showing signs of cracking throughout. These cracks do not appear to be surface only. Overall, it is in good condition.

- **Tennis Court, Resurfacing** – The basketball court is showing signs of cracking throughout. Overall, it is in poor condition.

Item Description:
Tennis Court

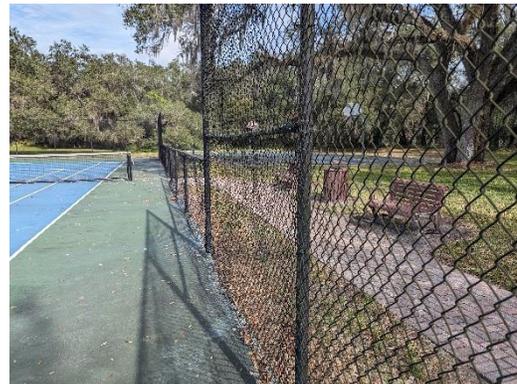
ID: 026

- **Tennis Court, Fencing, Chain Link** – The tennis court fencing is approximately 340 linear feet. The chain link is bent from wear. Overall, it is in fair condition. It is typically replaced at the time of rebuilding the court.

Item Description:
Tennis Court Fencing

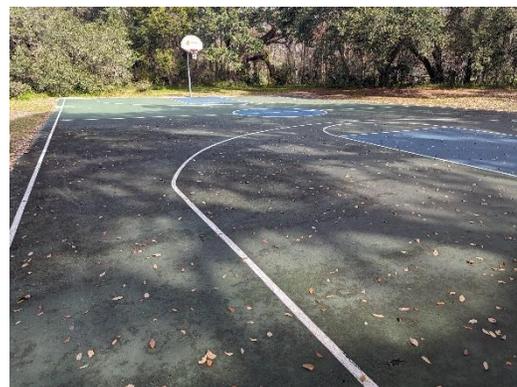
ID: 027

- **Basketball Court, rebuild** – The basketball court is showing signs of cracking and has water damage in several areas. These cracks do not appear to be surface only. Overall, it is in good condition.

- **Basketball Court, Resurfacing** – The basketball court is showing signs of cracking and has water damage in several areas. Overall, it is in poor condition.

Item Description:
Basketball Court

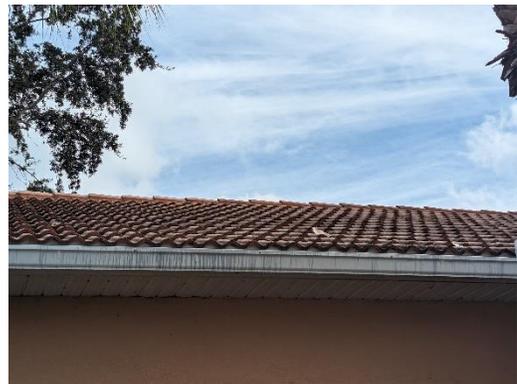
ID: 029

- **Roof, Terracotta** – There are approximately 72 squares of terracotta roof on the clubhouse. It is damaged from the hurricane and is leaking. It is in poor condition.

Item Description:
Clubhouse Roof

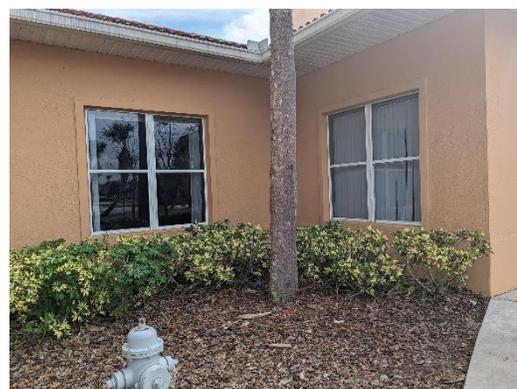
ID: 030

- **Exterior Bathrooms** – There are two exterior bathrooms. They appear to be in good condition.
- **Exterior Paint and Waterproofing** – There is approximately 3,590 square feet of exterior painting on the clubhouse. It appears to be in fair condition.

Item Description:
Clubhouse Exterior Paint

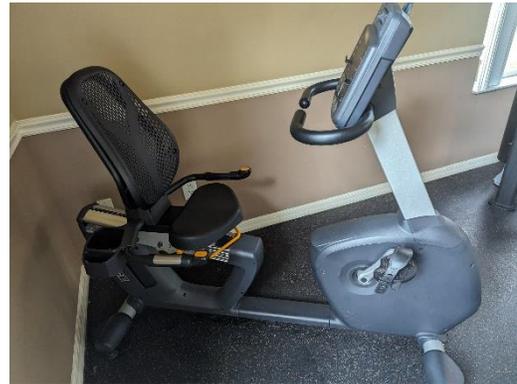
ID: 037

- **Cardio Equipment** – This allowance provides for the replacement of two Landice Treadmills, Sitting Stationary Bike and Elliptical. The elliptical is currently out of order. It appears that the rest are in working condition at the time of the on-site visit.

Item Description:
Cardio Equipment

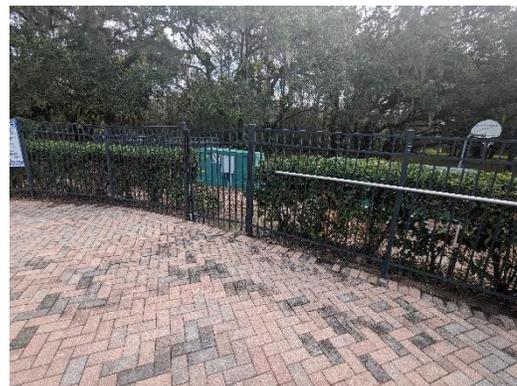
ID: 047

- **Equipment Enclosures, Allowance** – There are 4 fiberglass pump enclosures. They are in poor condition.
- **Fencing, Aluminum** – There are approximately 324 linear feet of aluminum fencing. There are some bent and damaged areas, including the gates. Overall, it is in fair condition.

Item Description:
Aluminum Fencing

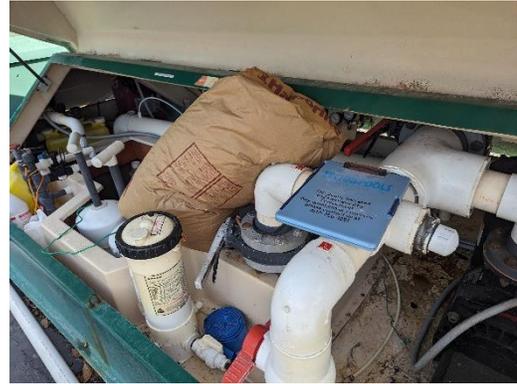
ID: 049

- **Pool Deck, Brick Pavers** – There are approximately 6,500 square feet of brick pavers. They appear to be in good condition.
- **Pool Equipment** – This provides for the replacement of pool pumps, motors, separation tanks and other related items. The 1.65 hp motor does not appear to be working at the time of the visit. Overall, it is in poor condition.

Item Description:
Pool Equipment

Excluded from study. Considered operational expense.

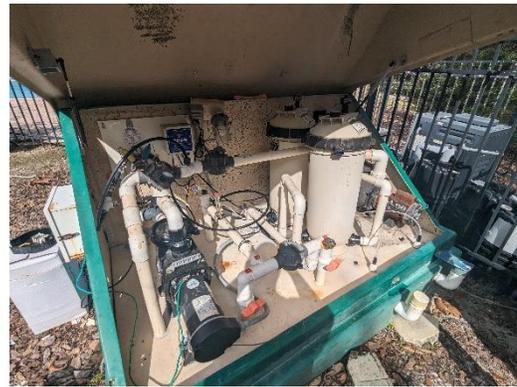
ID: 050

- **Pool, Remarcite** – The pool surface area is approximately 3,325 square feet. It appears to be in good condition.
- **Spa Equipment** – This provides for the replacement of the spa pumps, motors, filters, chemical controller, and other related components. They are in poor condition.

Item Description:
Spa Equipment
