# ***Cedar Hammock Community Development District***

### LAKE BANK EROSION AND STABILIZATION ANALYSIS

August 2026

**Cedar Hammock CDD  
Lake Bank Erosion Report  
August 2026**

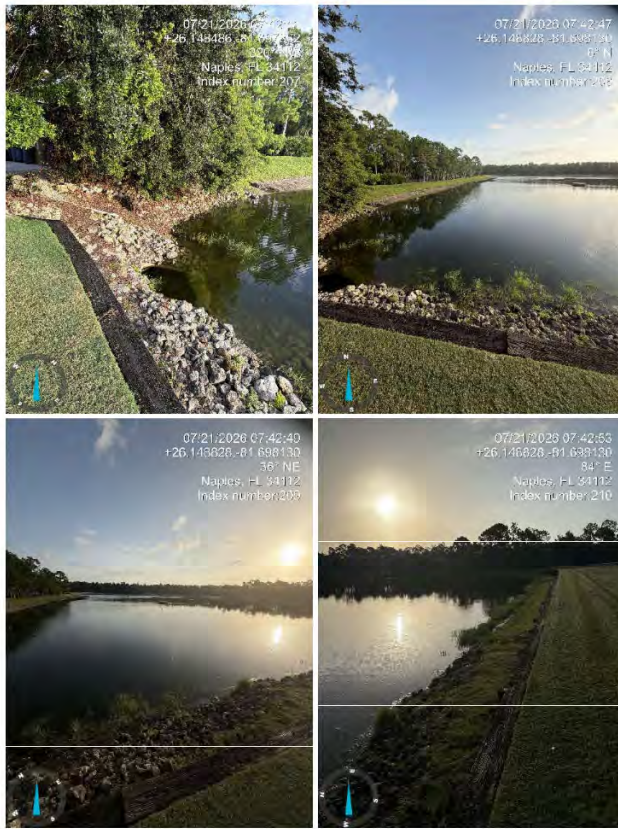
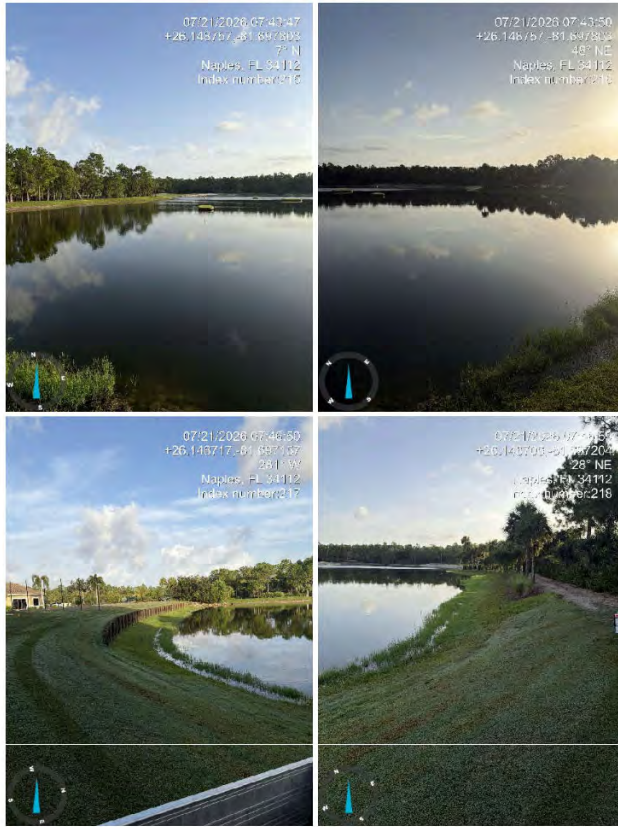
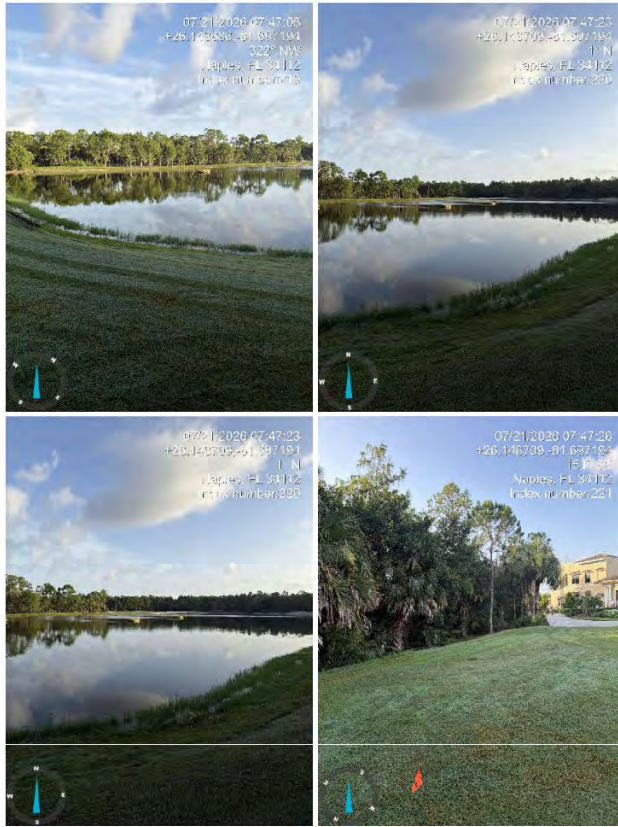
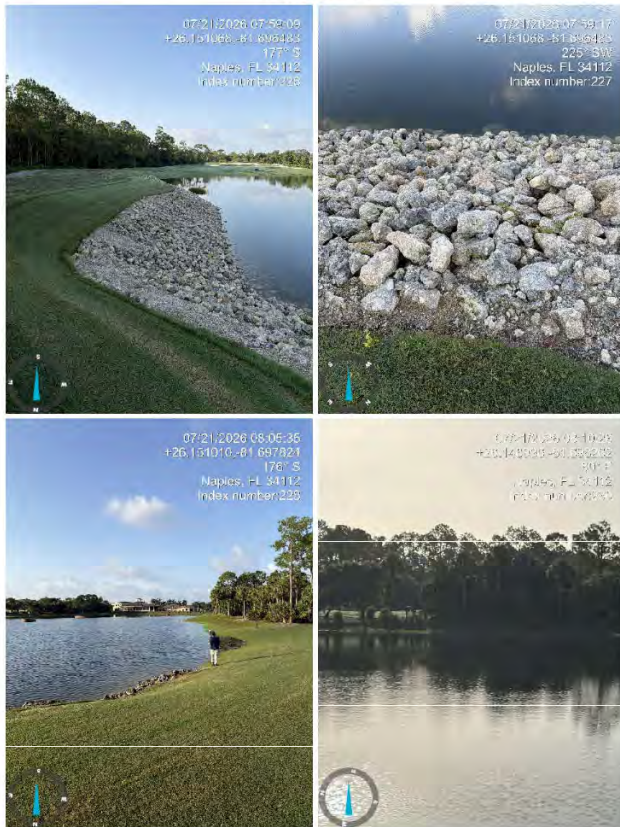
Lake 1 is reported as having minimal erosion. However, please note a portion of the western lake bank is permitted to be a 6:1 slope and appeared during the site inspection to be greater than designed. It is recommended to reestablish this slope with imported or dredge fill per a geotechnical engineer's specifications.

| Cedar Hammock CDD | | INSPECTION DATE: April 9, 2026 | |
|---|---|---|---|
| Lake 1 | Lake L-17 | MINOR EROSION | Photos: 114-125<br>115: Slight slope variation between soil and High Water Line (HWL).<br>124: Tree debris near system removal appears to have caused some minor erosion. |

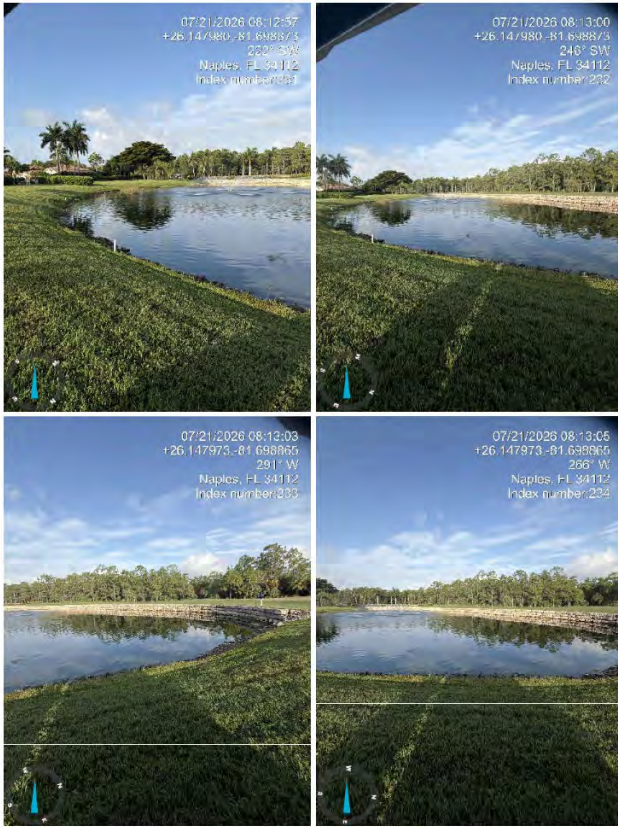
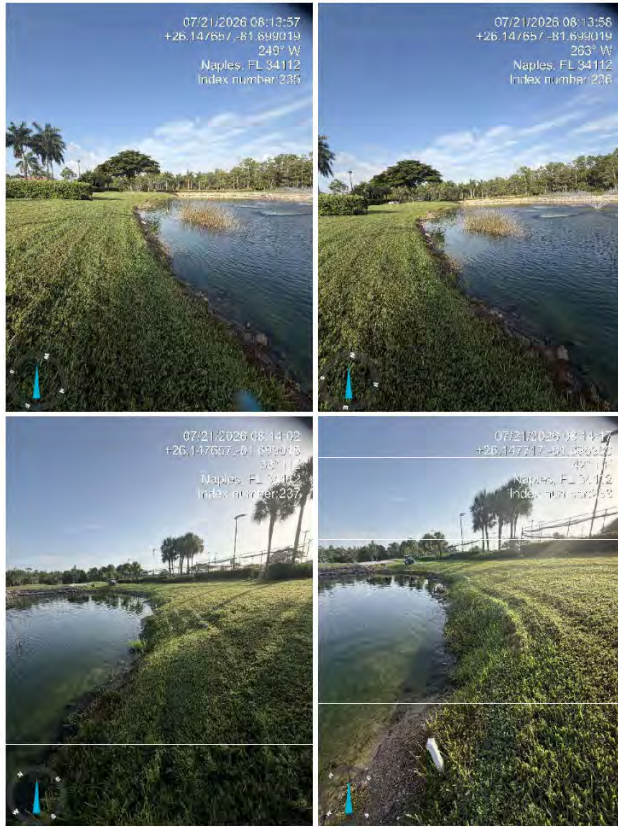
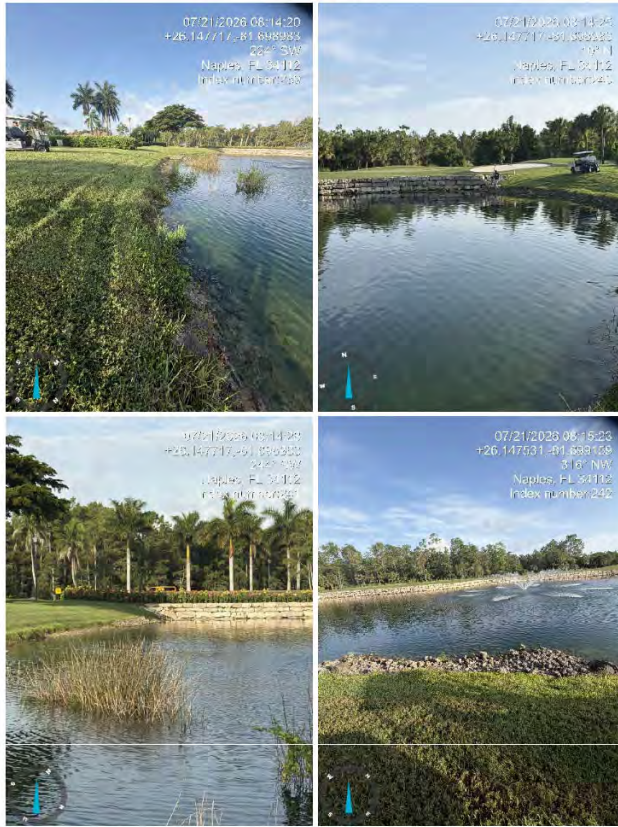
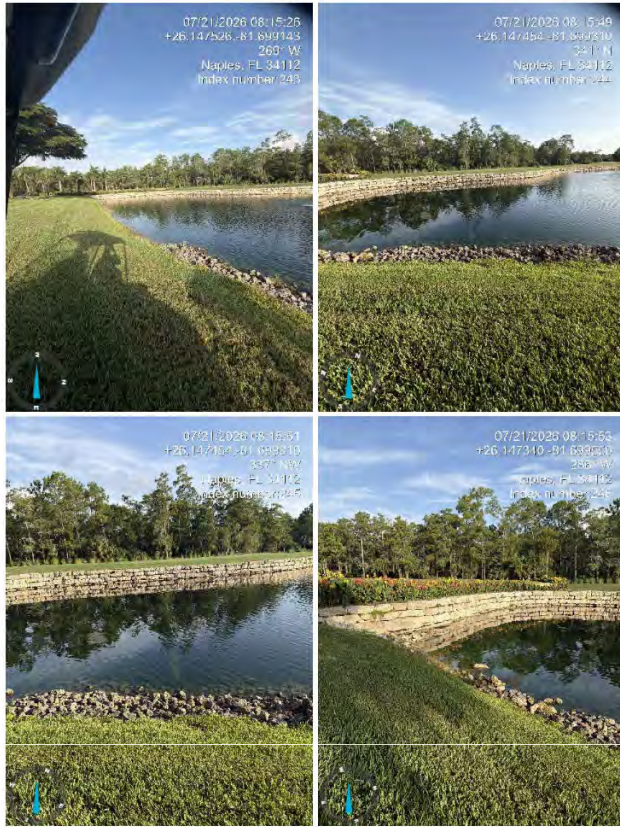
| Cedar Hammock CDD | | INSPECTION DATE: April 9, 2026 | |
|---|---|---|---|
| Lake 2 | Lake L-15 | MODERATE EROSION | Photos: 100-103<br>97: Slope degradation and drop-offs at vegetation line of the southwestern bank is present. It appears rip rap has been placed along portions of the southwestern bank. If rip rap was placed without filter fabric, degradation will continue rapidly. |
