Facilities Assessment of School Buildings

Oyster River Cooperative School District

December 6, 2024

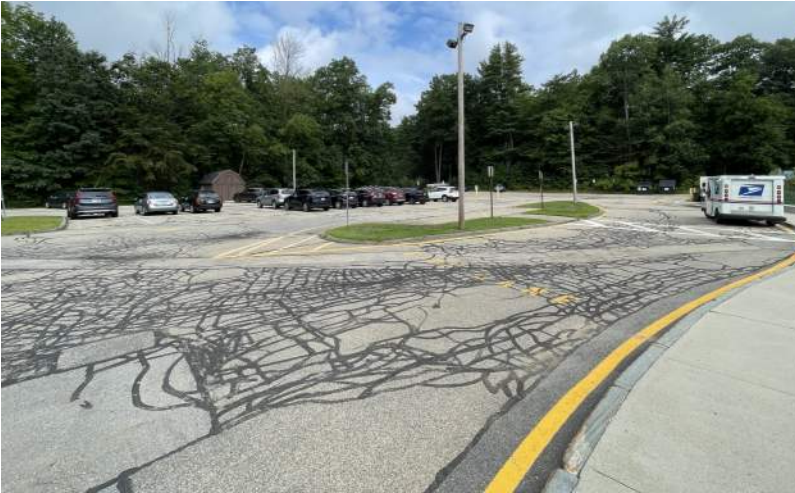
- The parking lot is in a serious state of disrepair, with the asphalt paving in a state of failure.
- Parent drop-off and pick-up is not consolidated on school property and relies on the use of the adjacent Madbury

Asphalt Paving in Poor Condition.

- Reconstruct parking areas at Moharimet, Mast Way, and High School.
- Replace track and turf field at the High School.

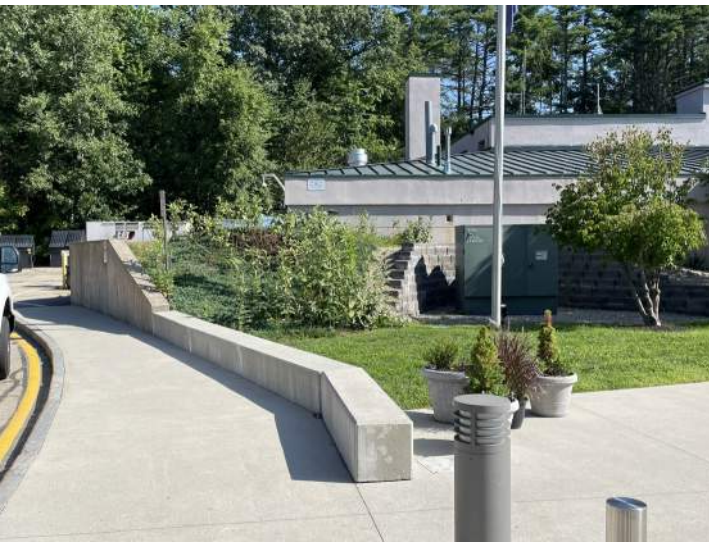
Berm Provides Easy Access to Roof, Gas Service, and Top of Transformer.

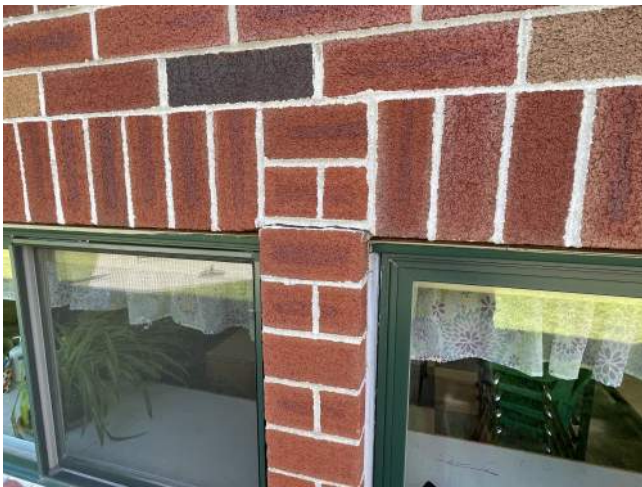
- Brick veneer cracking was noted at several window headers, especially at the courtyard windows.

Cracking of Brick Veneer at Window Head Conditions.

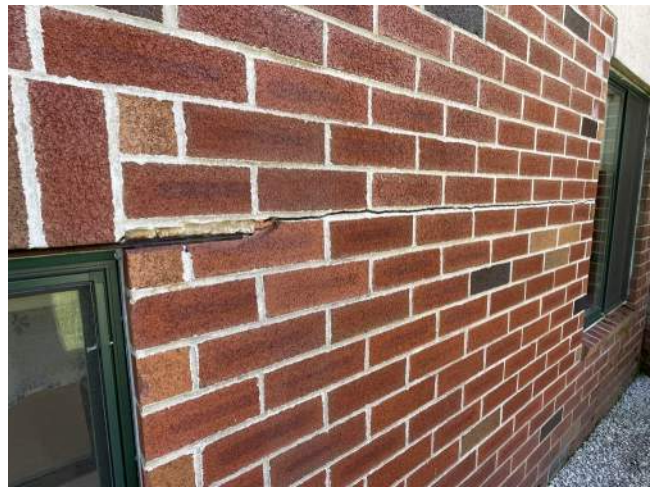
Cracking of Brick Veneer at Window Head Conditions.

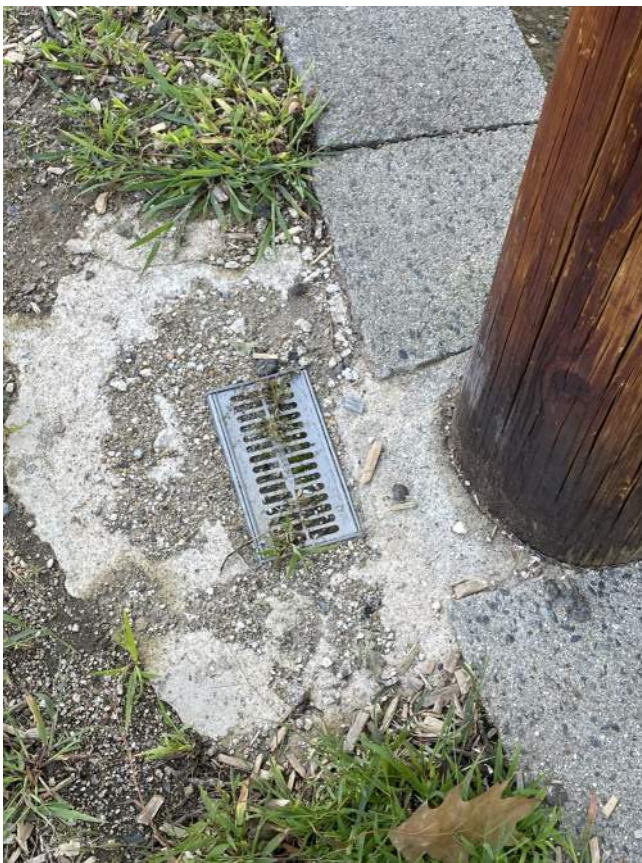
Clogged Area Drain.

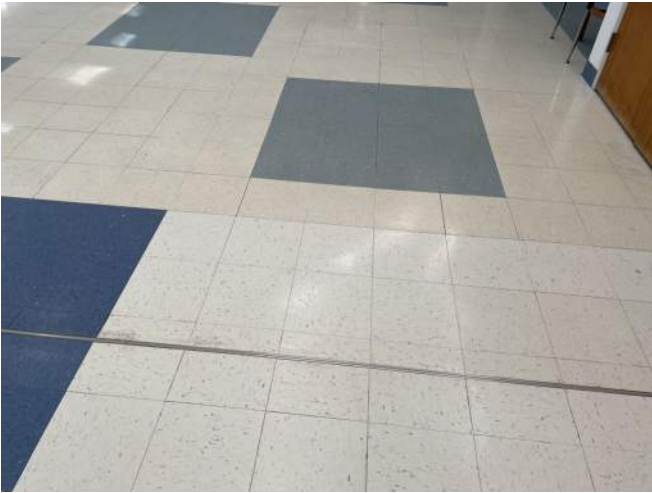
Vinyl Flooring on Poor Condition.

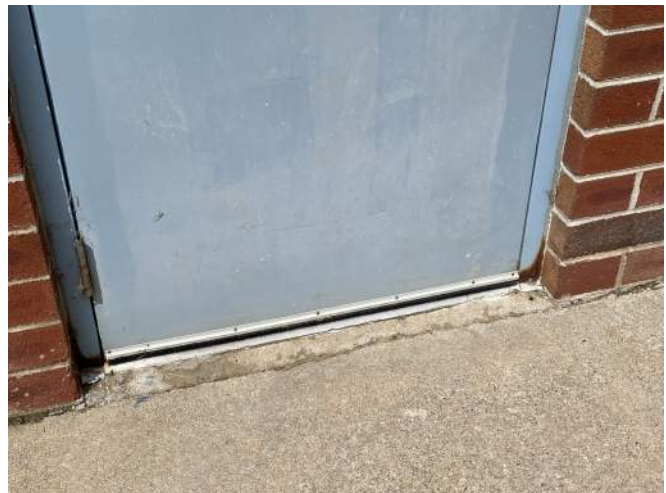
- Hollow metal door frames and doors exhibited rust and corrosion near the ground.

Corrosion at Exterior Doors.

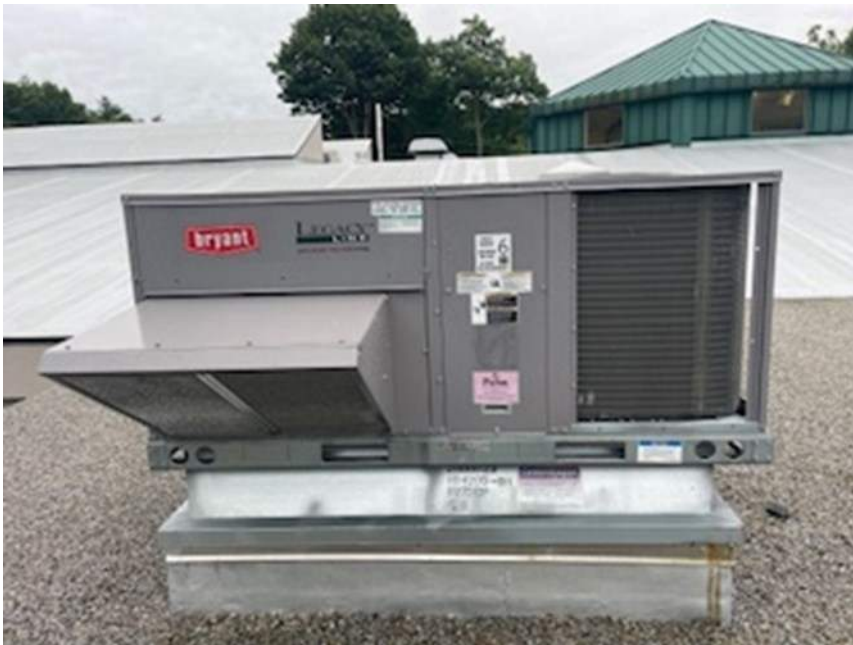
Roof Top Unit Original to Building.

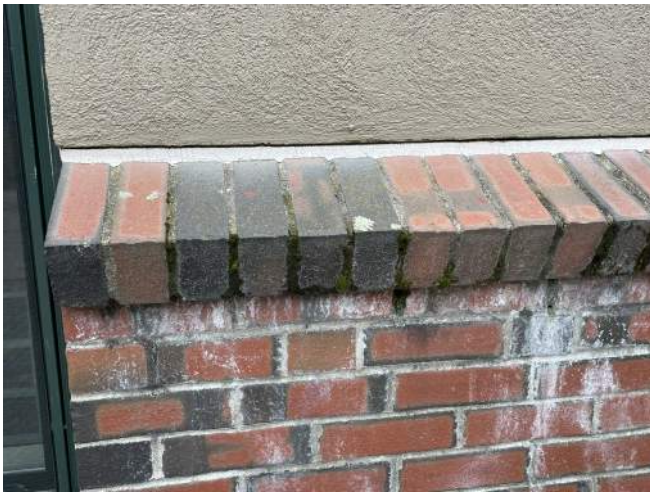
Efflorescence and Mildew at Brick Veneer.

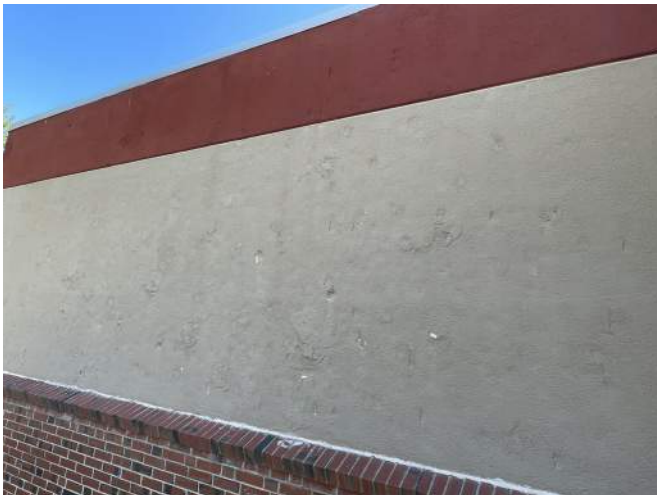
The exterior envelope at the High School and Moharimet are generally in good condition apart from typical maintenance and service repairs. The painted insulation finish (EIFS) at Mast Way is in poor condition.

Damage at EIFS.

- Masonry repairs are required at all three buildings.
- Replacement of exterior sealants are required at all three buildings.
- Replacement of the EIFS finish at Mast Way.

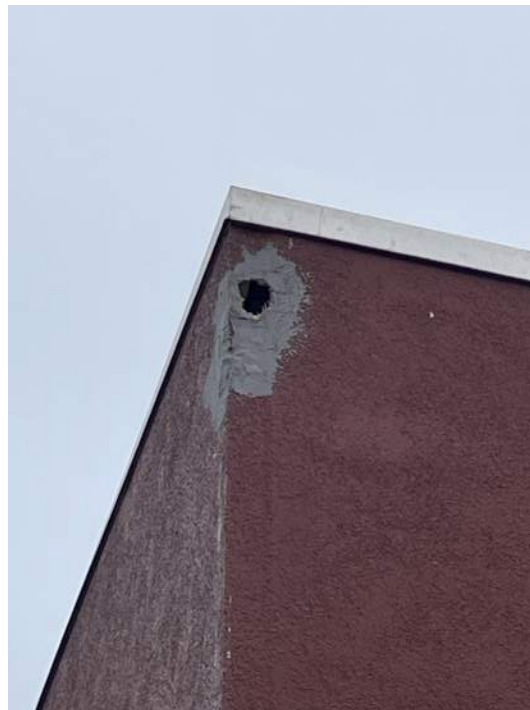
Damage at EIFS.

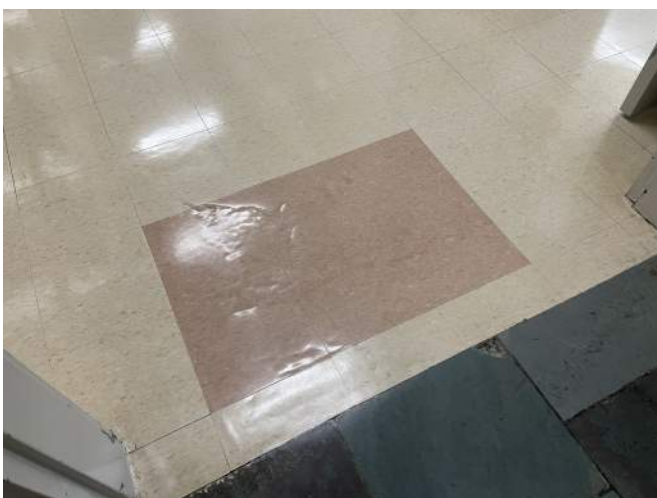
Flooring in Poor Condition.

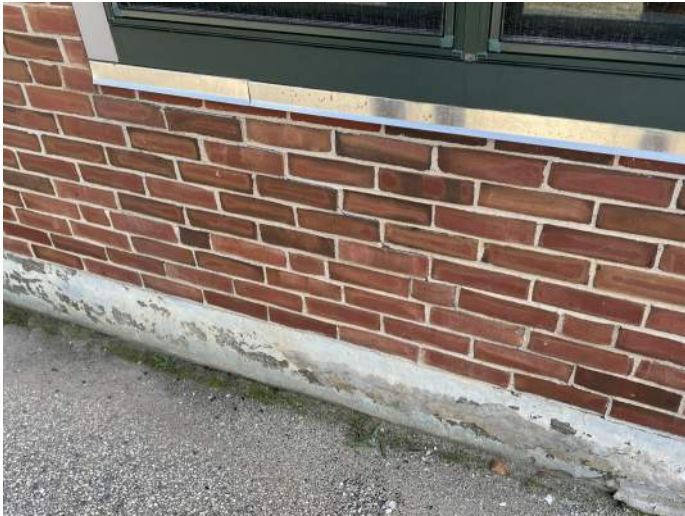
Concrete Foundation in Poor Condition.

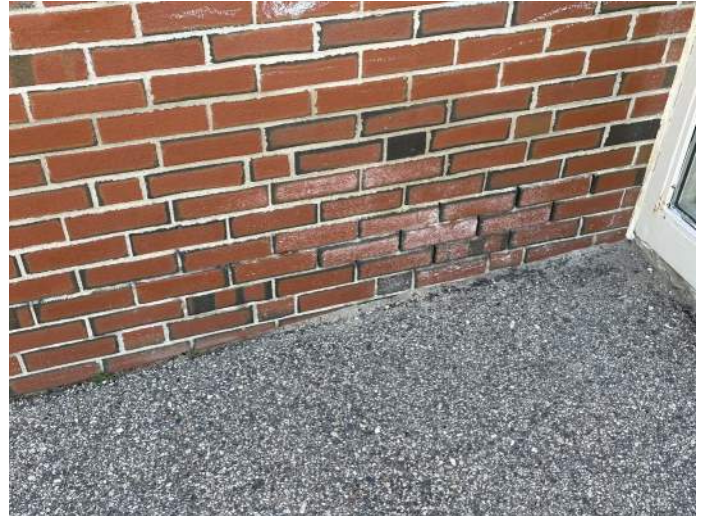
Brick Requiring Repointing.

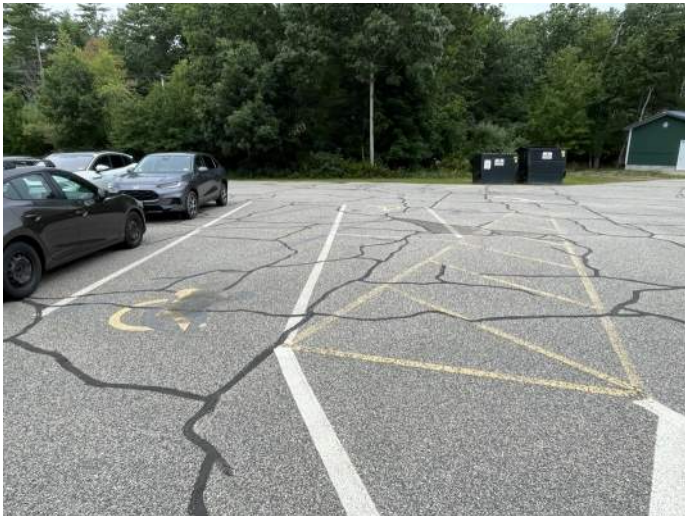
Asphalt Paving in Poor Condition.

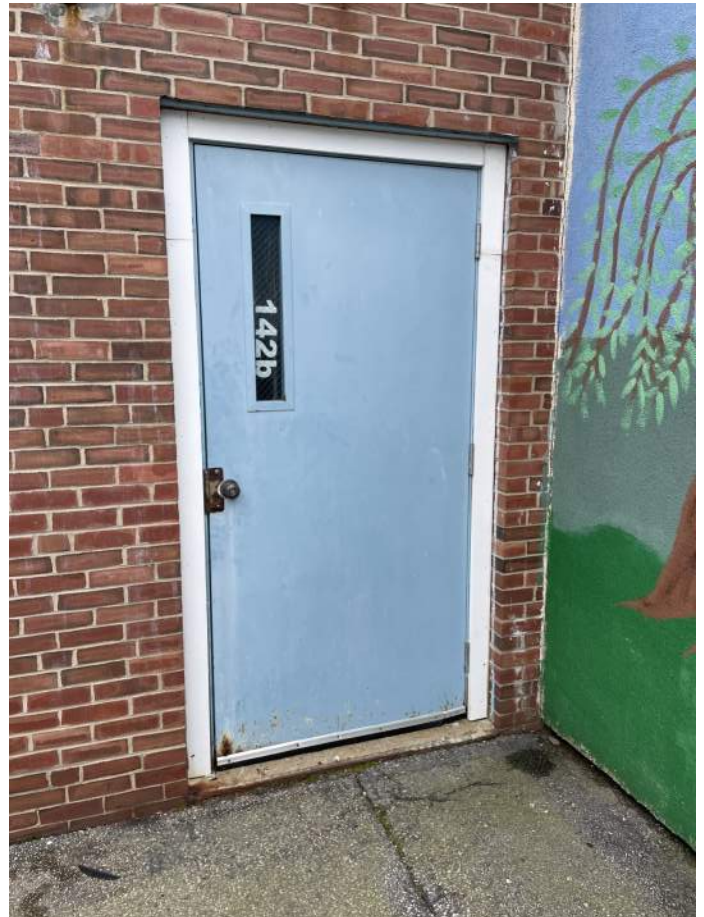
Exterior Door in Poor Condition.

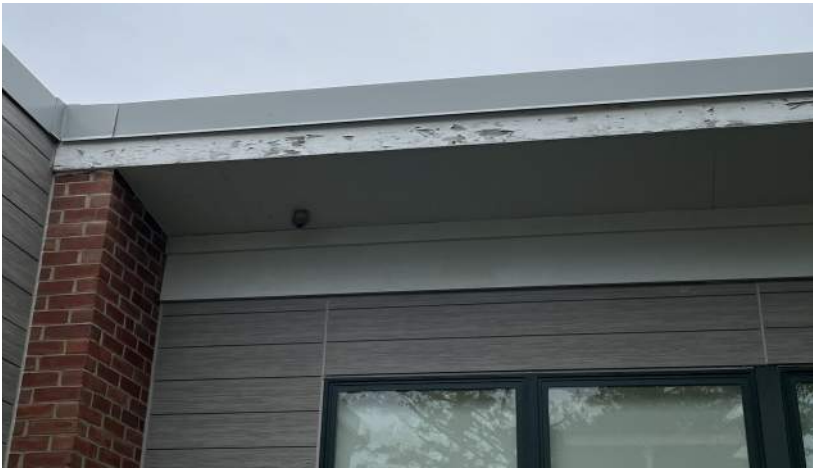
Roof Fascia Trim Requiring Repair.

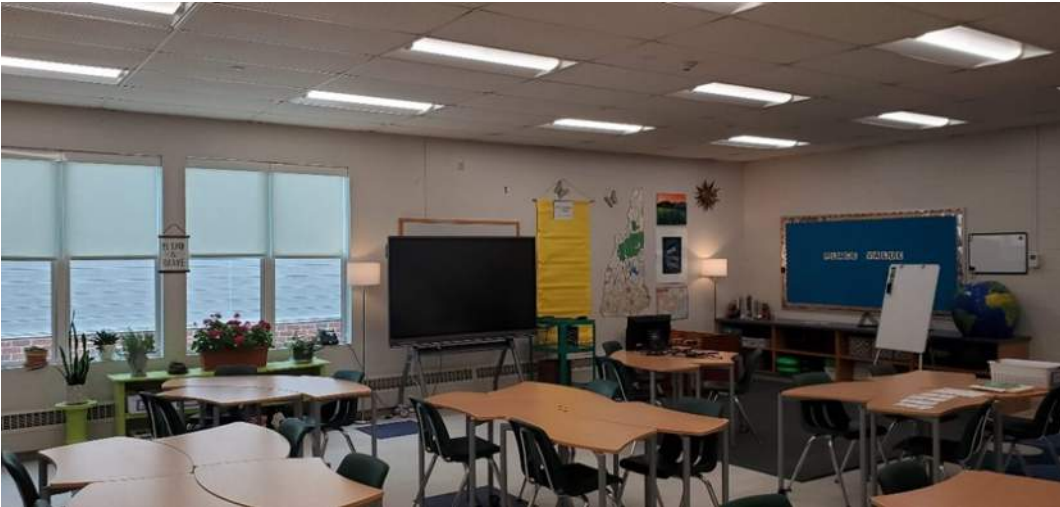
Typical Classroom with Fin Tube Radiation and No Cooling.

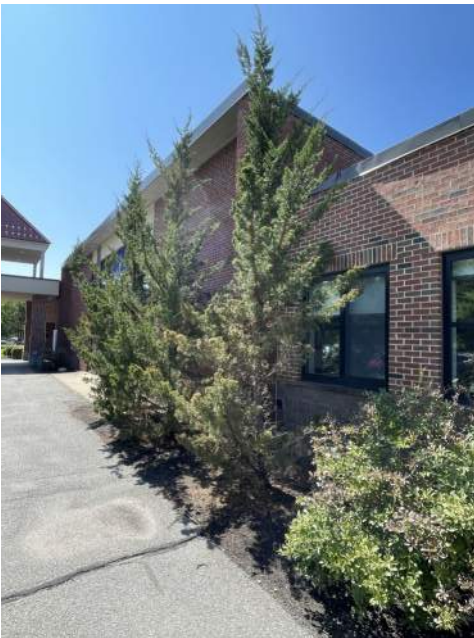
Landscaping to be Trimmed Back.

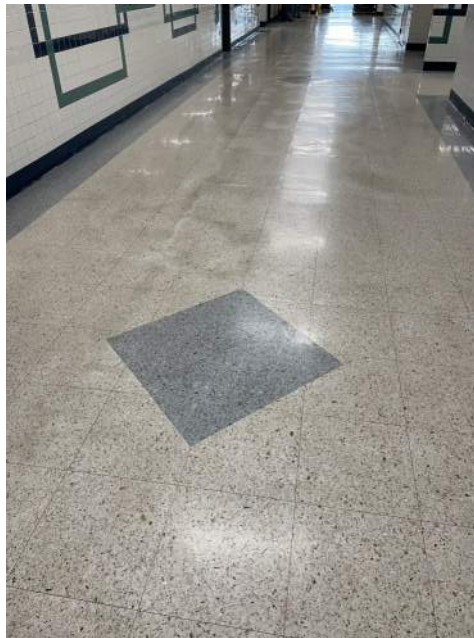
Flooring in Poor Condition.

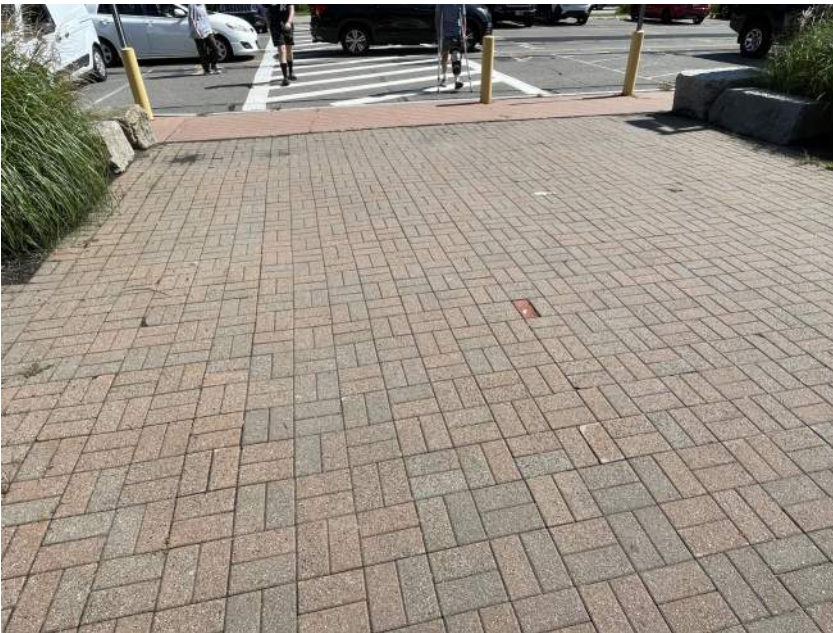
Main Entry Area Susceptible to Ponding.

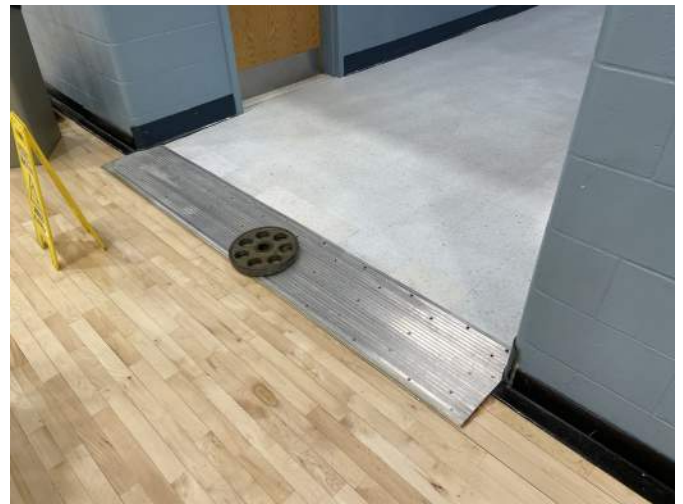
Gym Transition Strip in Poor Condition.

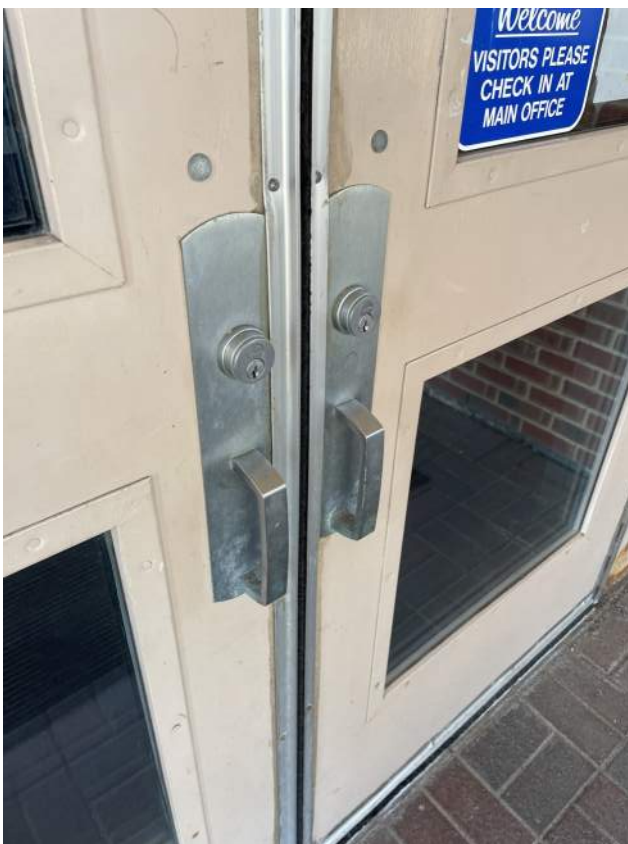
Exterior Door Hardware Recommended to be Replaced.

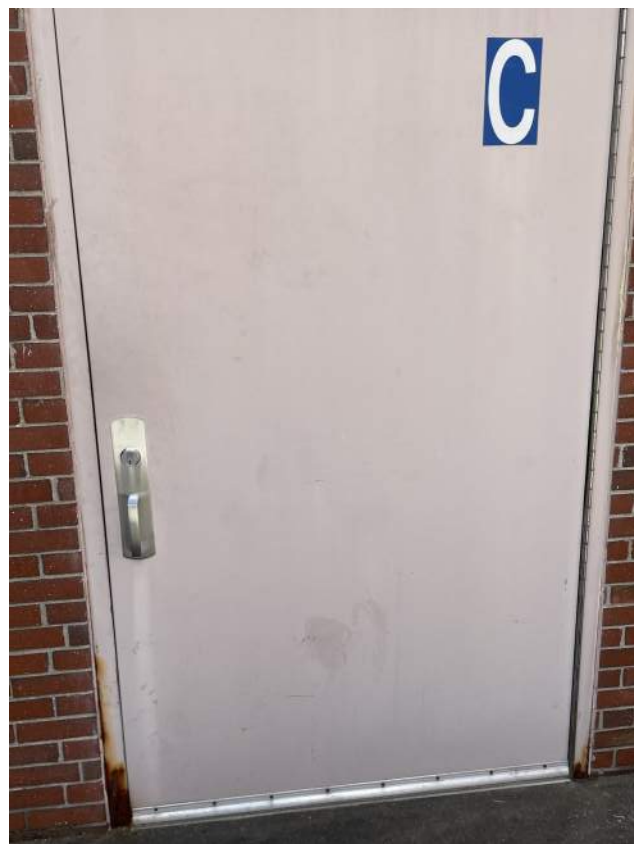
Exterior Door Corrosion.

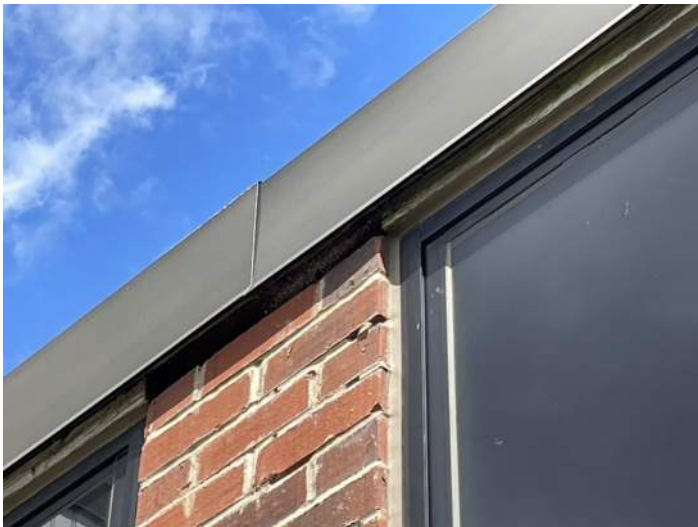
Wood Blocking in Poor Condition.

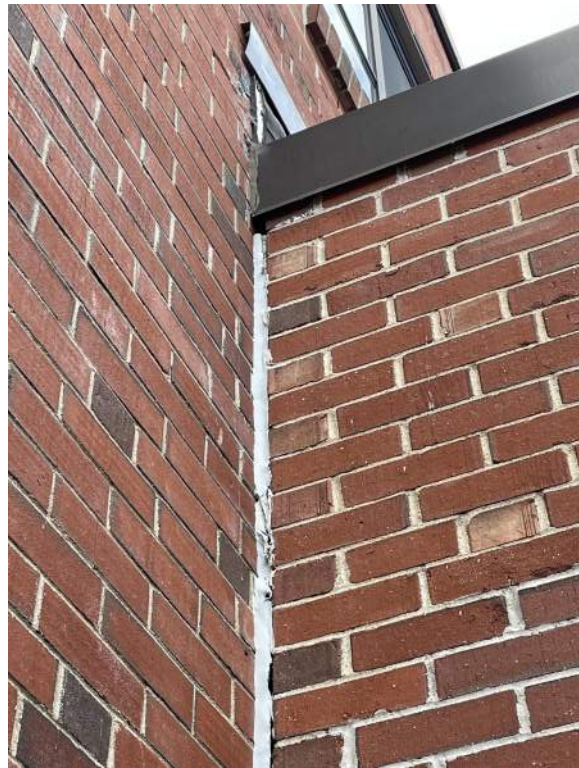
Sealants in Poor Condition.

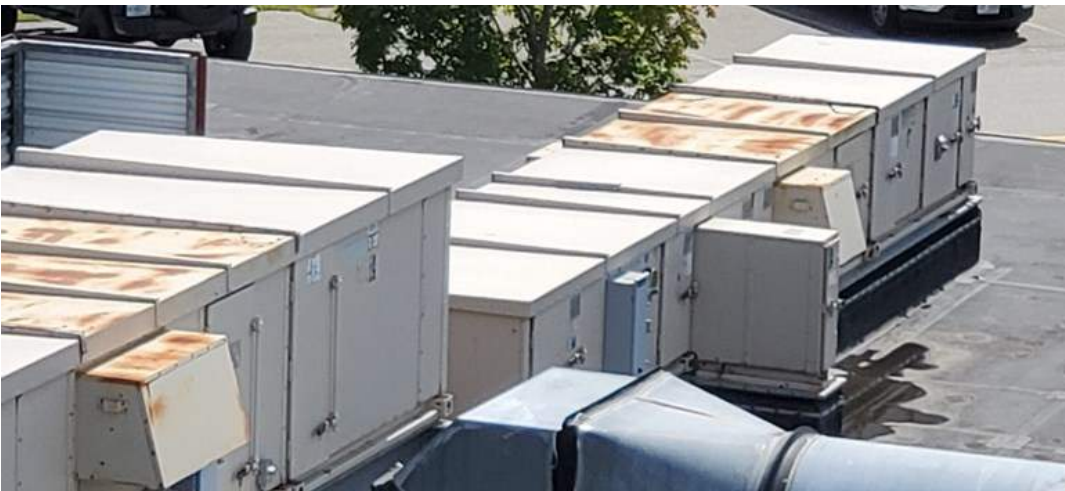
Condensate Pooling Adjacent to AHU-2.

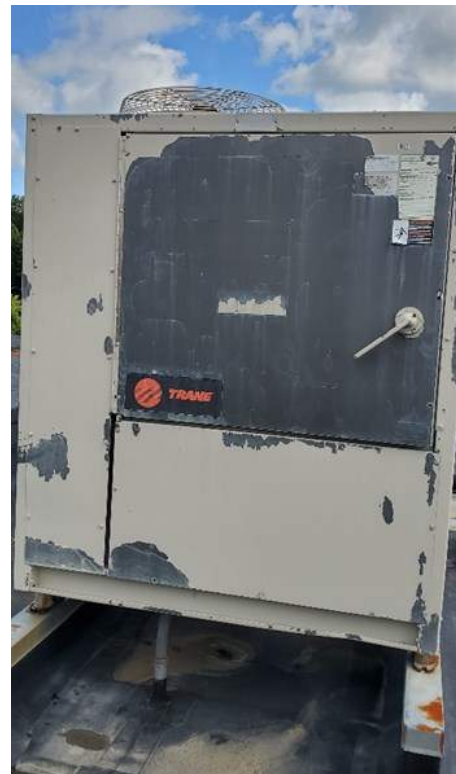
ACCU in Poor Condition.

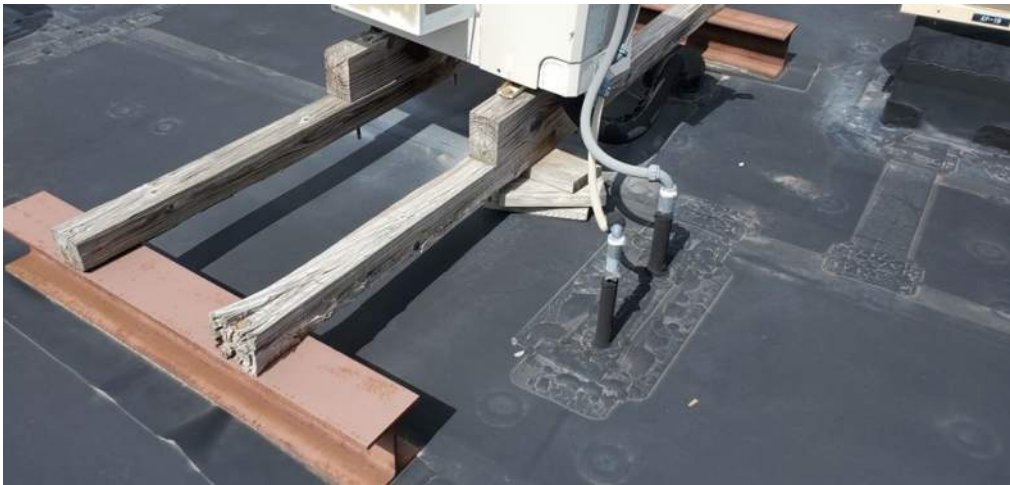
Failing Condenser Unit Supports.

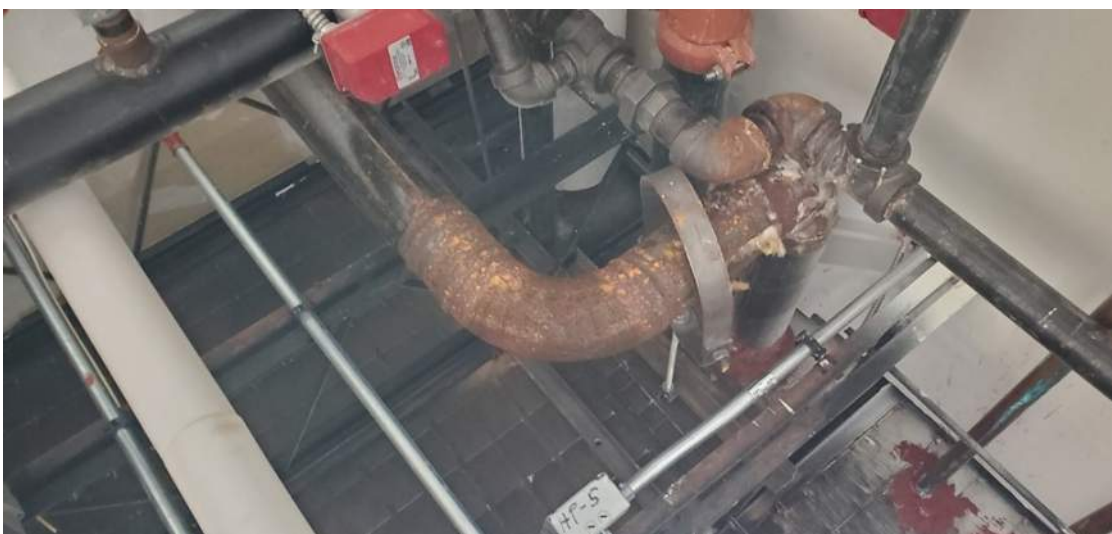
Corroded Fire Protection Piping in Compressor Room.
