AHERA 3-YEAR REINSPECTION

**Pennoyer School District #79
5200 North Cumberland Avenue
Norridge, Illinois 60706
School ID #14-016-0790-2001**

March 19, 2020

PROJECT #20-026

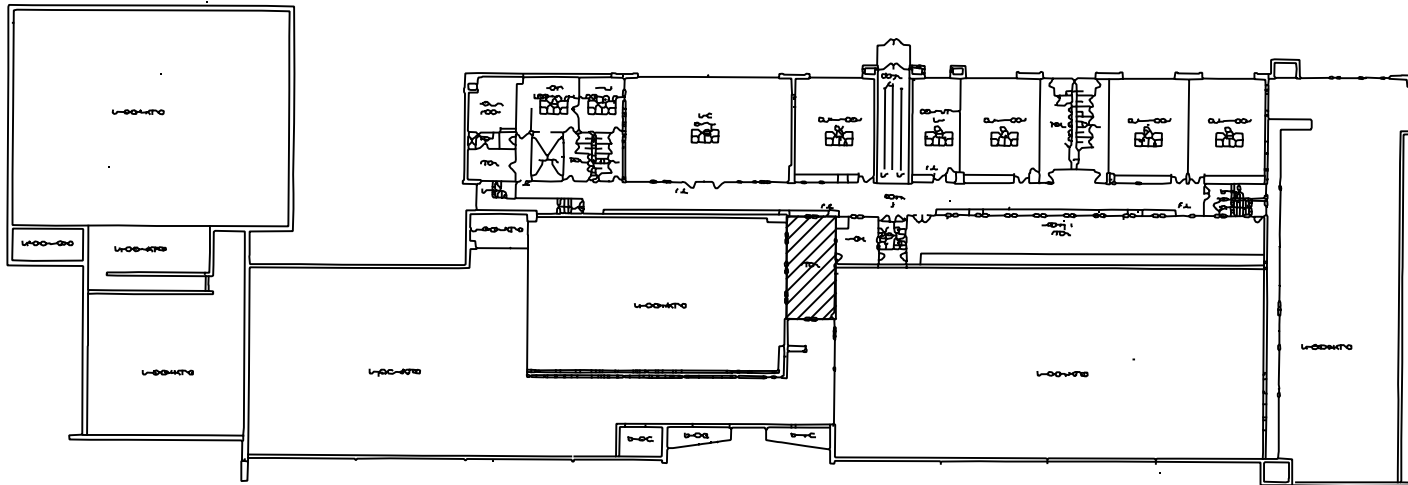
Lower Floor Plan

This floor plan defines the extent of asbestos containing floor tile/mastic found in the building.

The floor tile/mastic is assumed to be asbestos containing

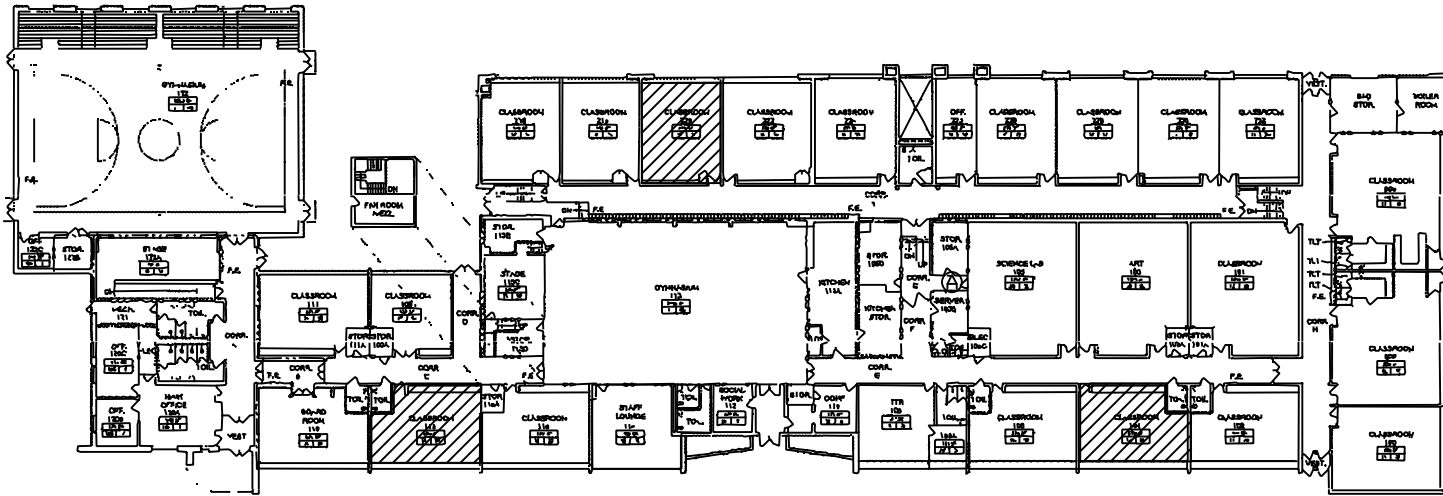
First Floor Plan

This floor plan defines the extent of asbestos containing floor tile/mastic found in the building.

The floor tile/mastic is assumed to be asbestos containing
