Epperson Ranch II Community Development District

July 2, 2026

Final Agenda Package

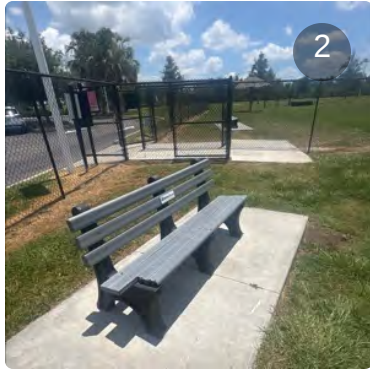
Bench at small dog park has broken slats that need to be repaired or replaced.

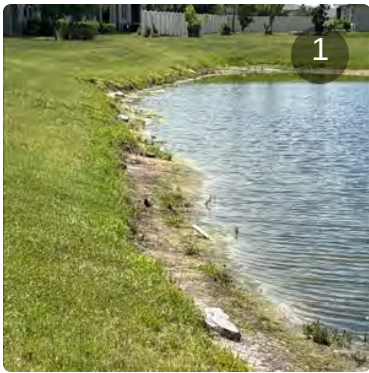
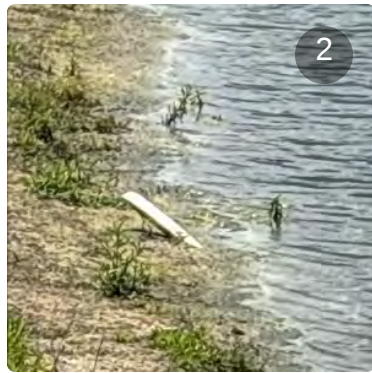
Treat undesirable weeds along pond bank 9. Also, there is an exposed broken PVC pipe along the West bank. Can this be removed or is it attached to an irrigation system?

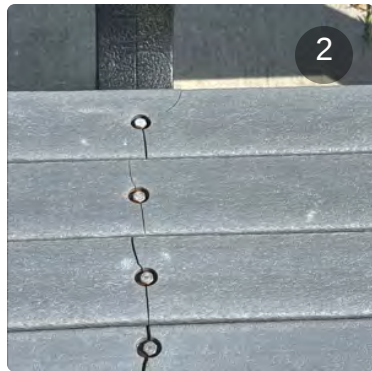
Noting a proposal is being generated to replace the broken bench at the large dog park.

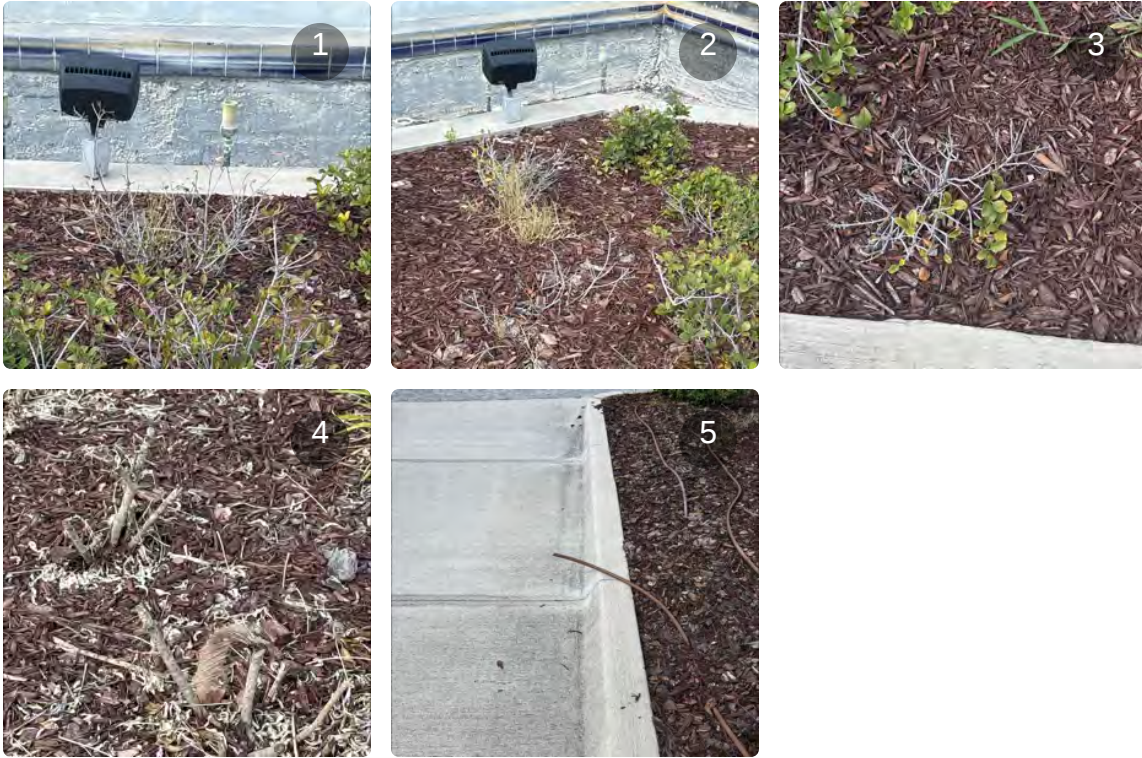
Diagnose and treat declining Indian Hawthorne in median bed of Anchor Point Dr. Remove any diseased or dead material. Noting a couple Variegated Arbutus that had rejuvenation cutbacks may need to be replaced that are not showing any new growth. There is a cut drip line over hanging the sidewalk. This is all for the entrance median of Anchor Point Drive.

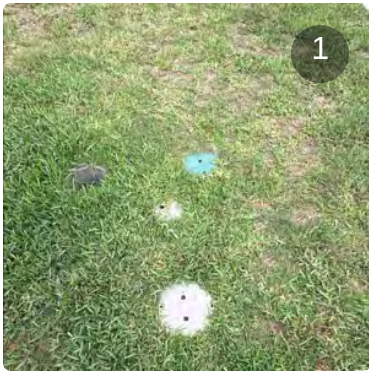
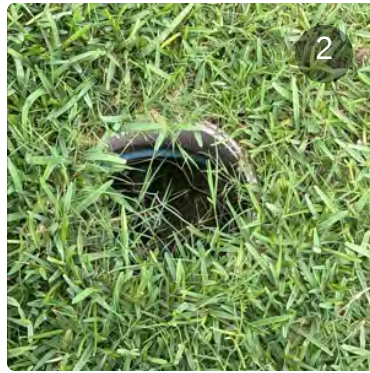
Ensure valve boxes are cleared of any vegetation on Blue Passing Loop near mailbox kiosk and pond 10. There is also a missing lid that should be replaced.

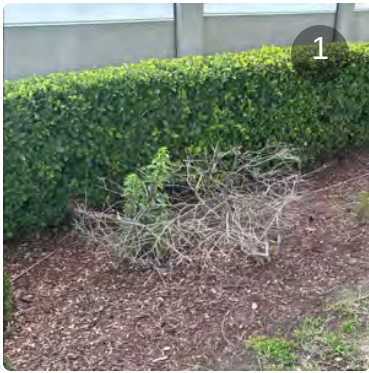
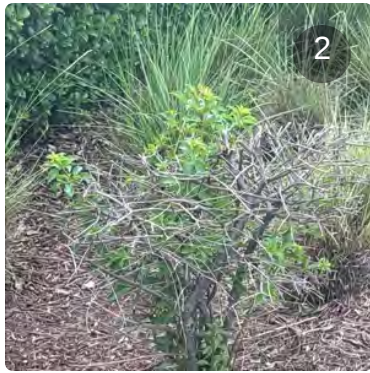
Noting Firebush are starting to push out new growth on Curley Road ROW. May want to consider fertilizing before the Nitrogen ban for the quickest recovery from the frost damage.

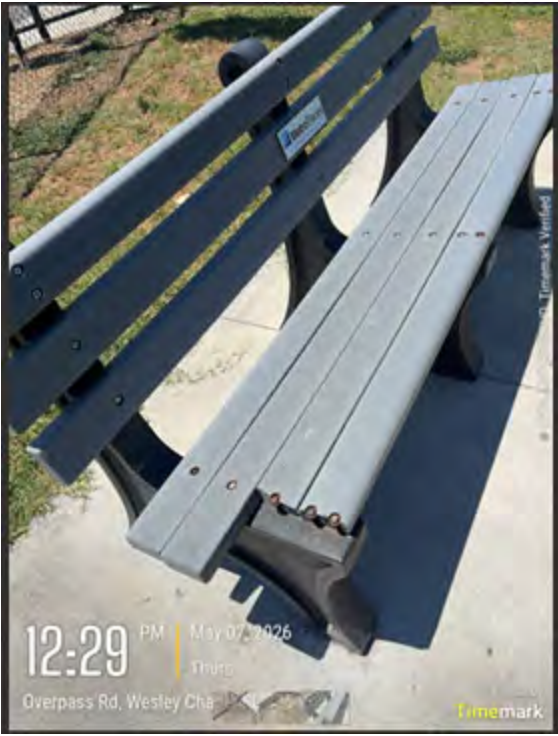
Full remove and replacement for Dog Park Bench. Too damaged to repair.

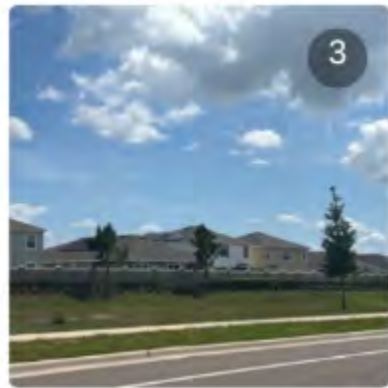
Proposal to replace the oak tree on Elam Rd that was flush cut.

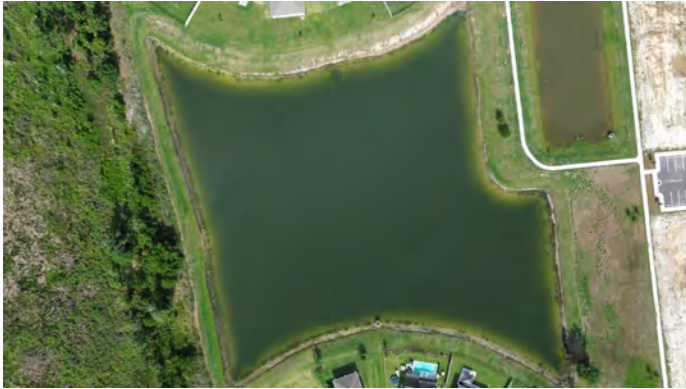
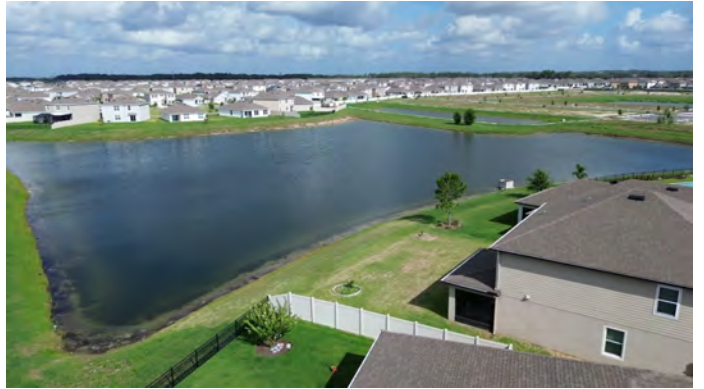
SITE: 1

Very mild nuisance grass growth on sections of the perimeter. A technician will address these during service later this week. No algae observed.

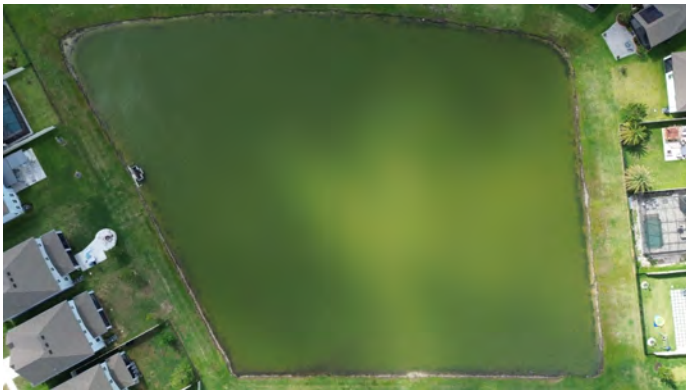
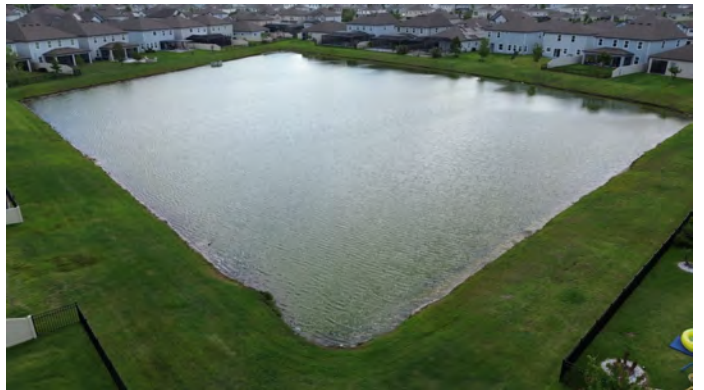
SITE: 2

Possible early signs of a planktonic algae bloom. A technician will inspect and treat if needed. Any patches of nuisance grass present will also be treated at that time.

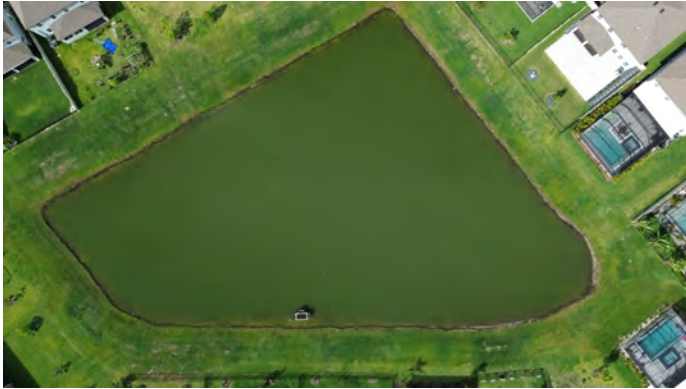
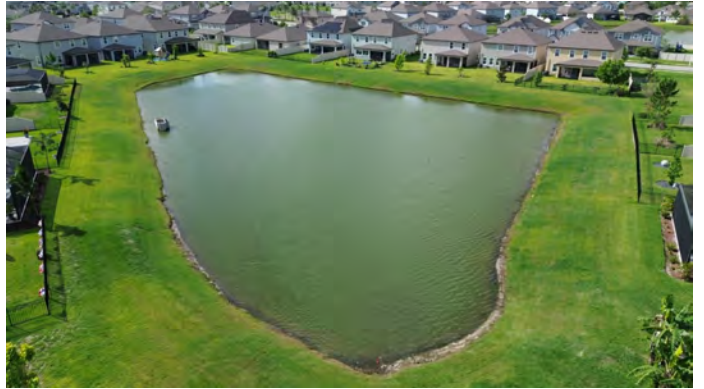
SITE: 3

Similar conditions to pond 2 as usual; possible planktonic algae bloom and mild nuisance grass. Both will be addressed during service this week.

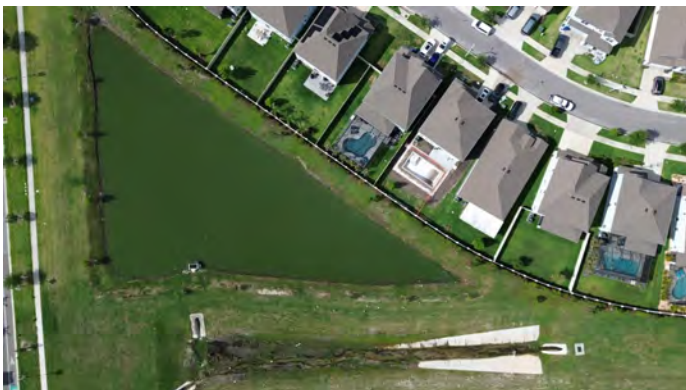
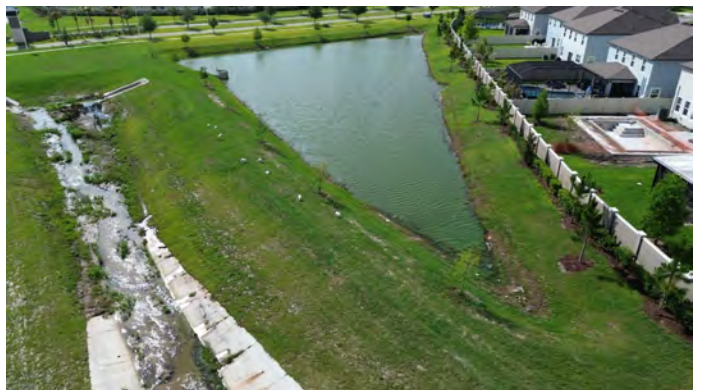
SITE: 4

It appears most of the perimeter growth is terrestrial grasses recently submerged by rain over the weekend. A technician will inspect and treat if needed. No algae observed.

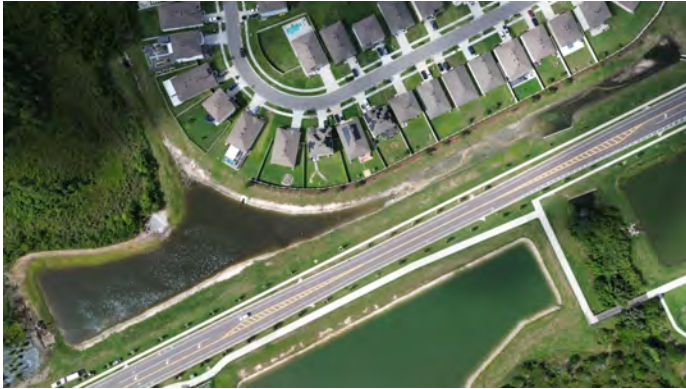
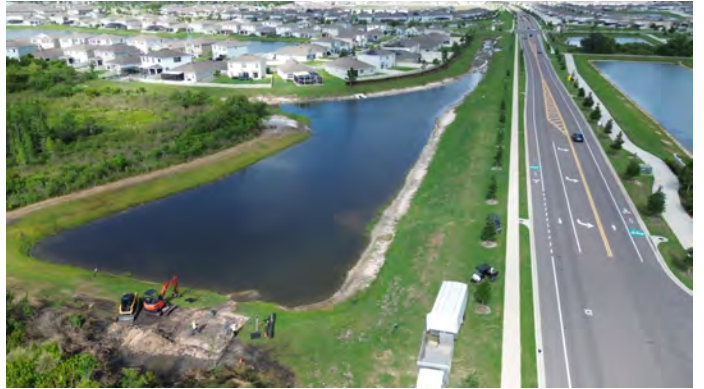
SITE: 5

Nuisance grasses present along the water's edge. These will be treated before water levels rise and they become submersed. No algae observed.

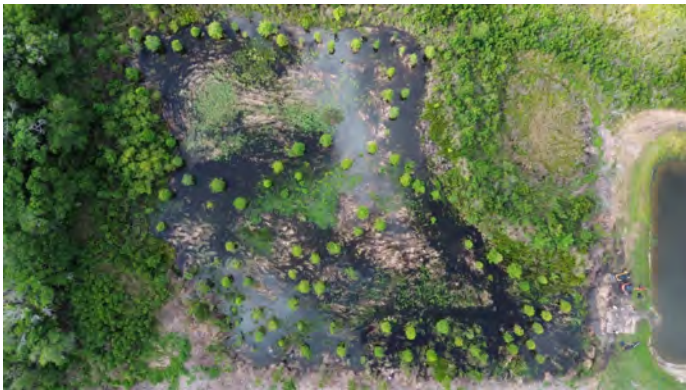
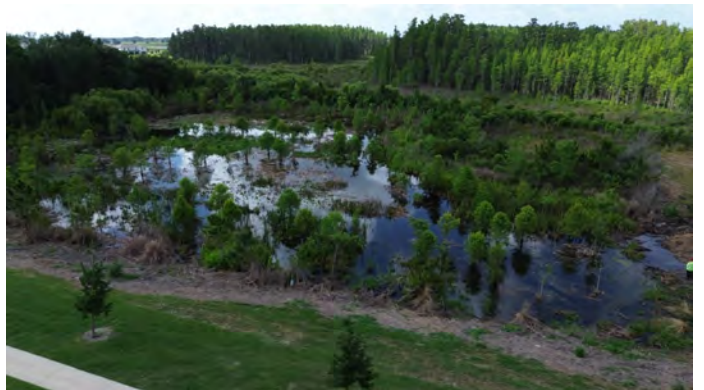
SITE: 6

Recent efforts to reduce invasive growth within the wetland are much clearer now that it is holding water. Much of the decayed growth is underwater or detached and floating. A little more rain will help clear this further.

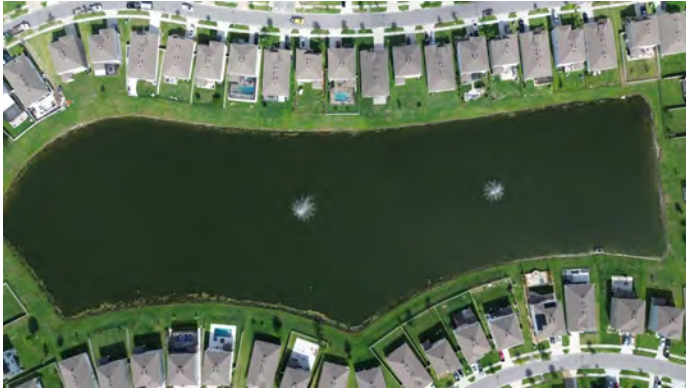
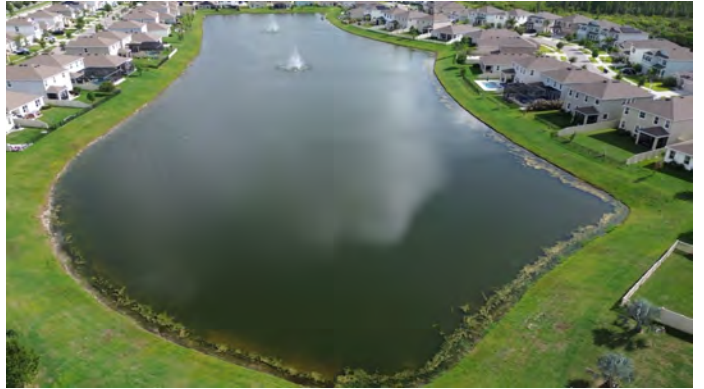
SITE: 7

Filamentous algae present around the perimeter. It appears fresh, likely from a nutrient influx after the weekend rains. A technician will treat for this and any patches of nuisance grasses during service this week.

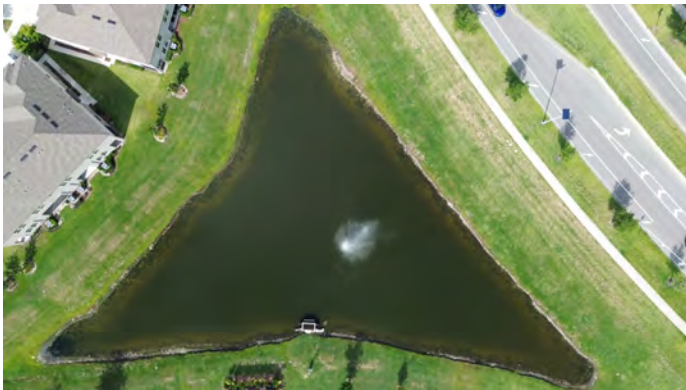
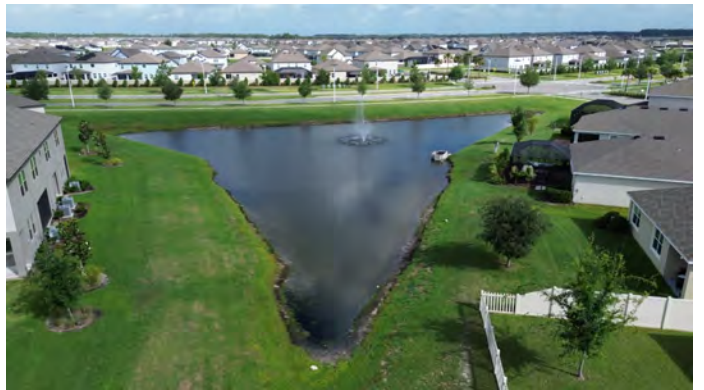
SITE: 8

One patch of decayed algae present and headed for the outflow to be flushed. Nuisance grasses present at the water's edge. A technician will address these later this week.

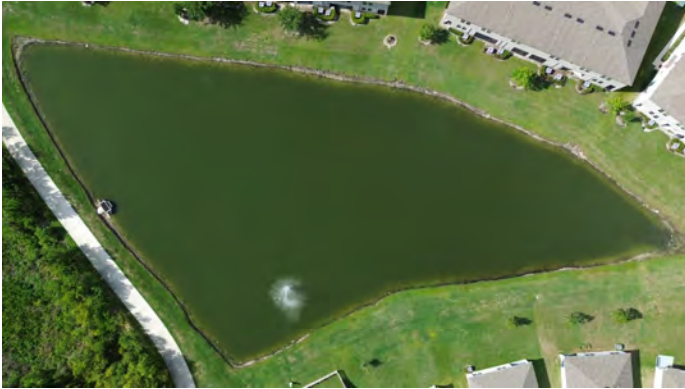
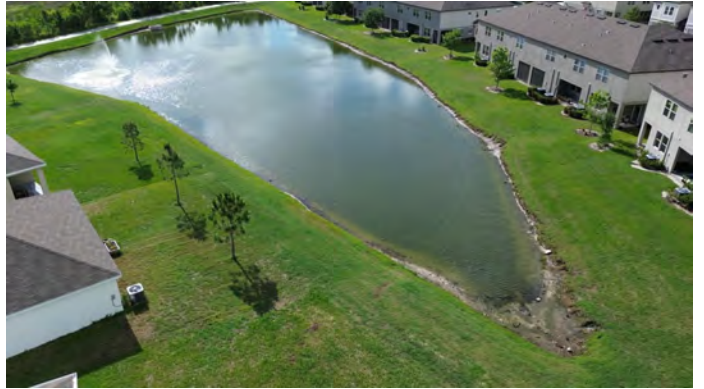
SITE: 9

Terrestrial weeds submerged by rain present near the shoreline. Otherwise the pond is in excellent condition.

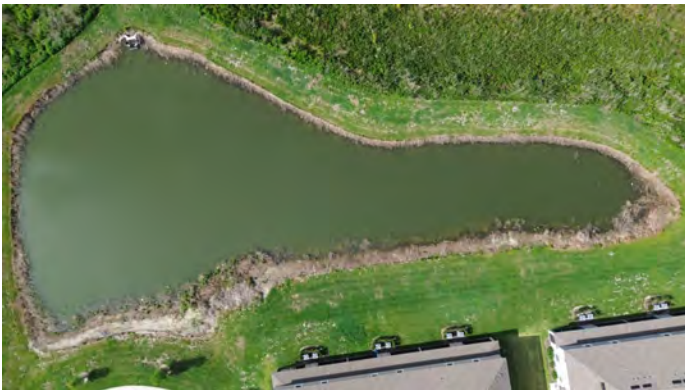
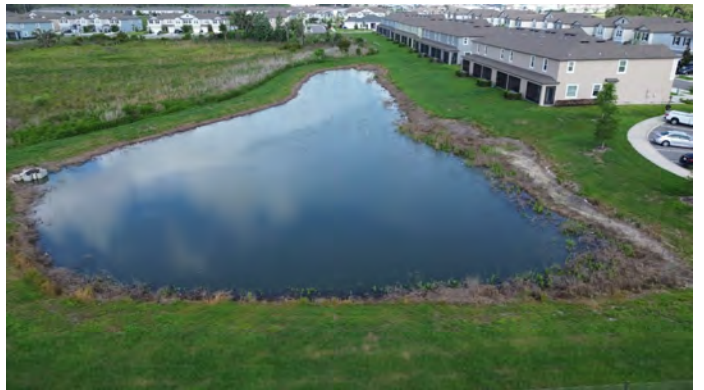
SITE: 21

Terrestrial weeds present on exposed and recently submerged shoreline. treatment will be applied if they do not decay on their own from drowning. No algae observed.

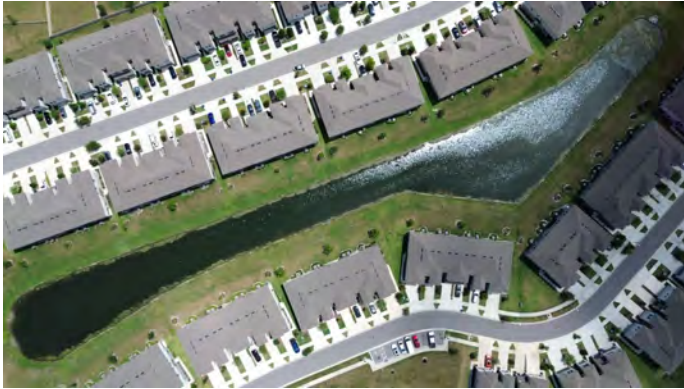
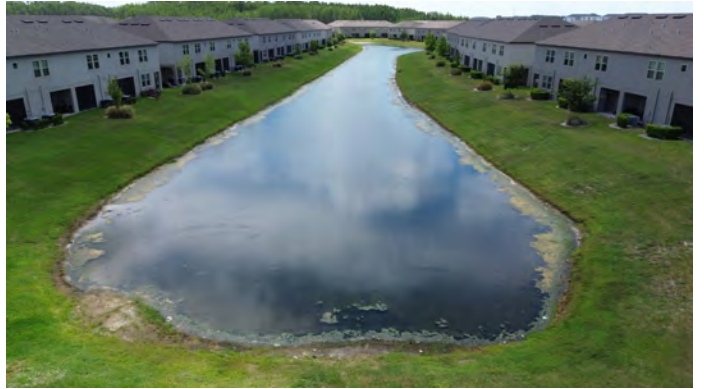
SITE: 10

As we'll see on most ponds today, algae blooms have appeared. I have informed the technician set to treat later this week about conditions so he can prepare accordingly.
 This pond has a tendency to bloom around the perimeter so it can be easily treated from the shore.
 No nuisance grass observed.

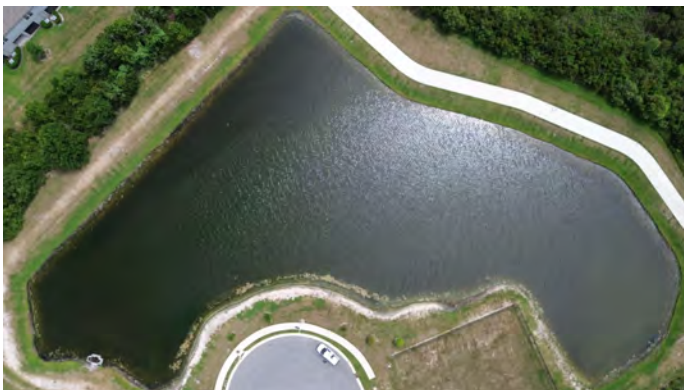
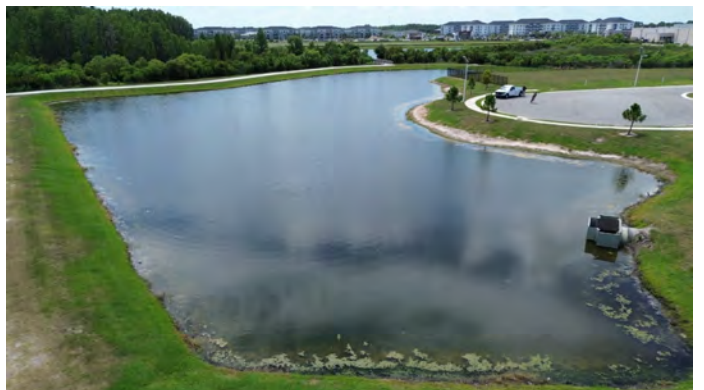
SITE: 11

Mild filamentous algae bloom present. This will be hit preemptively this week to prevent a larger bloom.
 Any nuisance grasses present are decaying.

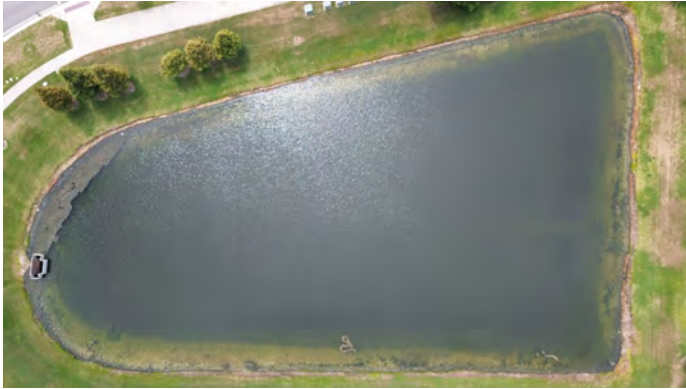
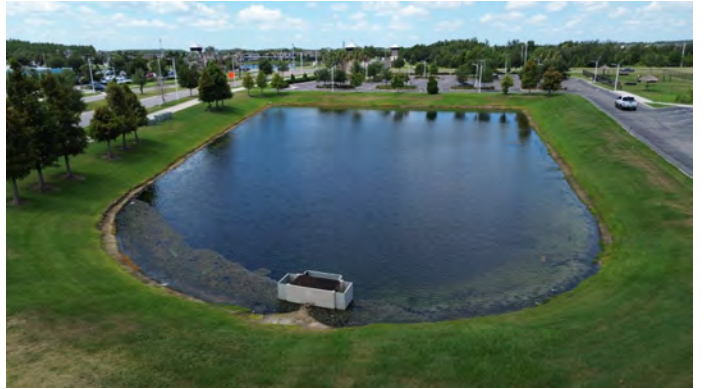
SITE: 12

Any algae present is decaying. Another round of algaecide will be applied if needed.
Any nuisance grasses present are decaying.

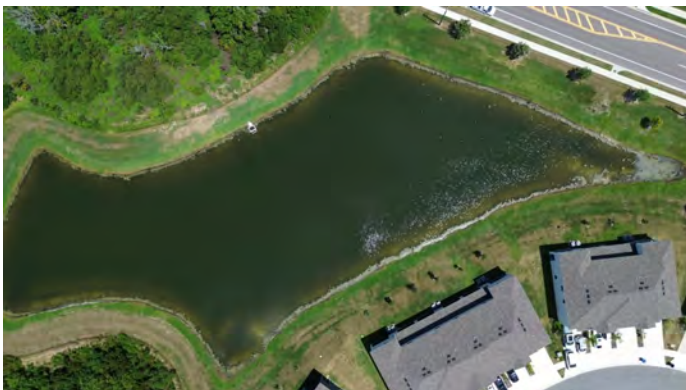
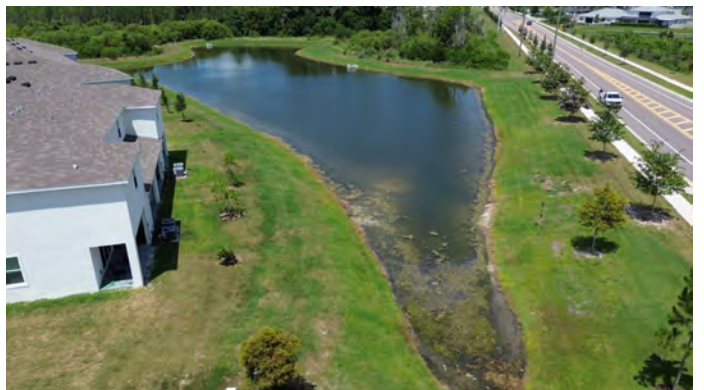
SITE: 13

The algae is contained to the shallow areas and shoreline where water is warmest. The perimeter growth is thin which will allow for better coverage when treated. No nuisance grasses observed.

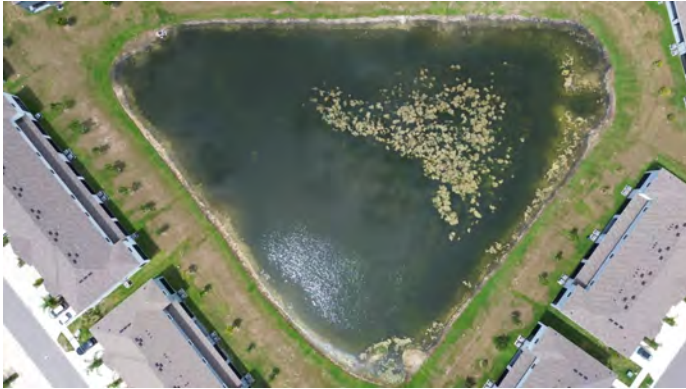
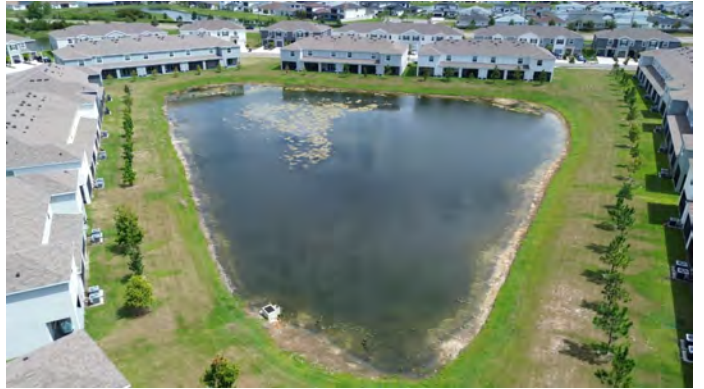
SITE: 14

Perimeter and offshore algae present. If shoreline treatments do not clear the growth in the middle, an amphibious vehicle can be deployed to address it. No nuisance grasses observed.

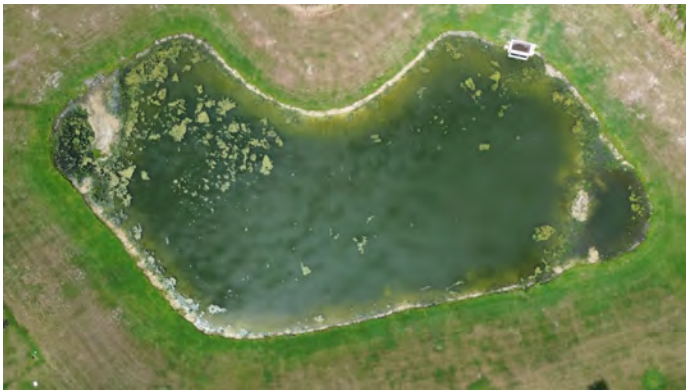
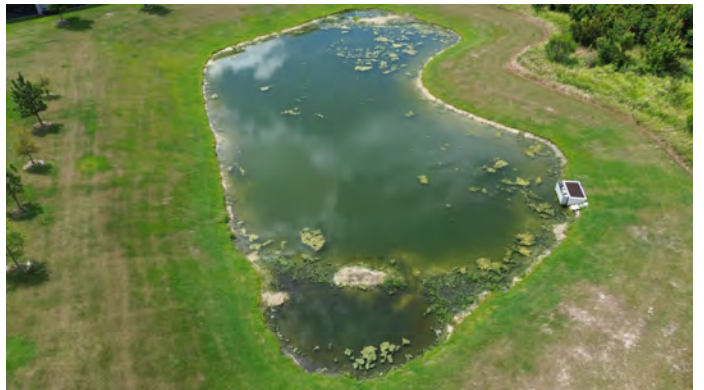
SITE: 15

This pond is small and shallow, making it more susceptible to algal blooms. Any mats present appear close enough to the edge to be treated from shore later this week. Nuisance grasses present will be addressed at that time as well.

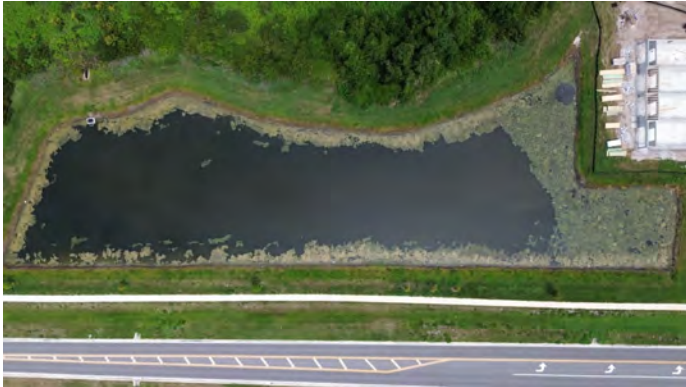
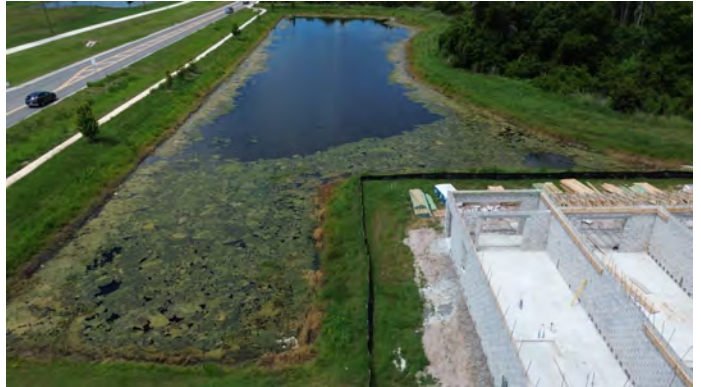
SITE: 16

There is a pipe discharging water from the construction site into the pond. This is likely flooding the pond with nutrients which are feeding algal growth. We will treat with everything we have to slow down the growth, but it won't truly improve until the discharge stops. I have a closer photo of the pipe attached at the end of this report. Nuisance grasses will benefit from the nutrient influx as well, but will be treated nonetheless.

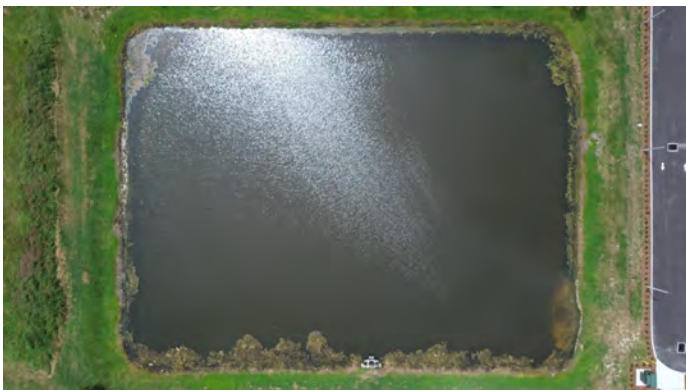
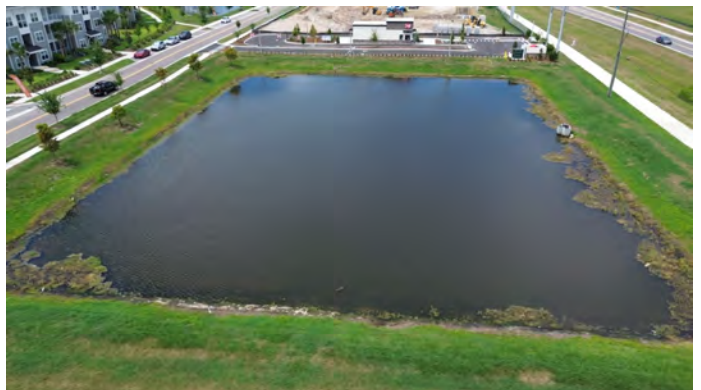
SITE: 17

Perimeter algal growth present. This will receive the same algaecide treatments as all other ponds listed. No nuisance grass observed.

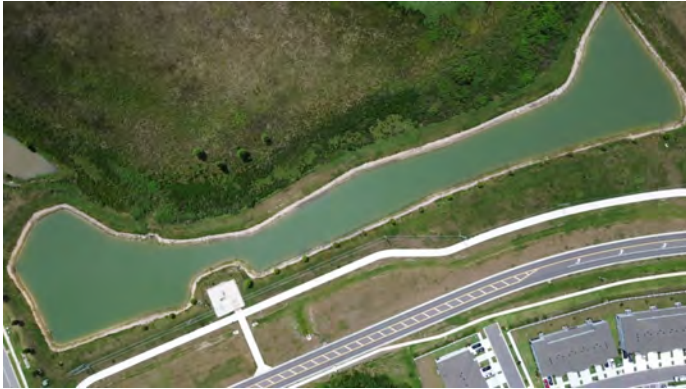
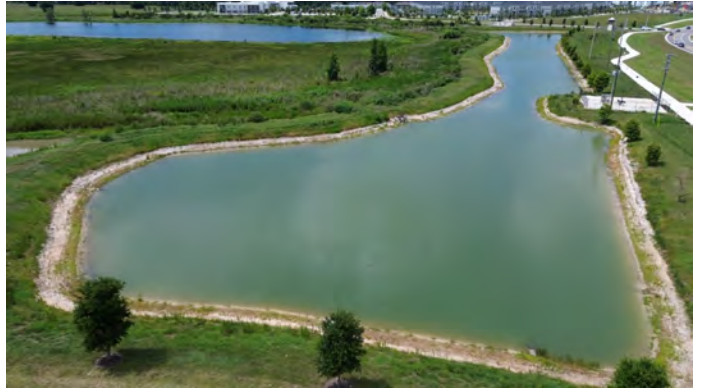
SITE: 18

Surprisingly good conditions given the state of every other pond. Any nuisance growth present is terrestrial weed which will drown once water levels return. No algae observed. Turbidity present.

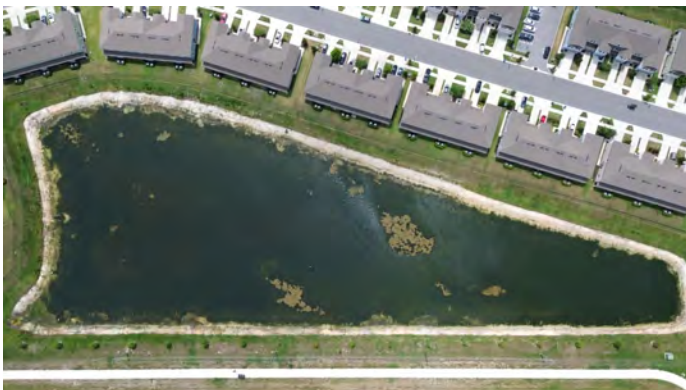
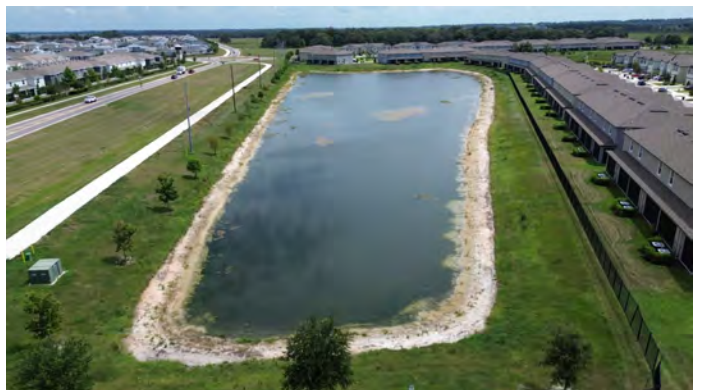
SITE: 19

Filamentous algae bloom present. Algaecide treatments will be done from shore, though this pond will likely benefit more from an amphib treatment. There appears to be submersed growth in the center that will need treatment from the XTV. Offshore grasses will also be addressed during that service.

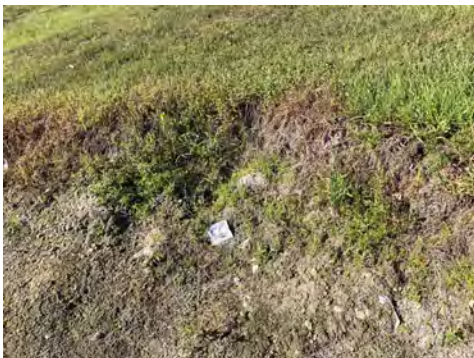
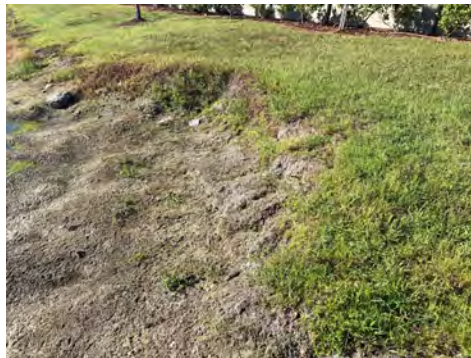
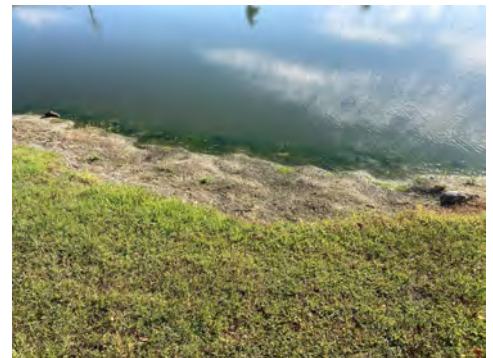
DESCRIPTION	QTY	RATE	AMOUNT
Erosion repair on pond 4 at Epperson Ranch II CDD.			
Scope of work to include: - Partially fill two washouts with dirt then tamp to compact and level. - Install a staked Geoweb system and fill cells with more dirt. - Cover the system and tamp further. - Lay C350 erosion mat over the repair. - Install Bahia sod	1.00	3,300.00	3,300.00
