Copperspring Community Development District

**Board of Supervisors' Meeting
March 10, 2026**

LANDSCAPE INSPECTION REPORT

February 18, 2026

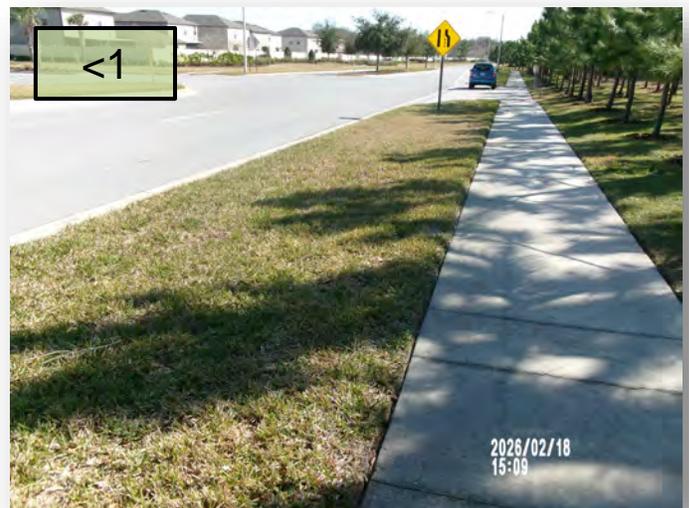
1. Copperspring Blvd: At the entrance Bahia encroachment along the ROW's, browning and mixed broadleaf weeds; spec calls for primarily St. Augustine. Suggestion – Selective Bahia suppression: Spot-blanket with Celsius WG (St. Augustine-safe) for mixed broadleaf + some grassy weeds, early AM is best. St. Augustine restoration: Where Bahia dominance plan plugging or sodding with St. Augustine 'Floritam' to match existing. Fertility: (Pic 1>) - **Complete.**

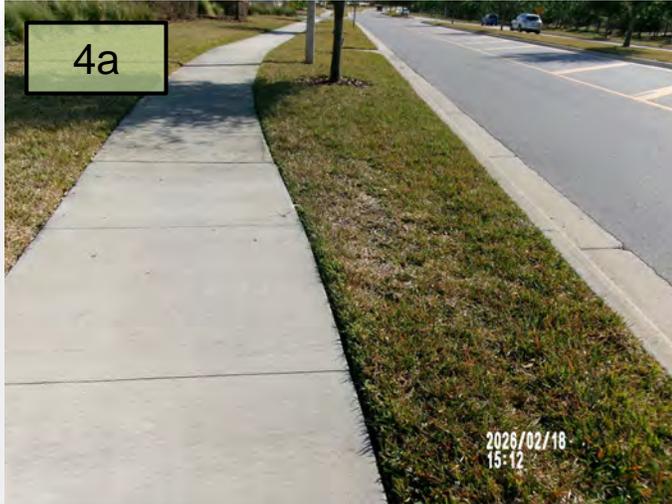
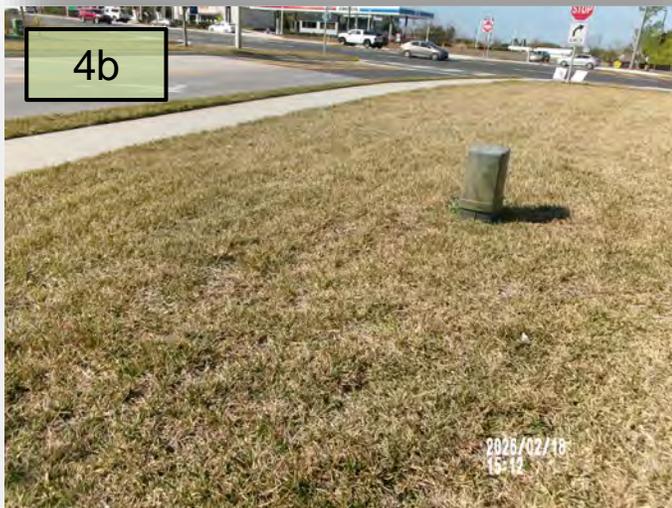
4. **Copperspring:** Along the east side of entrance and the ROW's, the turf is patchy, brown, and wild geraniums are growing throughout the area. Spot treat the geraniums, plug the St. Augustine in bare areas (if it becomes any worse), and follow with 0.5 lb. N/1,000 sq ft slow-release; add chelated Fe for color without surge growth. (Pic 4a, 4b) - **Complete.**

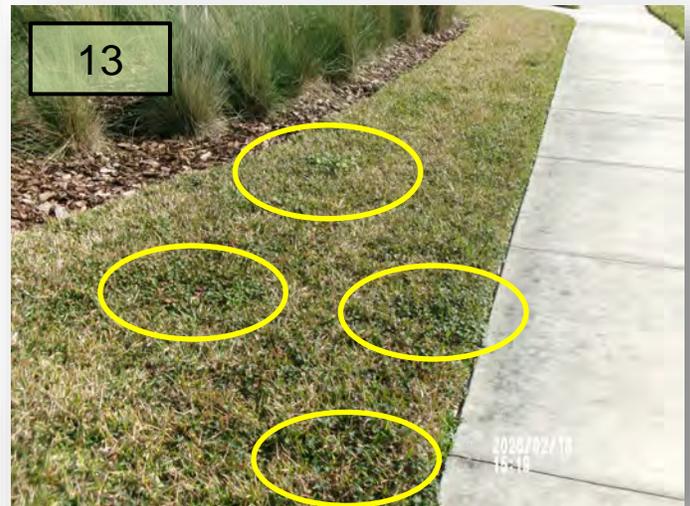
13. Wild Geranium– Water Hemlock & Copperspring Blvd: More geraniums present in the turf, throughout this area. Treat as needed. (Pic 13) - In progress.

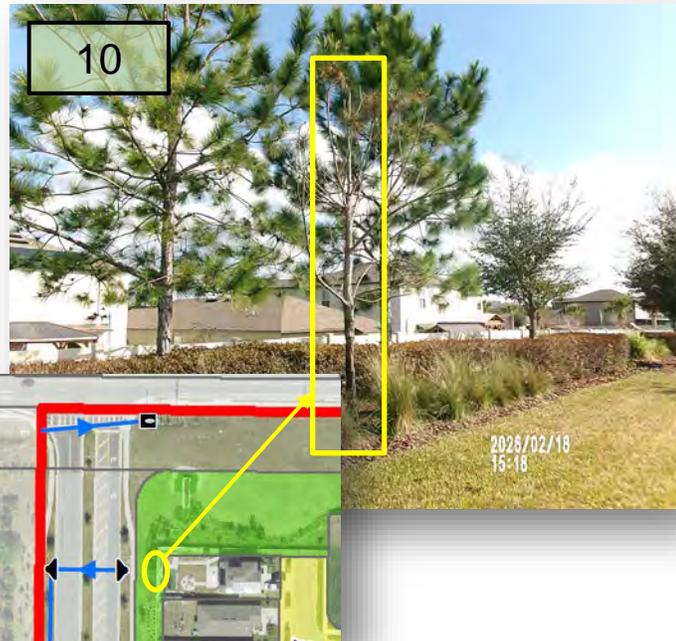
10. Declining Pine Tree – South of Copperspring Entrance Sign: One pine showing canopy thinning and overall decline. No visible evidence of pine borers; some green needles still present. Recommend scheduling an arborist to assess health and root conditions. Continue monitoring weekly for changes in canopy density, needle drop, or signs of pest activity. (Pic 10) - Complete.

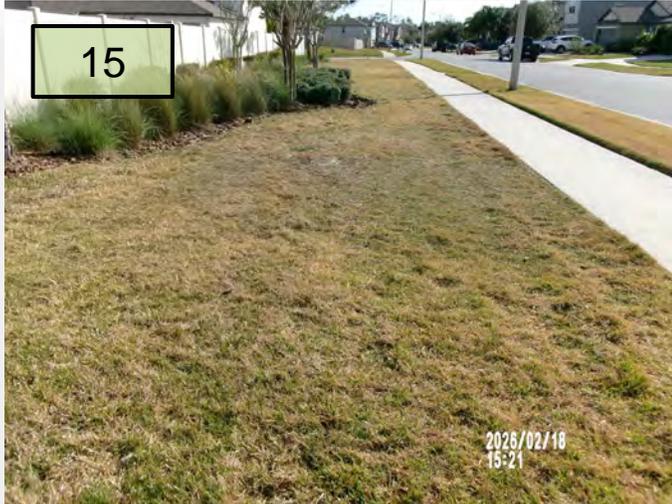
15. Turf Decline – Gainer Springs Ave: Turf is becoming increasingly patchy with....(Nxt pg)

(#15 Cont.).... each visit, and during the most recent inspection the grass appeared flattened, as if it had been compressed or damaged. Broadleaf and grassy weeds are actively spreading and require targeted treatment. Recommend evaluating for stress sources (traffic, irrigation, or pest pressure) and applying appropriate weed control and turf recovery measures. (Pic 15) - **Complete.**

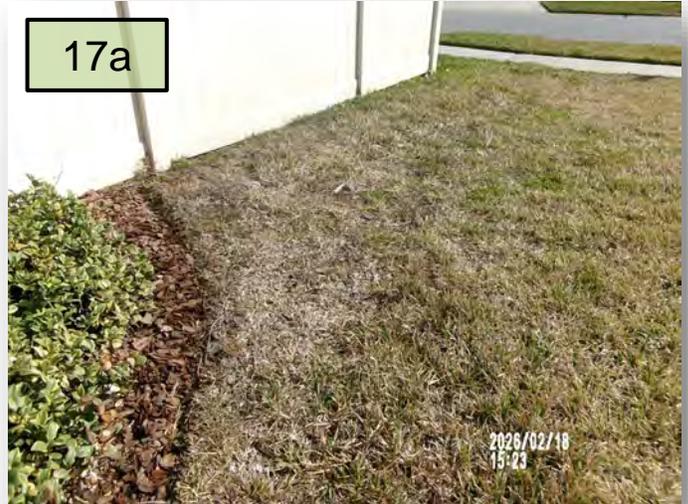
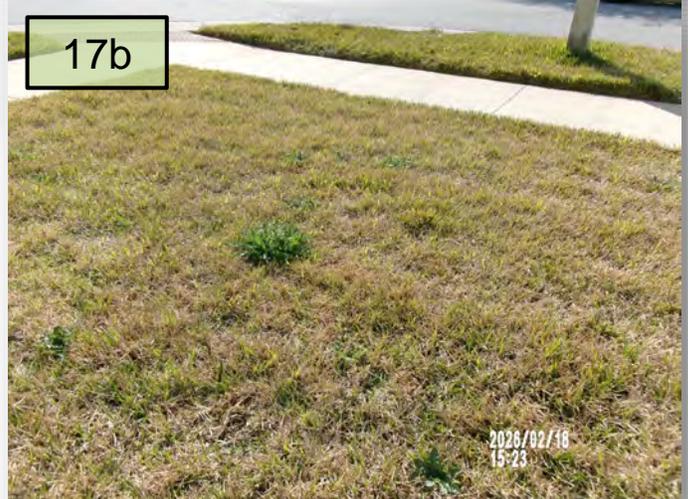
17. Gainer Springs Pocket Park (South End):
The turf is showing increased levels of stress and thinning, since my last visit. I recommend adjusting the fertilization program in this area to support recovery and improve turf density. (Pic 17a, 17b) - **Complete.**

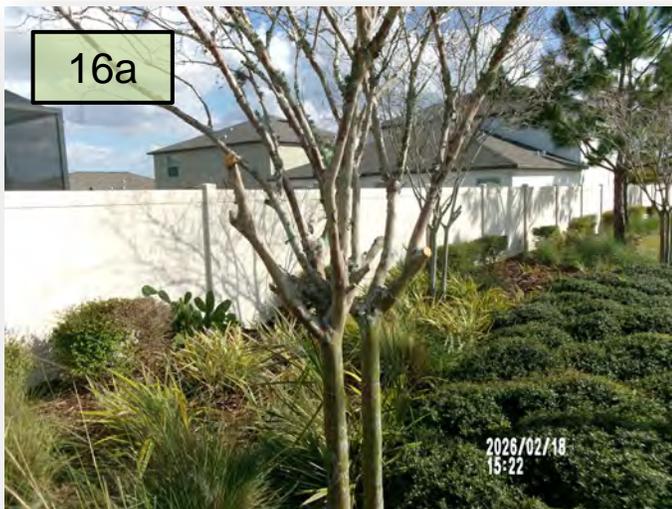
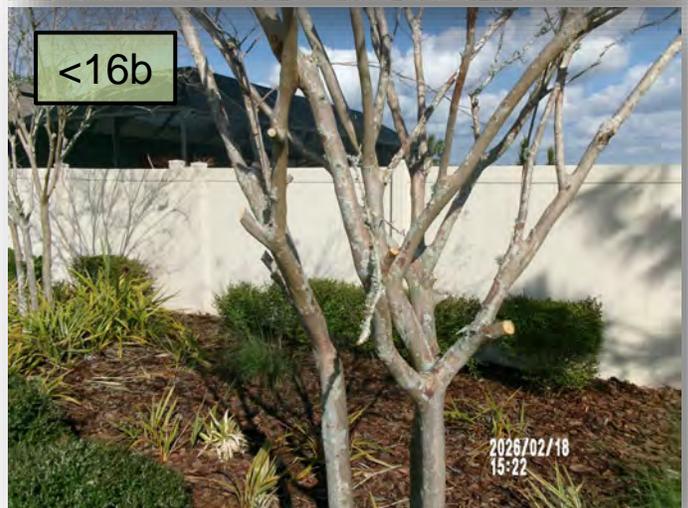
16. Crape Myrtle Pruning – Gainer Springs Ave: The 3 crape myrtles appear to have been improperly pruned, showing signs of severe and uneven cuts consistent with poor-quality pruning practices. These trees need to be revisited and properly corrected by a trained crew to restore natural structure and prevent long-term canopy deformity. (Pic 16a, 16b) - **In progress.**

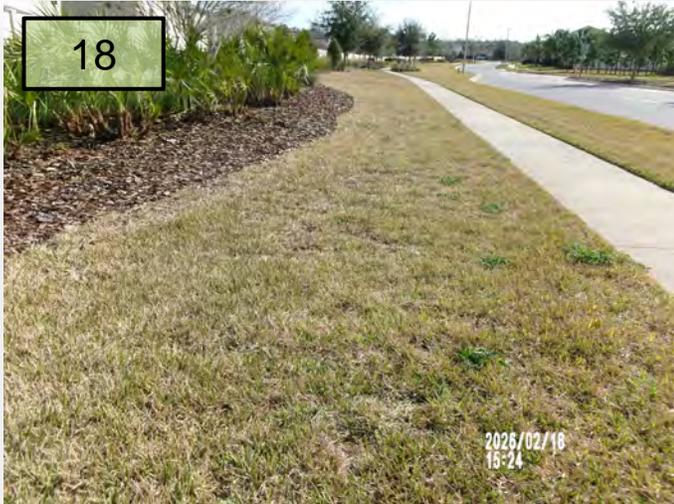
18. Turf Stress & Weed Presence – Water Hemlock (South Side): Similar to the conditions on Gainer Springs, the turf along the south side of Water Hemlock is becoming increasingly patchy and stressed. Broadleaf and grassy weeds are actively spreading and require treatment. (Pic 18) - Complete.

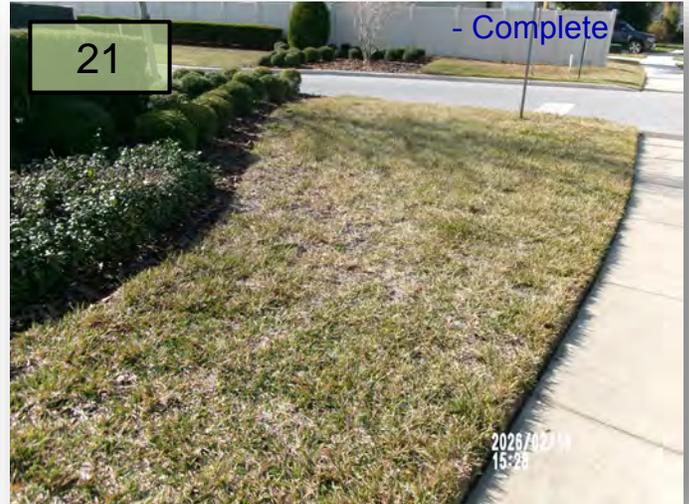
21. Turf Decline – Mail Kiosk Parking Area: The turf area adjacent to the mail kiosk parking lot is showing visible decline and thinning. Recommend identifying the affected section, evaluating for contributing stress factors (foot-traffic, irrigation, soil compaction, or pests), and treating the turf as needed to support recovery and restore uniform density. (Pic 21) - Complete

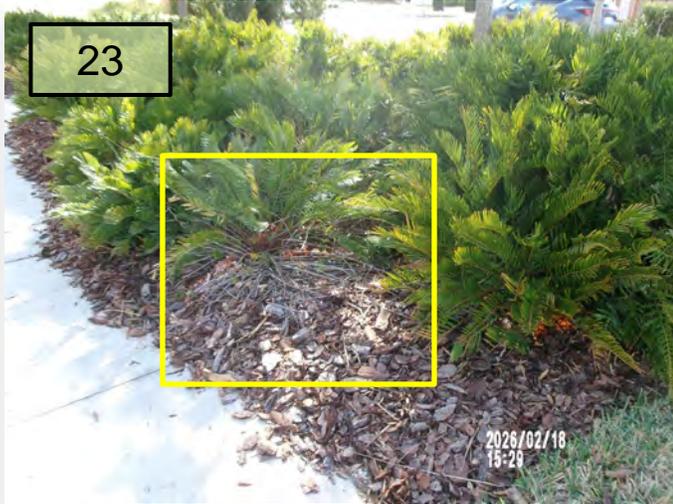
23. Coontie Palms – Mail Kiosk Area: Several coontie palms still contain dead and broken fronds that were not fully removed during previous maintenance. A section of broken branches remains lodged within the plant. Recommend returning to properly remove all dead material and clear out remaining debris. (Pic 23) - Complete.

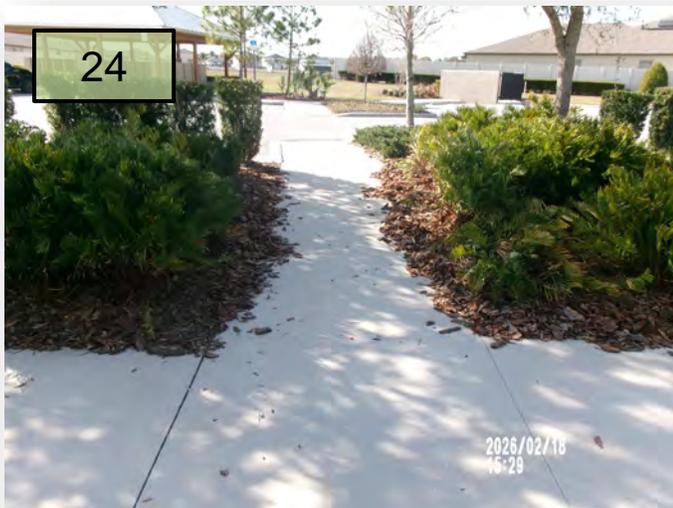
24. Mail Kiosk Walkway: Excess mulch has been installed along the walkway leading to the mail kiosk, resulting in mulch spilling onto the concrete surface. Recommend removing the surplus mulch, redistributing it to nearby thin areas as needed, and thoroughly blowing off the walkway to maintain a clean, safe, and tidy path. (Pic 24) - Complete.

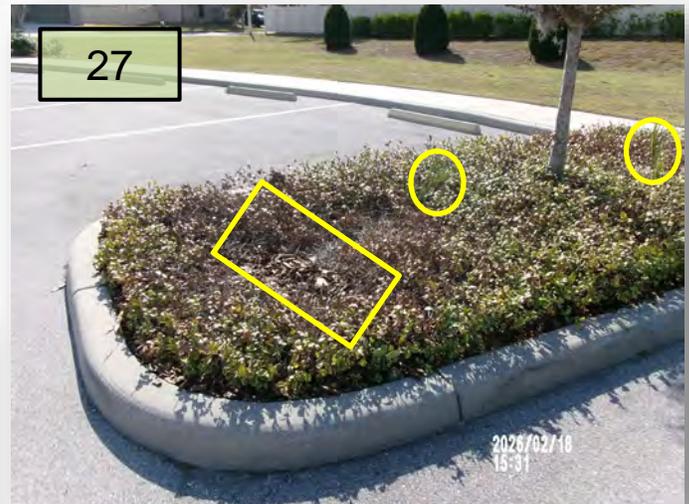
27. Jasmine Bullnose Planting Beds – Mail Kiosk Parking Lot: The jasmine bed has a small concentrated mulch pile left on top of the vine canopy instead of being evenly dispersed. Recommend redistributing the mulch and adding the overflowing mulch from the walkway beds. Additionally, remove the palm saplings that are emerging within the jasmine planting area. (Pic 27) - Complete.

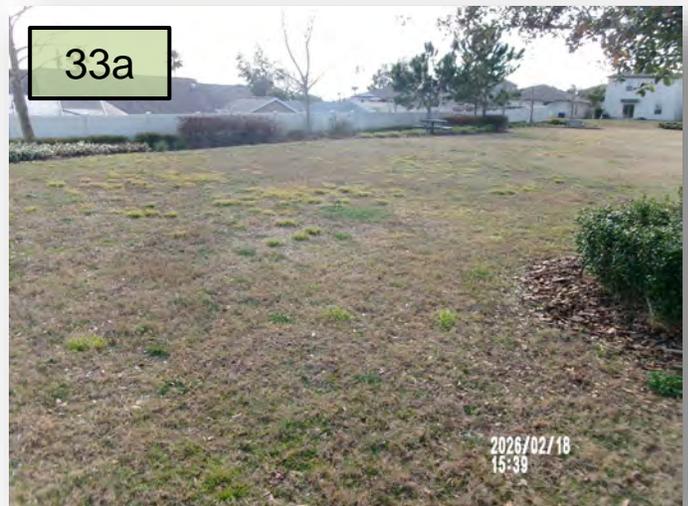
33. Turf Recovery Plan – Spider Lily Park:

Park turf remains heavily infested with broadleaf and grassy weeds. Request a comprehensive recovery plan from RedTree including inspection/diagnosis, weed suppression (pre- and post-emergent), fertility adjustments, irrigation tuning, selective turf replacement (plug/sod), and a 60–90-day timeline with QA checkpoints. (Pic 33a, 33b>) - Complete.

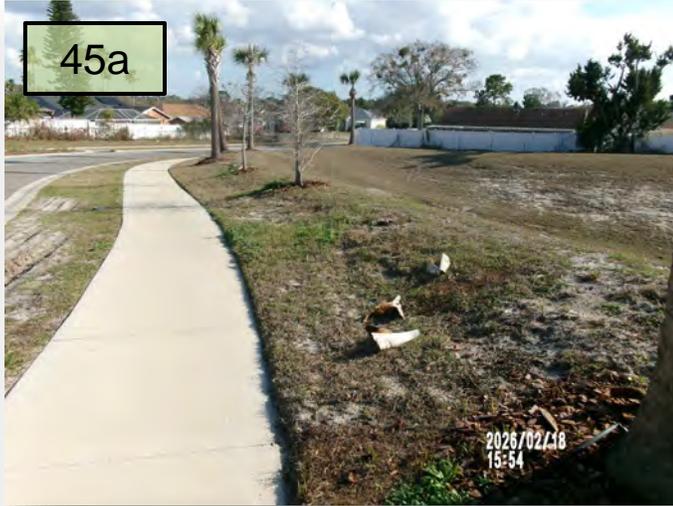
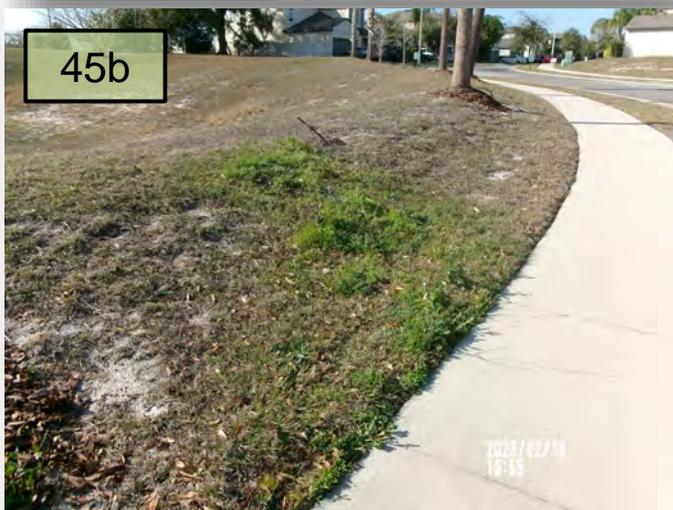
45. Dead End of Hanover – Palm Debris & New Weeds in Mulch: Significant palm boots have fallen and remain on the ground at the dead end of Hanover. In addition, newly installed mulch in this area already has active weed growth. Please confirm when this area was last treated for weeds, and schedule removal of the palm debris along with a full weed treatment. (Pic 45a, 45b) - **Complete.**
