# **Glen St. Johns Community Development District**

**Board of Supervisors'  
Meeting  
December 10, 2025**

## ENGINEER'S 2025 ANNUAL REPORT

The purpose of this Annual Engineer's Report is to provide the Board of Supervisors of the Glen St. Johns with a summary of the District's public infrastructure, inspections preformed, maintenance activities observed, and recommendations for the upcoming fiscal year.

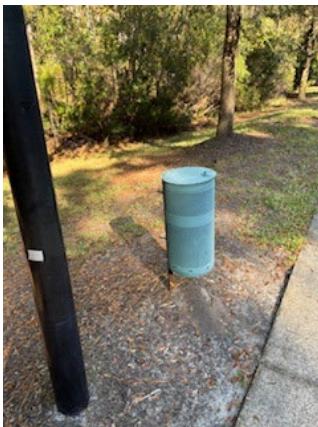
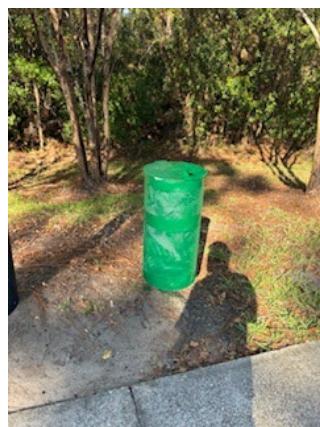
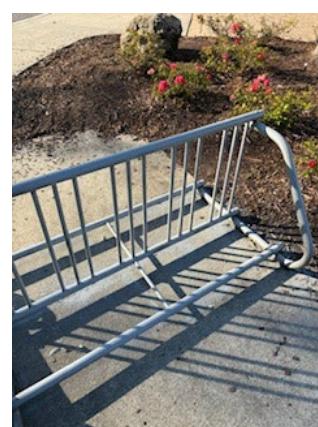
- I have continued to work with FPL on refurbishing the transformer box and the invoice was received so we expect the work to be completed ASAP. The issue at this point is the payment of \$400.00. FPL payment system does not accept electronic payment therefore a paper check must be sent to FPL. This writer has been trying to work out coordination and will continue to do so.
- Points of contacts and updated pool policies have been posted to the bulletin board at entrance of amenity center.
- All Dog Stations and the bike rack located at the amenity center have been refinished. Two bikes in the neighborhood are beyond repair and require replacement. Cost to replace will be provided at the meeting.

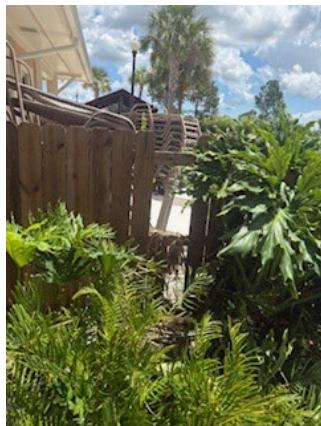
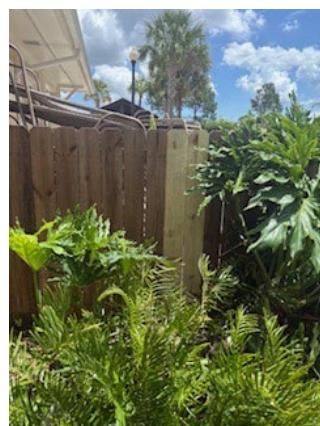
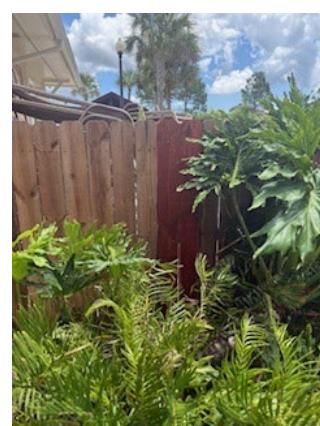
- Fence repairs to the pool motor area have been completed.

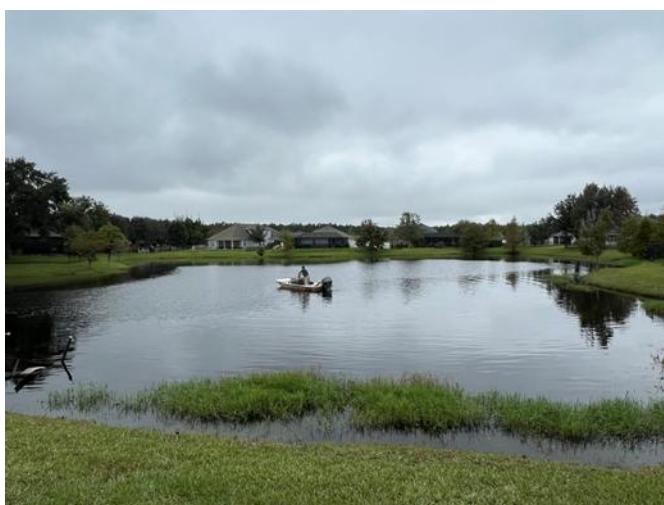
**Pond 1:** Pond was in overall good shape with Torpedo Grass upon inspection. An application was applied and is improving. Water level and clarity were both good. Removed minor trash noticed during inspection.

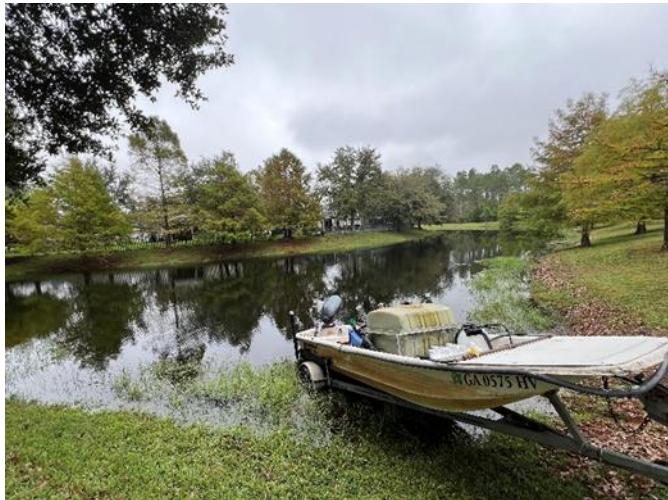
**Pond 2:** Pond was in overall good shape with Torpedo Grass upon inspection. An application was applied and is improving. Water level and clarity were both good. Removed minor trash noticed during inspection.

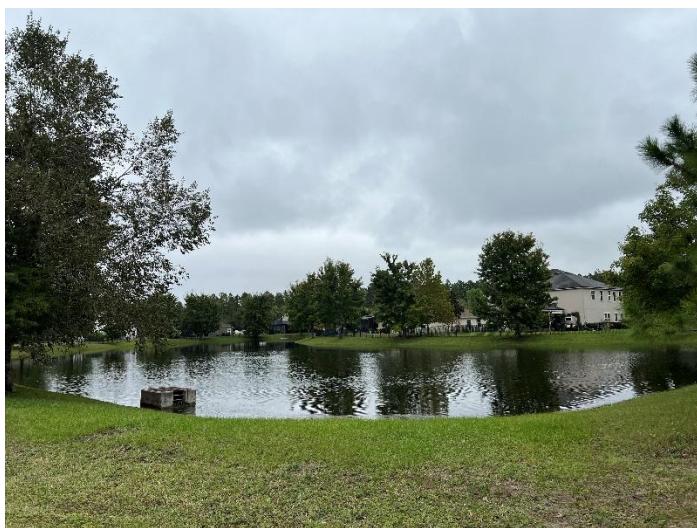
**Pond 3:** Pond was in overall good shape with minor algae upon inspection. An application was applied and is improving. Water level and clarity were both good. Removed minor trash noticed during inspection.

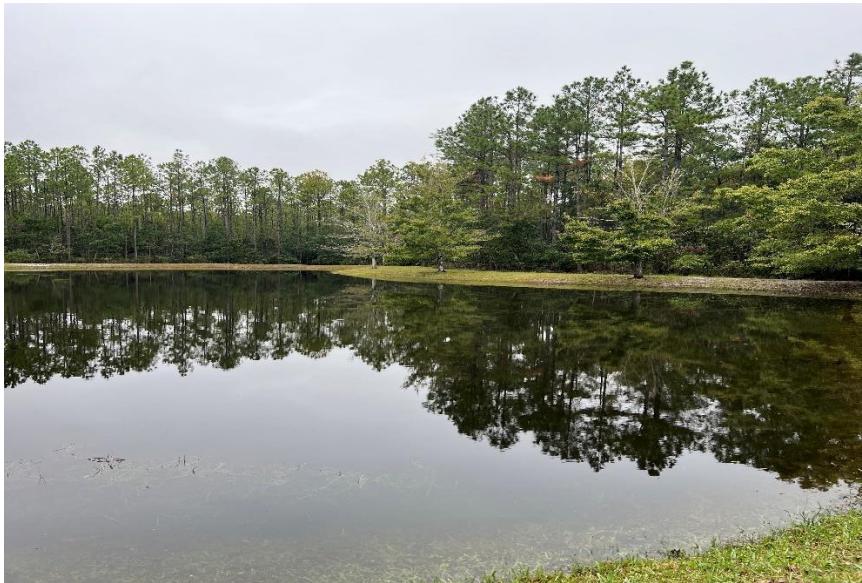
**Pond 4:** Pond was in good shape upon inspection. Water level was good. Removed all trash that was noticed during inspection.

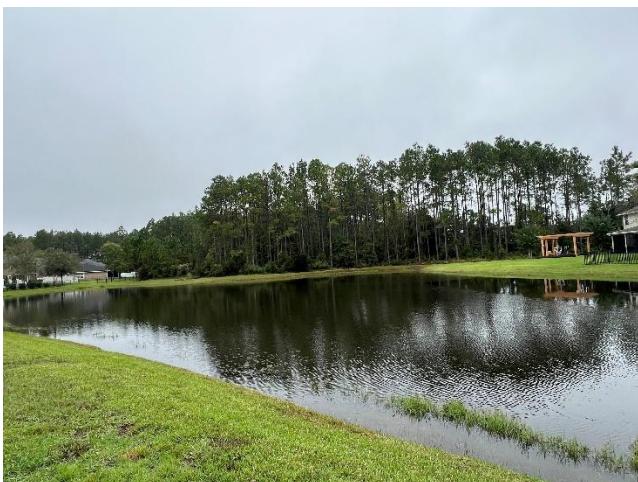
**Pond 5:** Pond was in overall good shape with minor Torpedo Grass upon inspection. An application was applied and is improving. Water level and clarity were both good. Removed minor trash noticed during inspection.

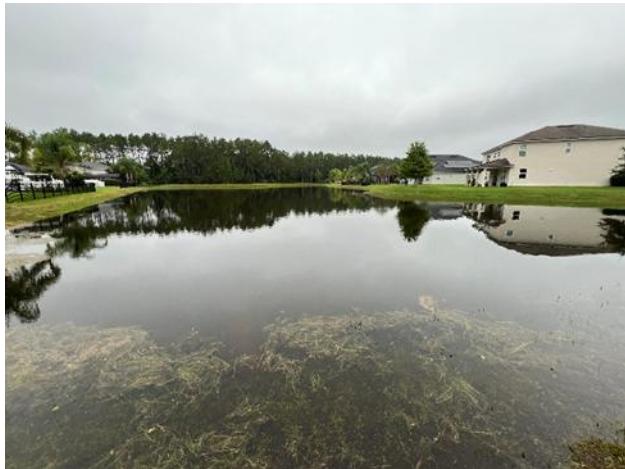
**Pond 6:** Pond was in good shape with Algae and vegetation at road end upon inspection. Water level and clarity were both good. Removed all significant trash that was noticed during inspection.

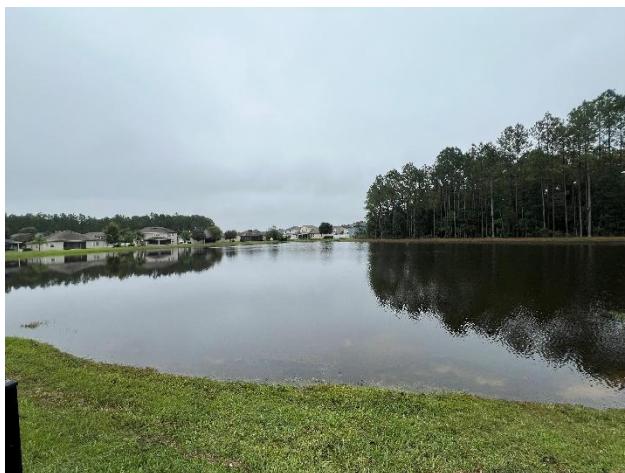
**Pond 7:** Pond was in overall good shape with inspection. Water level and clarity were both good. Removed trash noticed during inspection.

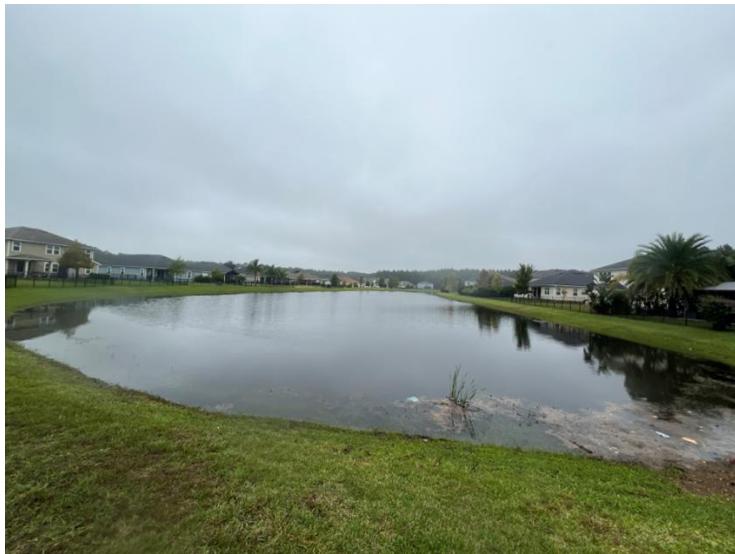
**Pond 8:** Pond was in good overall shape with minor algae upon inspection. An application was applied and is improving. Water level and clarity were both good. Removed minor trash noticed during inspection.

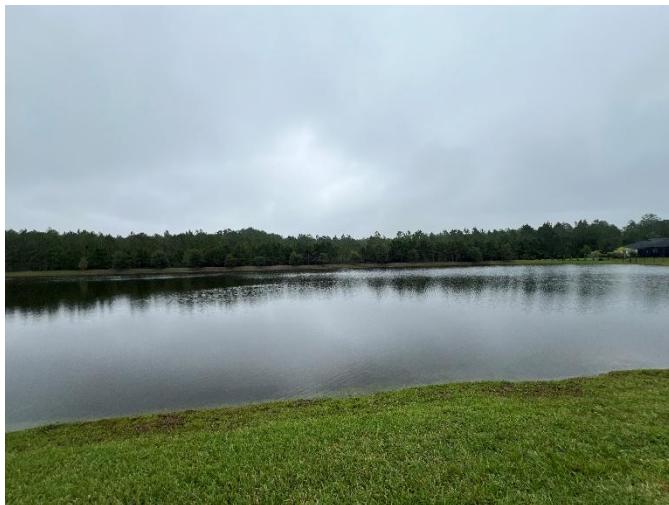
**Pond 9:** Pond was in good shape upon inspection. Water level was good. Removed all trash that was noticed during inspection.

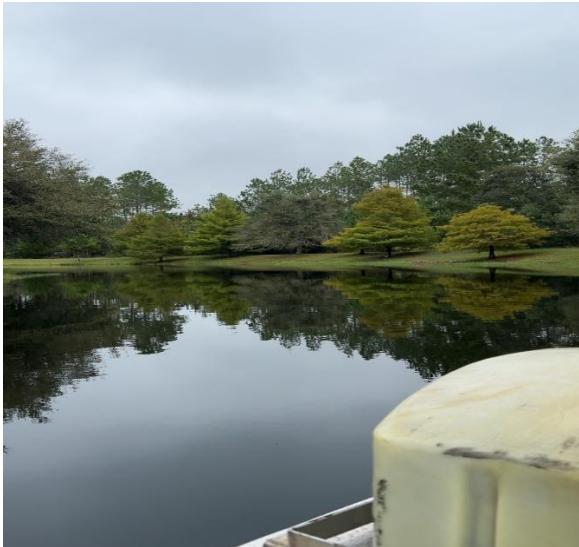
**Pond 10:** Pond was in overall good shape with minor algae upon inspection. An application was applied and is improving. Water level and clarity were both good. Removed minor trash noticed during inspection.

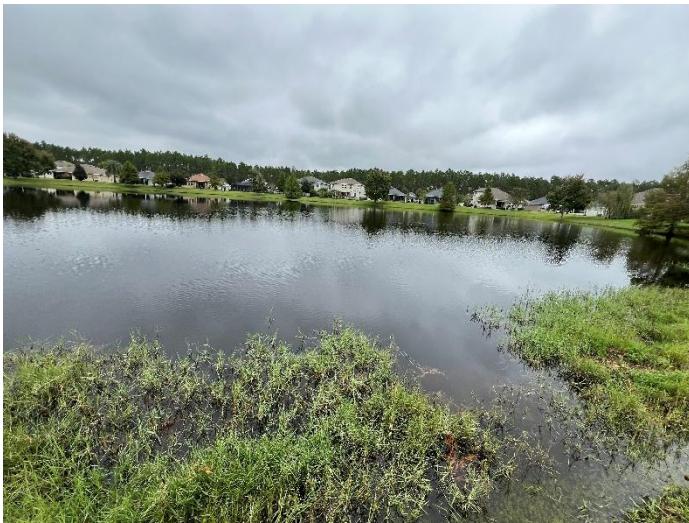
**Pond 11:** Pond was in overall good shape with minor Torpedo Grass upon inspection. An application was applied and is improving. Water level and clarity were both good. Removed minor trash noticed during inspection.

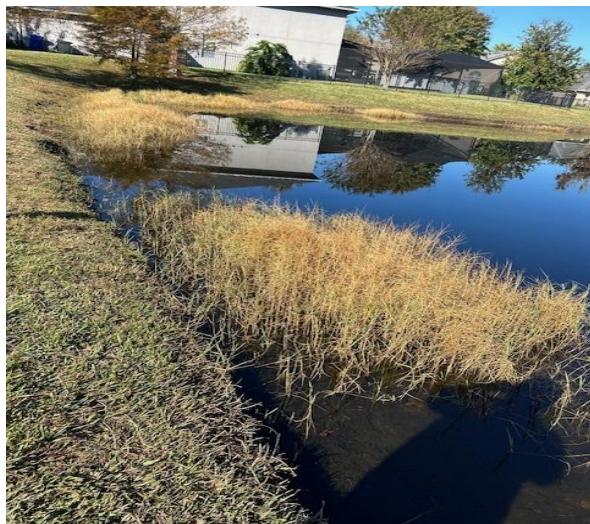
**Pond 1:** Pond was in overall good shape. Torpedo Grass was dead upon inspection. An is improving. Water level and clarity were both good. Removed minor trash noticed during inspection.

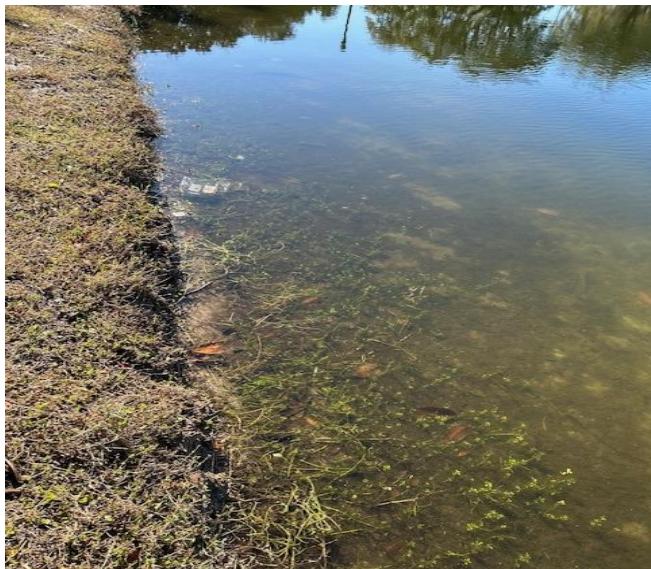
**Pond 2:** Pond was in overall good shape upon inspection. Water level and clarity were both good. Removed minor trash noticed during inspection.

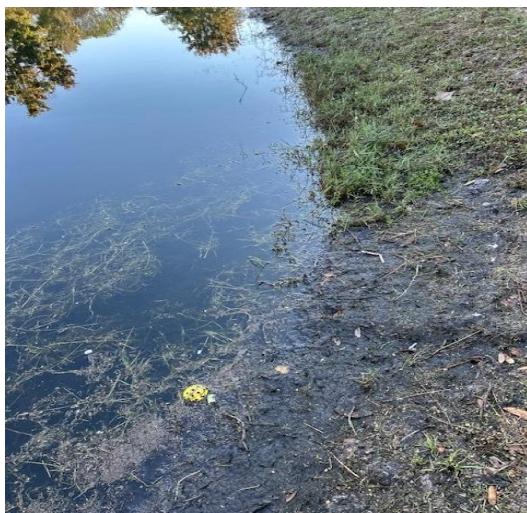
**Pond 3:** Pond was in overall good shape with minor algae upon inspection. An application was applied and is improving. Water level and clarity were both good. Removed minor trash noticed during inspection.

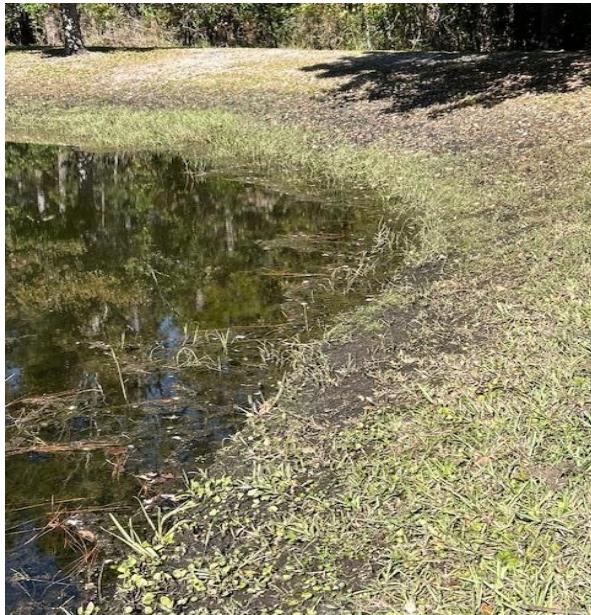
**Pond 4:** Pond was in good shape upon inspection. Water level was good. Removed all trash that was noticed during inspection.

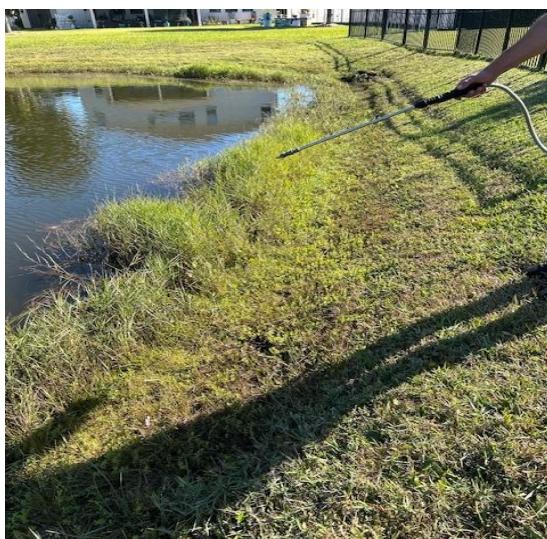
**Pond 5:** Pond was in overall good shape with minor Torpedo Grass upon inspection. An application was applied and is improving. Water level and clarity were both good. Removed minor trash noticed during inspection.

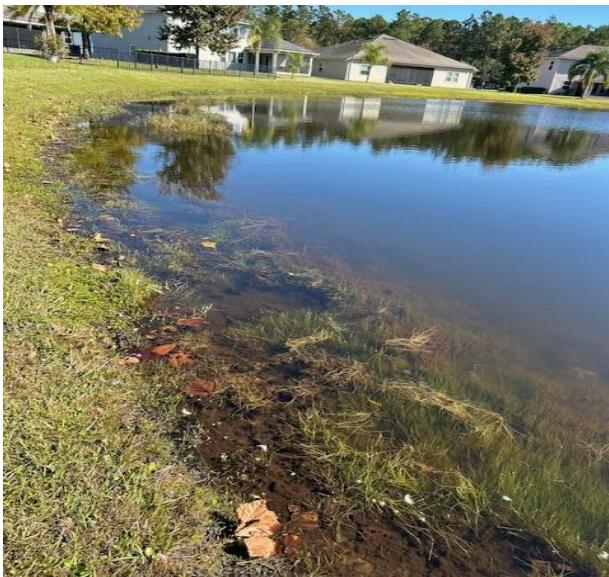
**Pond 6:** Pond was in good shape with Algae and vegetation at road end upon inspection. Water level and clarity were both good. Removed significant trash that was noticed during inspection.

Trash in pond 6 is continuing to be a constant issue and complaints have been made. We pick up what's there on a visit but anything in between is being an issue. We have made a couple of visits to address this issue from complaints, but that can't continue monthly. We can make extra visits for trash for a fee if needed. Please let us know if that is needed.

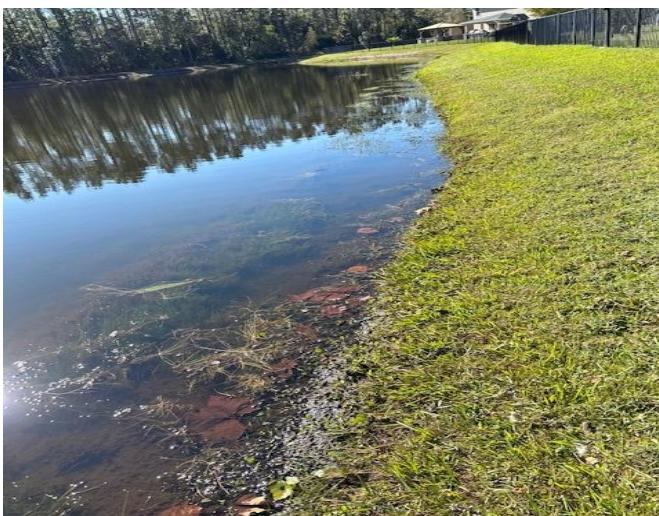
**Pond 7:** Pond was in overall good shape with inspection. Water level and clarity were both good. Removed trash noticed during inspection.

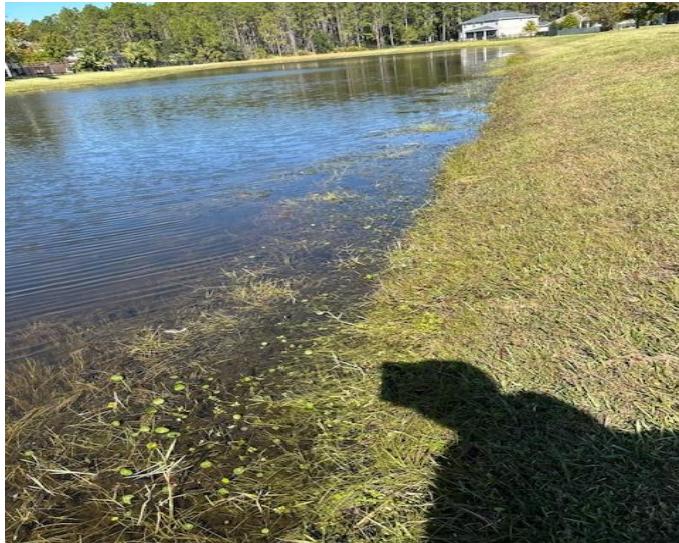
**Pond 8:** Pond was in good overall shape with minor algae upon inspection. An application was applied and is improving. Water level and clarity were both good. Removed minor trash noticed during inspection.

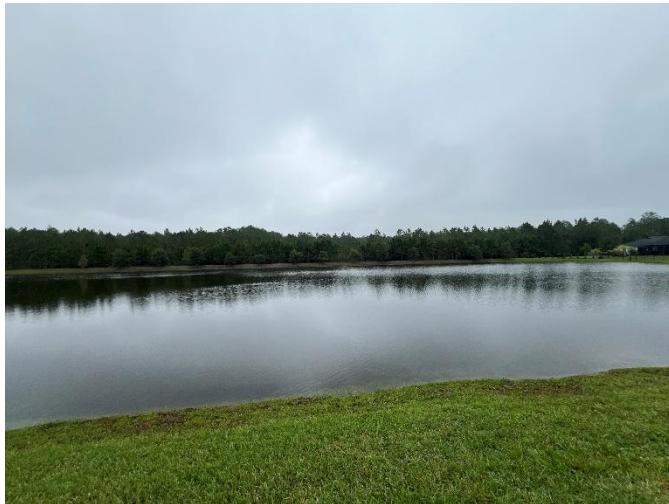
**Pond 9:** Pond was in good shape upon inspection. Water level was good. Removed all trash that was noticed during inspection.

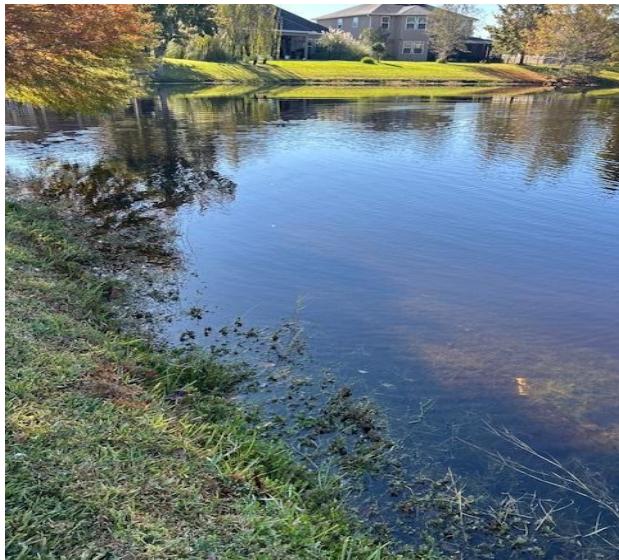
**Pond 10:** Pond was in overall good shape with minor algae upon inspection. An application was applied and is improving. Water level and clarity were both good. Removed minor trash noticed during inspection.

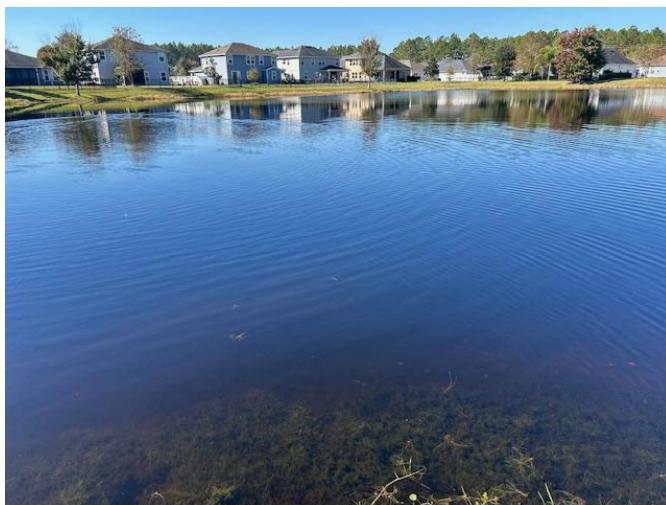
**Pond 11:** Pond was in overall good shape with minor Torpedo Grass upon inspection. An application was applied and is improving. Water level and clarity were both good. Removed minor trash noticed during inspection.

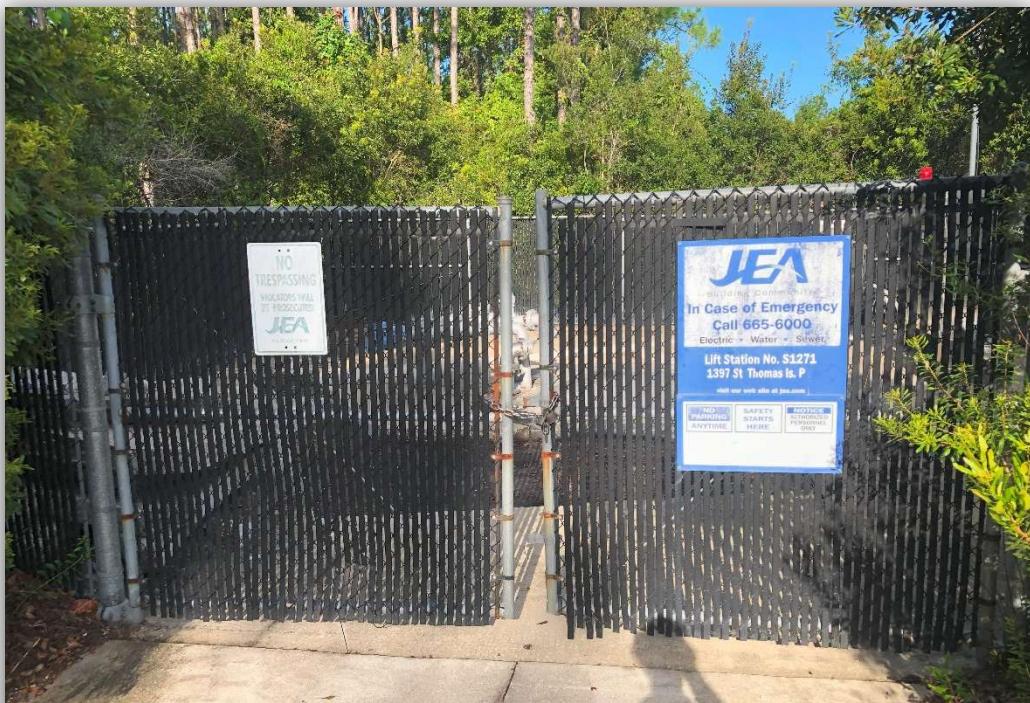
The District accounts for two wastewater lift stations on site. A lift station is a pumping facility designed to convey wastewater or stormwater from a lower elevation collection point to a higher elevation for continued conveyance by gravity or pressure piping. Lift stations are utilized where gravity flow is not feasible due to site topography or system design constraints.

The locations of these facilities are 28 West Teague Bay Drive and 1397 St. Thomas Island Parkway. Both lift stations seemed to be currently in good working order. Routine inspections should have been conducted during the past year to assess structural integrity, mechanical condition, and electrical components. Preventative maintenance should be ongoing and recommended to continue to ensure reliable operation.

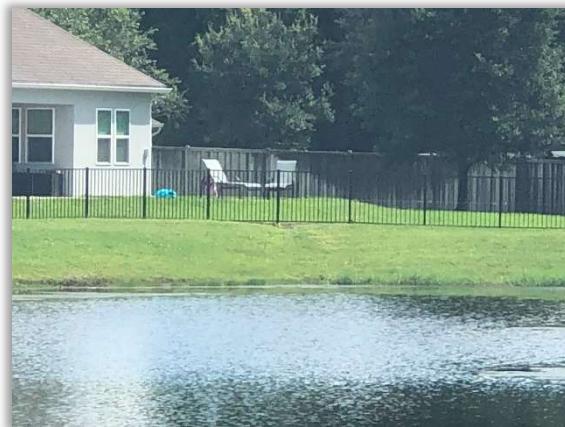
- **SWMF 1** - Good condition. Minor pond bank erosion adjacent at resident's black metal fencing. This appears to be located at 71 Long Point Way.

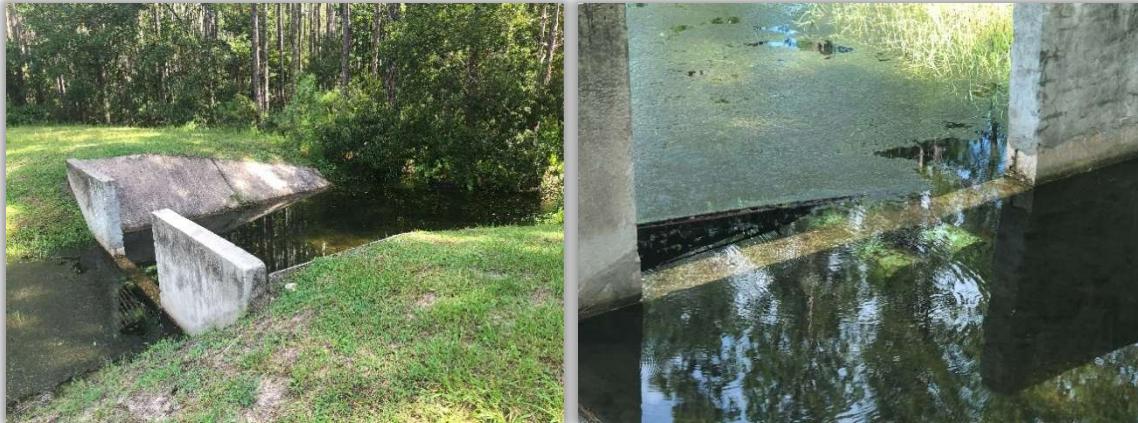
- **SWMF 2** - The control structure of SWMF 2 is not functioning as intended. See narrative in the subsequent pages regarding the control structure. Algae and vegetation growth around pond banks. The debris barrier has fallen into the pond which should be collected and reattached. The pond banks and slopes are in good condition.

At the time of the field inspection, it was observed that SWMF 2 and 5 appear to be not functioning as originally intended. The normal water elevation of the ponds is consistently higher than the designed water level control elevation resulting in continuous surface water seepage and uncontrolled discharge into the adjacent wetlands. This condition indicates that these ponds are not properly draining through their outfall structure and are failing to provide the intended water quality treatment measures such as providing a Permanent Pool 21-day residence time and/or 3-day drawdown of the Pollution Abatement Volume as required by the water management district. Due to this condition, the highwater levels during the Mean Annual and 25-Year storm events will most likely be slightly higher than was originally designed for or intended.

To restore the proper function of SWMF 2 and 5, the following actions are recommended:

- Flush or jet-clean the outfall pipe if obstructions are present.
- Repair/replace the weir boards or structure components if deteriorated.
- Hydrologic Evaluation: If survey results indicate the outfall control structure elevations were constructed incorrectly, pursue corrective action to reset the structure to its permitted elevation.
- Regulatory Coordination: Coordinate with SJRWMD to clear obstructions, vegetation and/or sediment built up over time from within the outfall waterways the outlet control structures discharge into. Maintenance of waterways off CDD property are typically the responsibility of the water management district if the conditions are not caused by neglect on the part of the CDD.

Since the Outlet Control Structures at SWMF 2 and 5 may not be currently serving their intended purpose as a functional stormwater facility, inspection and corrective measures are recommended to restore compliance with the water management district's stormwater permit. This will ensure adequate flood protection and water quality treatment and possibly preempt costly action by the water management district. The CDD Board may wish to discuss this issue with Alliant to determine their intention to resolve it and document measurement actions taken to address.

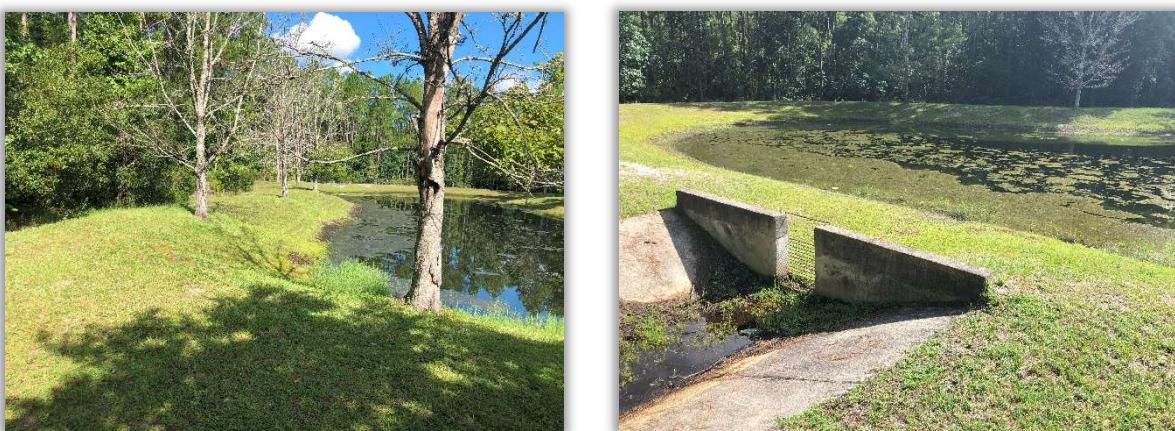
- **SWMF 3** - Good condition. The control structure appears to be in working order. There is a large amount of algae growth along pond banks and localized locations.
- **SWMF 4** - Good condition, however, most perimeter trees around the pond are deceased or are in poor condition. Tree losses around stormwater facilities can reduce the overall aesthetic value of the community. We recommend engaging an ISA-certified arborist to assess the cause of tree decline and remove any dead/diseased trees and monitor pond banks for erosion where roots have decayed. Algae and some vegetation growth exist throughout the pond area. The control structure orifice, which addresses water quality for discharges from the CDD, was not observed whereas the civil plans on file show should

exist. However, this orifice may exist but could be hidden under collected sediment present at the time of the field inspection in the overflow spillway which has collected over time. We recommend the spillway be cleared of debris and sediment, and if a water quality orifice

does exist, further engage with Alliant to discuss measures to implement to ensure the orifice will function properly.

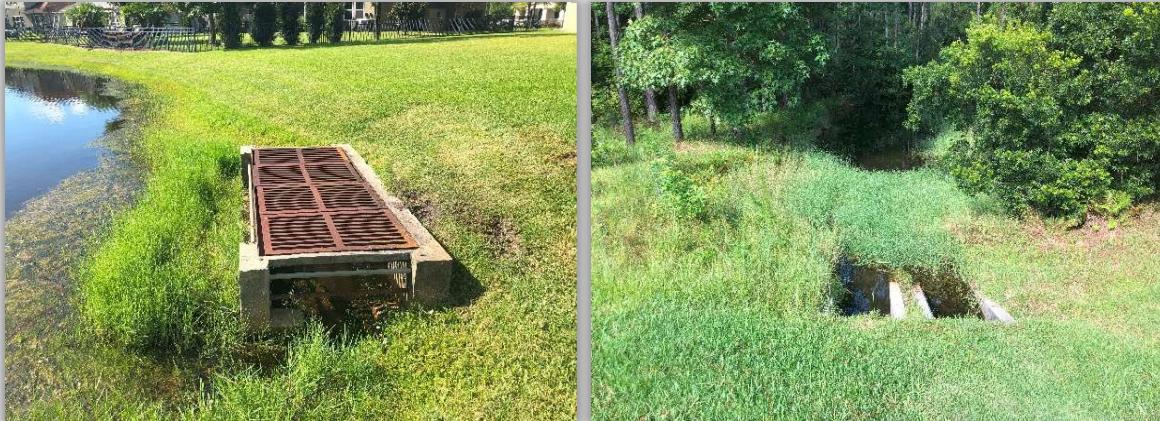
- **SWMF 5** - The control structure of SWMF 5 is not functioning properly. The normal water level is over the weir elevation and the orifice is not visible. The water at the outfall pipe

appears stable and is not flowing therefore the wetland may be higher than originally anticipated. See narrative in the subsequent pages regarding the control structure. The vegetation around the control structure is excessive and there are algae growth throughout the pond area. The pond banks and slopes are in good condition.

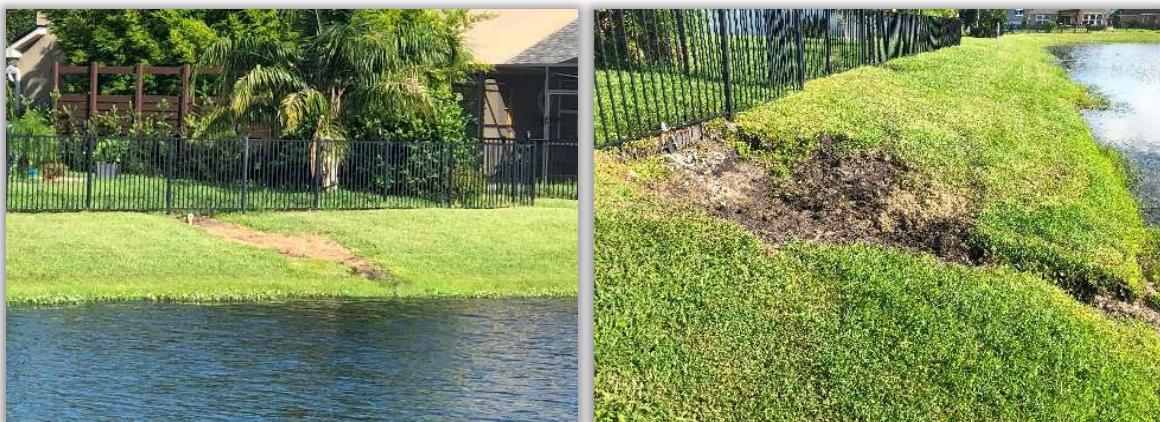
- **SWMF 6** - Good condition.
- **SWMF 7** - Good condition. Minor algae growth around pond banks with trash/debris present.
- **SWMF 8** - Good condition. A resident's pool pump is eroding away the pond bank. This appears to be located at 152 Spanish Bay Drive.

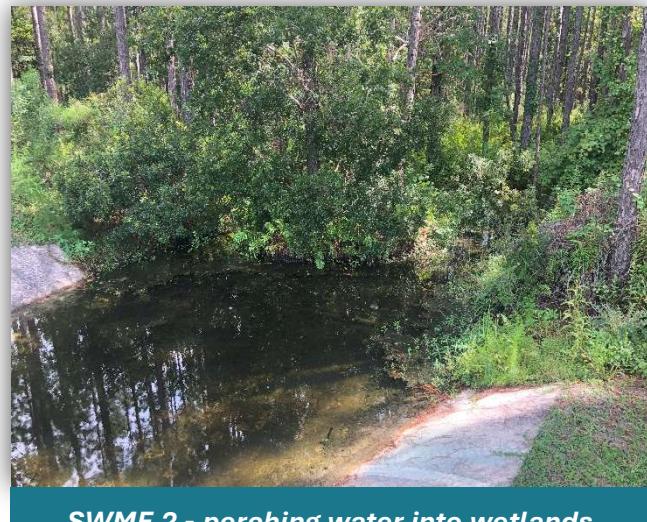
***SWMF 2 - perching water into wetlands***

- The elevation of the adjacent wetlands has risen since the original design.
- Improperly set wetland extents and elevations.
- Improperly set control structure elevations during design or construction.

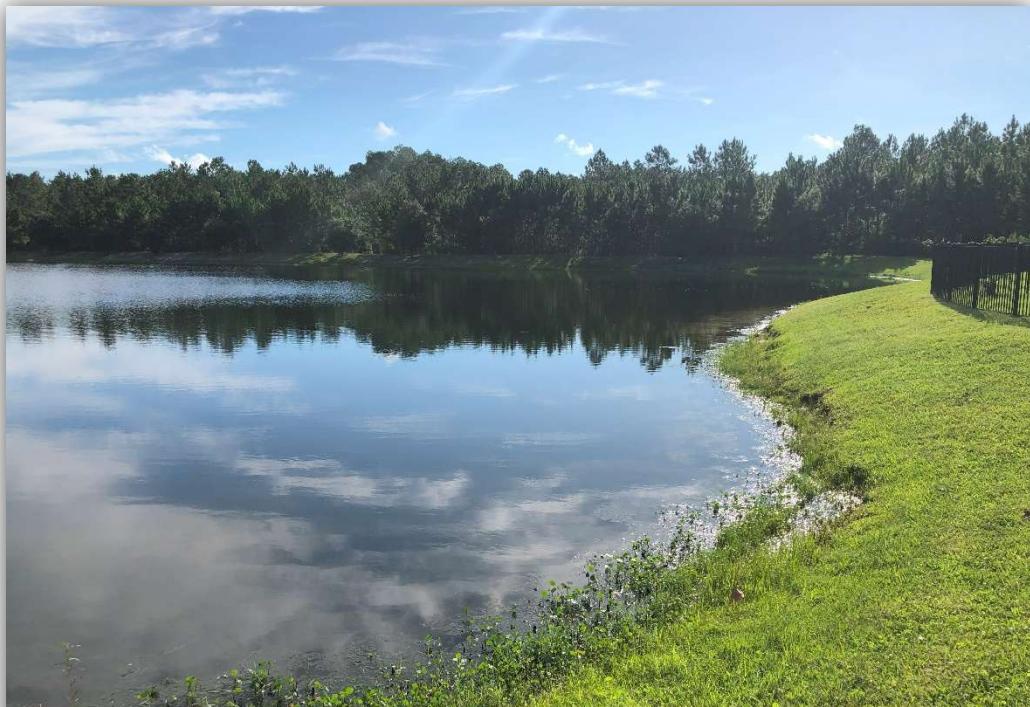
***Stormwater Management Facility 9***

- **SWMF 9** - Good condition. A resident's pool pump is eroding away the pond bank. This appears to be located at 746 Trellis Bay Drive.

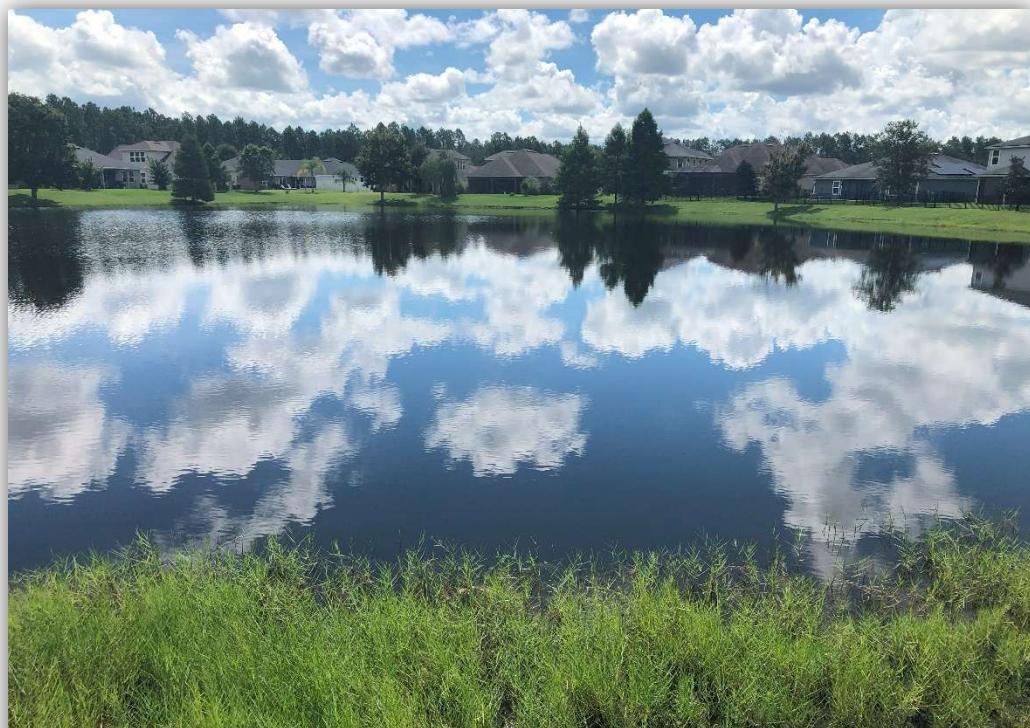
***Stormwater Management Facility 11***

- **SWMF 11** - Good condition. Algae and vegetation growth around pond banks.
