# **Mitchell Ranch Community Development District**

## **Board of Supervisors' Regular Meeting March 10, 2026**

## LANDSCAPE INSPECTION REPORT

February 18, 2026  
Rizzetta & Company  
Amiee Brodeen – Landscape Specialist  
Landscape Inspection Services

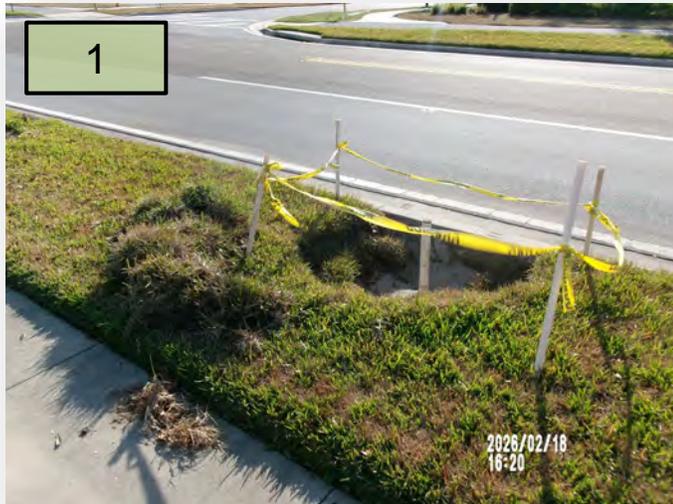
Inspected the newly dug-out pit at Legends Pasture Way. Please provide an update on the status of this excavation. Confirm whether this was related to an irrigation mainline break and outline the remaining steps and expected timeline for repair and restoration. (Pic 1)

- 1- Irrigation repair on Legends Pasture is filled in and will be resodded. Hole is filled in on 2-25-26.
- 2- Pencil pruning of Crapees will take place over the next couple of visits up to 10'

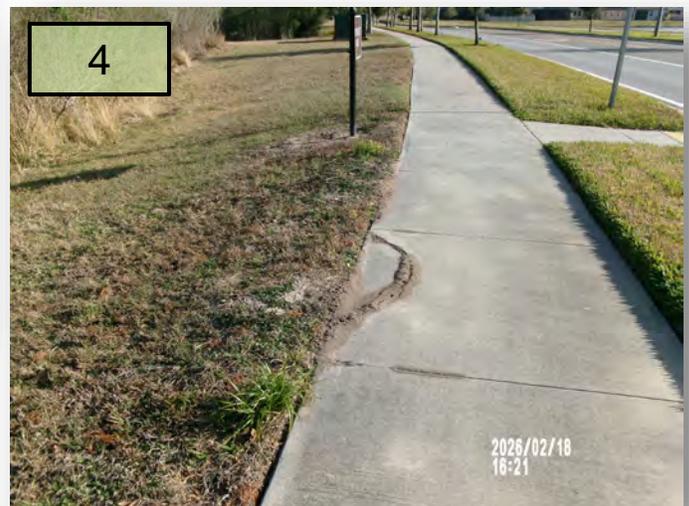
Multiple ant mounds are forming within the broken concrete cracks along the east side walkway. Recommend treating all active mounds accordingly during the next service visit and monitoring for continued activity. (Pic 4)

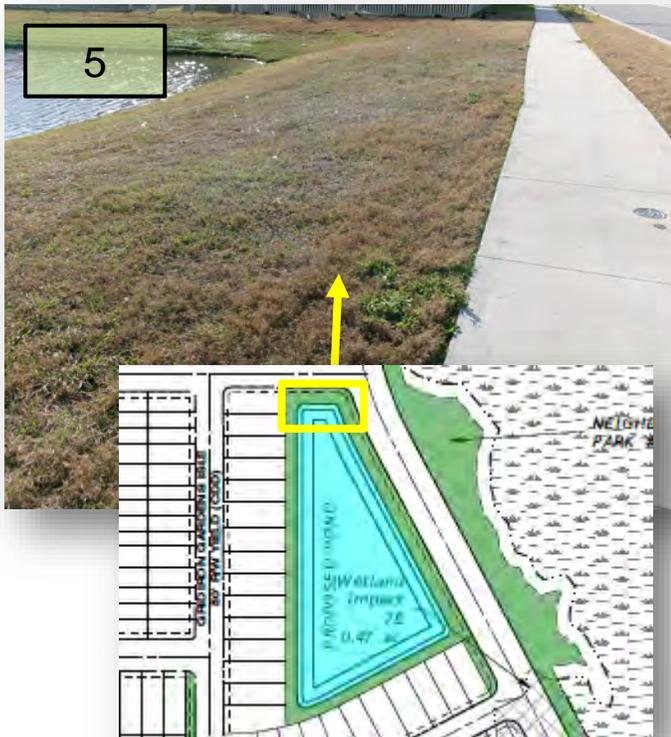
**(#5 Cont.)**.... between Legends Pasture and Houndstooth Enclave. Recommend treating all active broadleaf and grassy weeds during the next service visit and monitoring the area for continued weed pressure.

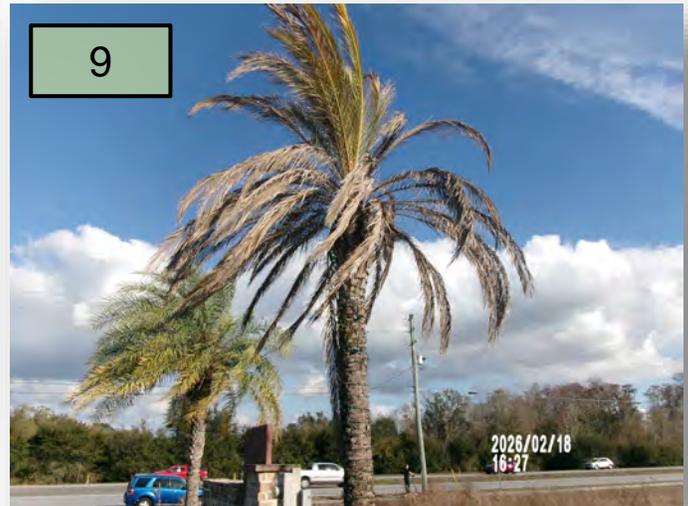
**(#9 Cont.)**.... decline, likely due to cold-snap damage combined with pre-existing health issues. Please have the team assess the palm to determine whether it is salvageable. Recommend monitoring its condition as temperatures warm, as recovery may still be possible with improved weather and supportive care.

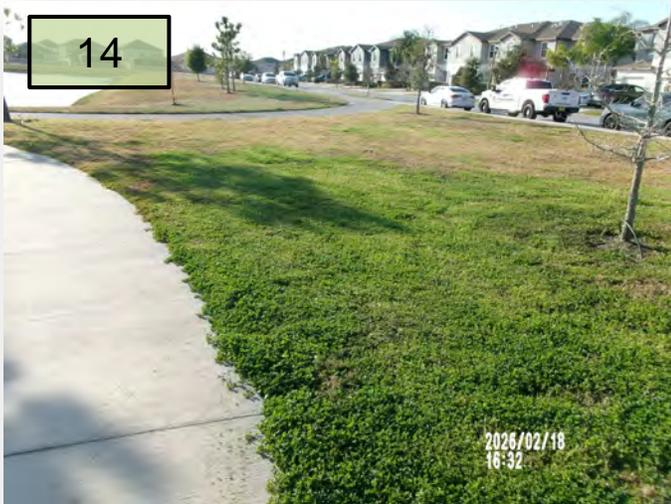
**14. Turf Weeds – Yellowhammer Way (Foster Park):** Significant turf weed activity noted along the concrete edges, including dollarweed and clover. Recommend treating all active weeds during the next service visit and monitoring the edges for continued weed pressure. (Pic 14)

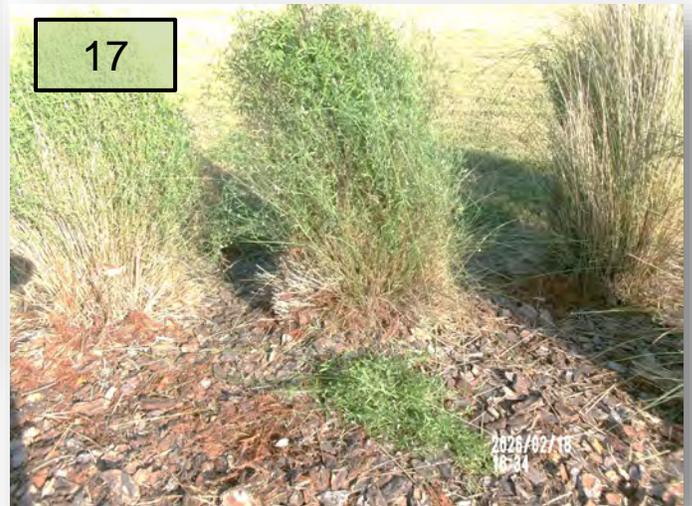
**17. Ornamental Grass Beds – Foster Park:** The ornamental grasses have still not been properly weeded. Weeds are being cut during grass trimming rather than pulled from the base, allowing continual regrowth. Recommend fully weeding out the ornamental grass beds, removing all weeds at the root to prevent ongoing intrusion. (Pic 17)

- 17- Foster Park Ornaments grasses – Grasses were weeded on 2-24-26. Weeds were pulled and removed the edging needs to be completed and we will be apply a pre-emergent before mulching

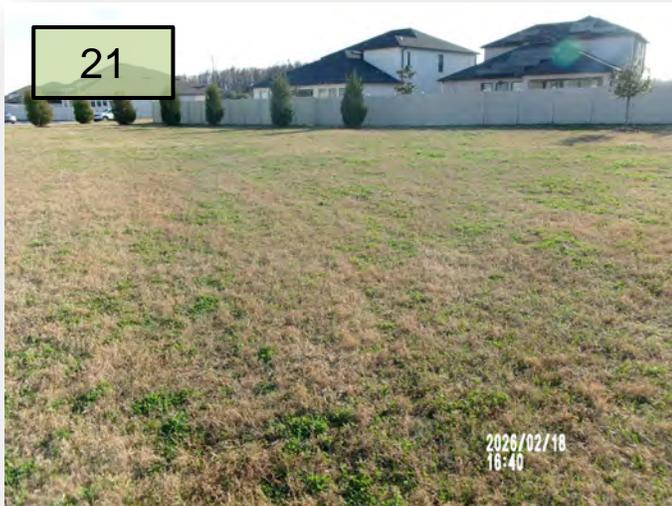
**21. Irrigation & Turf Recovery – Bear Landing Park:** Please confirm whether the irrigation system is currently functioning at Bear Landing Park. If irrigation is operational, treat all active turf weeds during the next visit and apply fertilizer to support recovery. Current morning dew conditions make this an ideal time for product uptake. (Pic 21)

21- Bear Landing Park – The irrigation is only along the curb line and bubblers for some of the trees. The majority of this park is not irrigated. The turf installed is Bahia Typically we do not fertilize Bahia turf. I will investigate if there is anything that can be applied. I think we should also lower the mower height  $\frac{1}{4}$  to  $\frac{1}{2}$ " over the next couple of mow events.

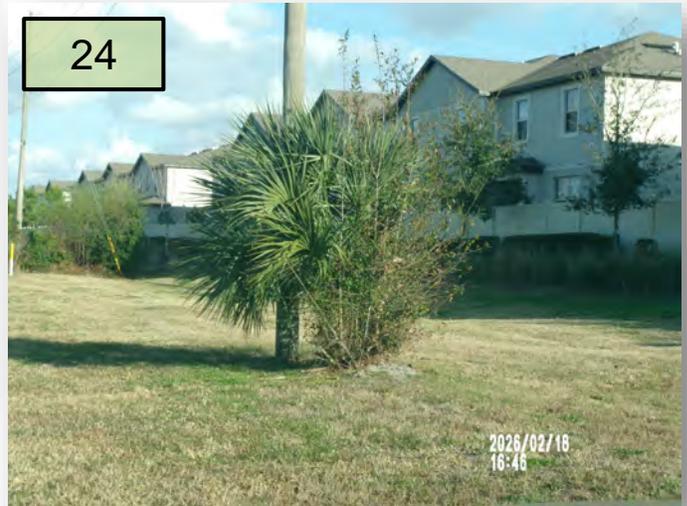
**24. Welbilt Road (North of Property) – Weed Trees in Palm:** Weed trees are growing up through the palm located just north of the property line along Welbilt Road. Recommend trimming out and removing the weed trees. If the Board prefers full cleanup of the entire area, please advise so a broader scope can be proposed. (Pic 24)

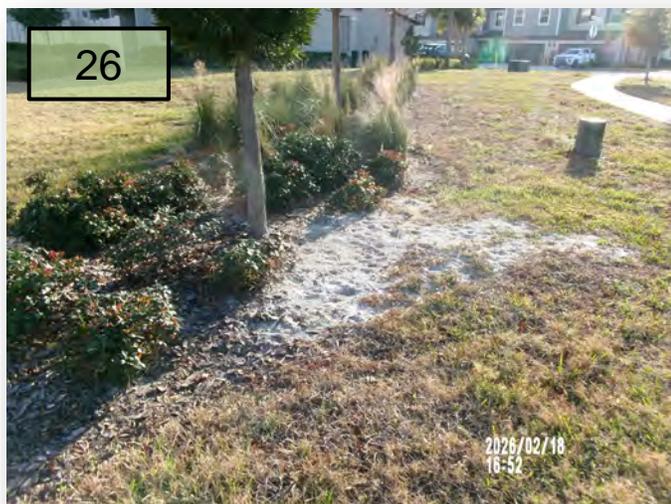
**26. Birch Haven & Bear Landing Corner – Sand Cleanup Needed:** The sand at the corner of Birch Haven and Bear Landing has not yet been raked out and properly dispersed. The area appears unfinished following the irrigation repair work. Recommend raking and leveling the sand to restore a clean, finished appearance, especially before the new mulch is installed. (Pic 26)

- 26- Birch Haven -Bear Landing corner – Sand has been raked and spoils removed. Some sand remains filling in the hole created by the irrigation main line break. Area was raked and cleared but recommended sodding to fill in several bare areas.

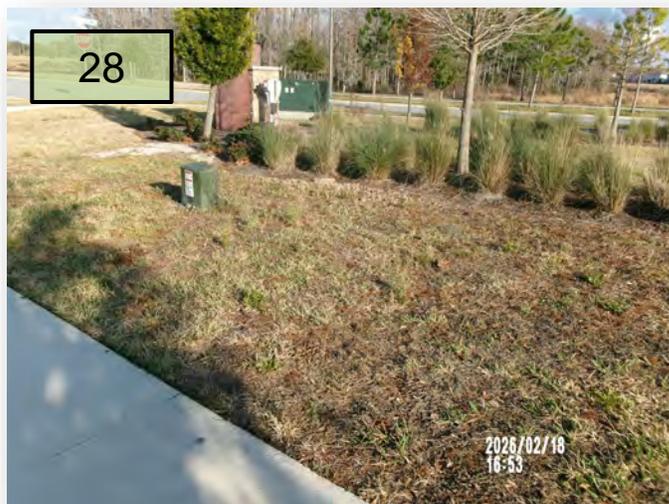
**28. Turf Recovery Plan – Birch Haven & Bear Landing Corner:** Turf remains very weedy and is in poor condition. I would like to request implementation of a targeted recovery plan including weed suppression (pre- and post-emergent), irrigation and mowing adjustments, fertility to drive density,....

**(#28 Cont.)**.... and plug/sod repairs in bare zones. Include a 30–60 day timeline with QA checkpoints. (Pic 28)

- 27- Bed edge and pre-emergent are scheduled for this area before mid -March mulching.
- 28- Corner of Bear Landing and Birch Haven – Turf diagnosis is failed turf due to irrigation mainline that was down for 2-3vweeks in mid summer last year. Turf recovery will be very slow especially after the additional stress of freezing temps and frost. We will apply fertilizer and pre-emergent in March now that temperatures have warmed. The irrigation is currently programed to run 3 times a week. Mowers to avoid the area so allow turf to recover and when mowing resumes to mow the turf at the 4” height. Monitor turf until the end of March for recovery (30 days) if no significant improvement I would recommend installing sod before the heat of the summer.

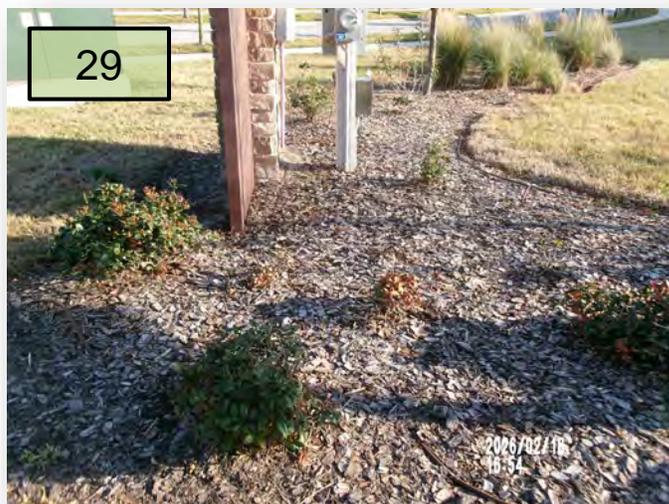
**29. Hawthorn Loss – Birch Haven & Bear Landing Corner:** Several hawthorn shrubs near the B Residence sign have died. Recommend removing the dead material and noting quantities needed for replacement during the next planting cycle (Mid-to-Late March). (Pic 29)

- 29- Bear Landing and Birch Haven corner - Propose to replace the dead Indian Hawthorn and fill in the bed. Proposal attached.

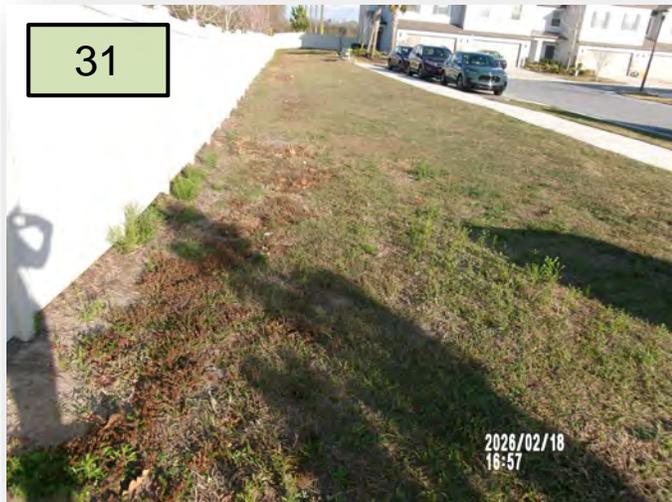
**Weed Treatment:** The turf in this area is heavily weedy. Recommend applying a Bahia-safe weed and feed treatment early in the morning so the natural dew can help the product adhere and “water in” for improved effectiveness. (Pic 31)

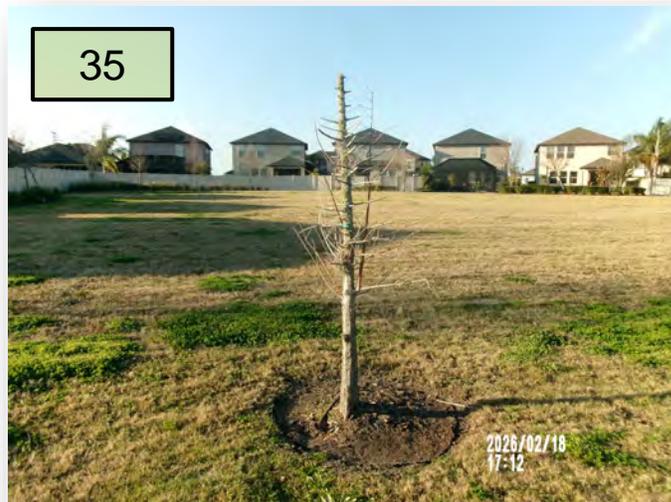
### 35. Cypress Tree Removal – Capstone Ranch

**(Harmon Park):** The cypress tree in Harmon Park has lost its main stem and is no longer structurally viable. Recommend removing the remaining tree and cleaning up the area during the next maintenance visit. (Pic 35)

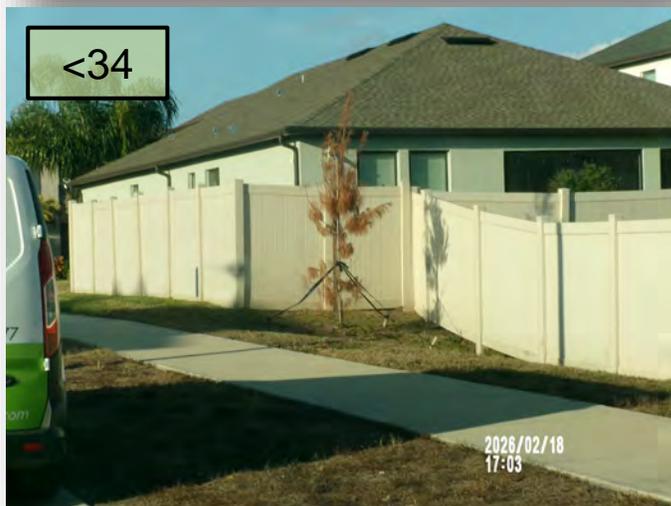
A pine tree near the corner of the vinyl fence is completely brown and appears to have fully declined. Recommend evaluating the tree to determine whether removal is necessary or if monitoring is still appropriate, though current condition strongly suggests the tree may be non-recoverable. (Pic 34>)

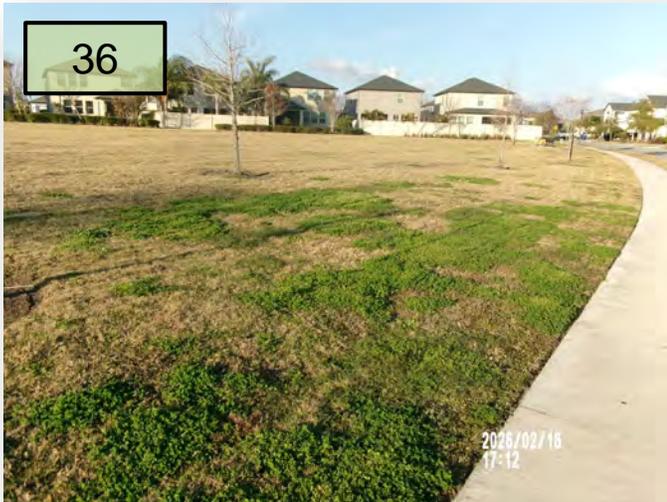
Turf throughout Harmon Park is in decline and needs full treatment and recovery. Recommend applying a fertilizer application promptly and treating all active turf weeds to begin restoring density, color, and overall turf health. (Pic 36)

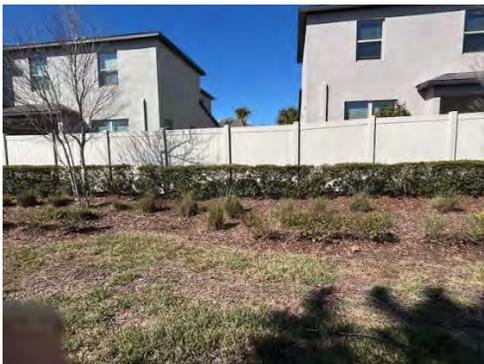
Vinyl fence along Bear Landing – fill in for missing or dead plant material

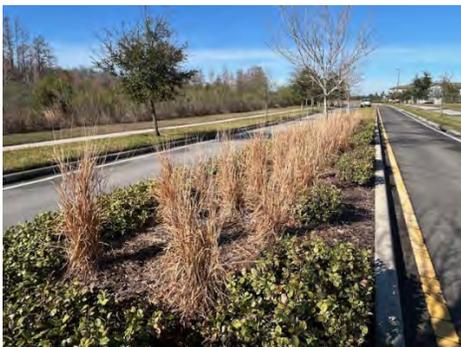
Purple Fountain grass may need replacement

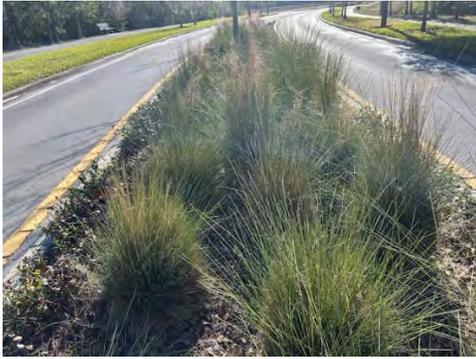
Pink Muhly look like they are recovering nicely
