# **Mitchell Ranch Community Development District**

**Board of Supervisors' Regular  
Meeting  
April 14, 2026**

## COMMUNITY ASSET MANAGEMENT REPORT

## LANDSCAPE INSPECTION REPORT

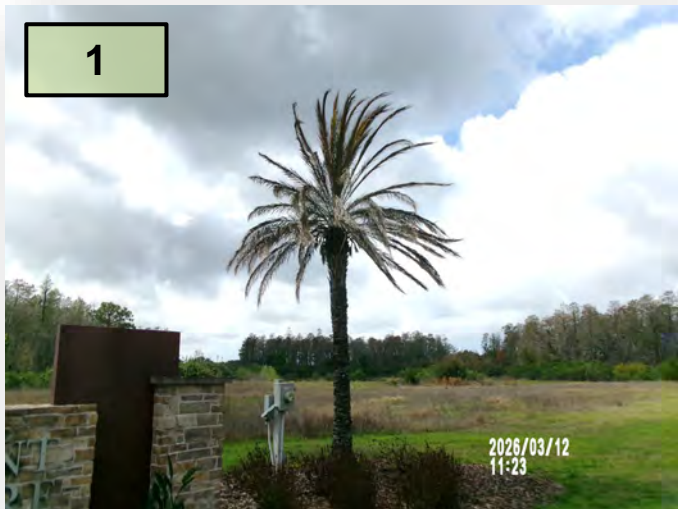
- 1. Legends Pasture Rd:** The Canary Palm is showing some green in the top spears. I would like input from an arborist regarding the overall outlook of this tree to determine whether it is recovering or in decline. (Pic 1)

# 1 – Observation on 4/1/26 – Canary Palm has not shown improvement – re-fertilized and root drench done again on March 24<sup>th</sup>. Horticulture manager said to wait another 6 weeks and reevaluate.

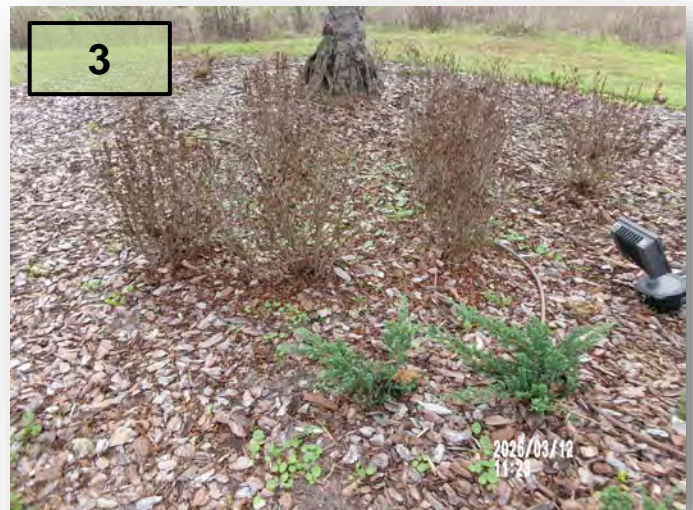
- 3. Legends Pasture Rd:** In the plant beds along the roadway, I observed Dollar Weed beginning to emerge around the irrigation lines. This could indicate overwatering in an effort to revive previously damaged plants, or possibly an underground irrigation leak. Please inspect the area, diagnose the issue, treat the weeds, and make any necessary repairs. (Pic 3)

#3 – bed on the corner of Little Rd and Legends Pasture – Dollar weed has been treated and removed

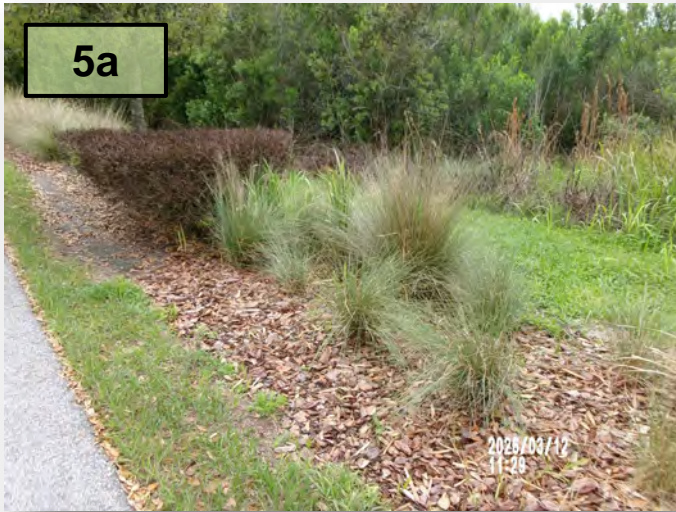
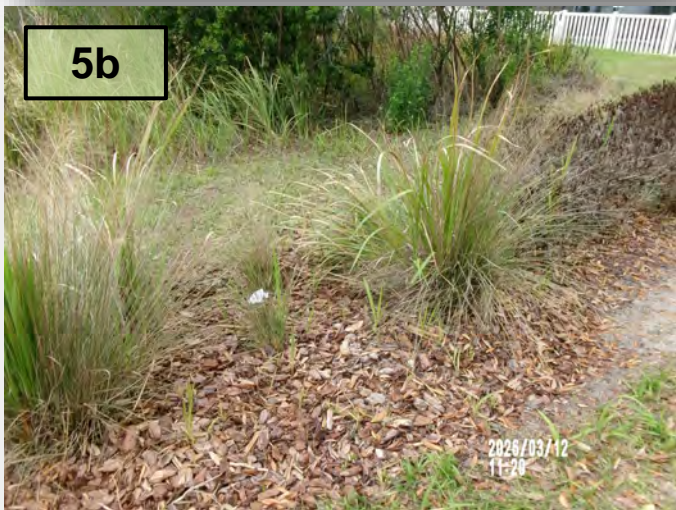
5. **Legends Pasture:** Near the recent preserve cutback area, south of Capstone Ranch, I noticed Cogongrass emerging again within the Muhly Grasses. This time, it is also appearing in the turf areas behind the planting bed. Please treat this promptly before it spreads further into the beds. (Pic 5a, 5b)

# 5 – Cogongrass – This will be removed and sprayed before mid- April. Crew will need to be directed on what specifically needs to be done

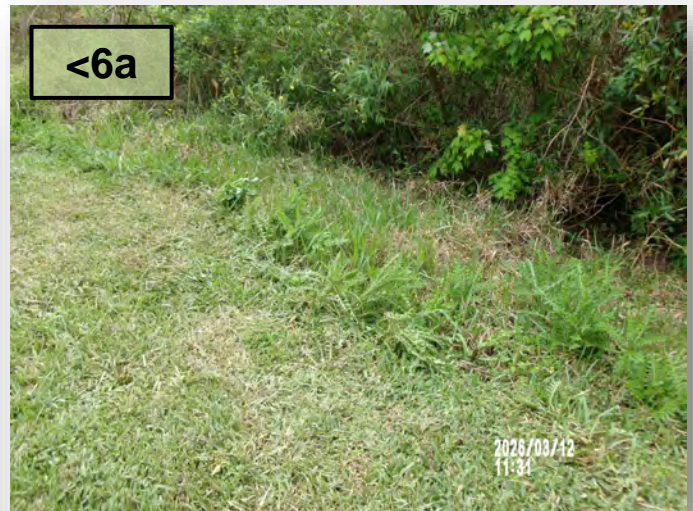
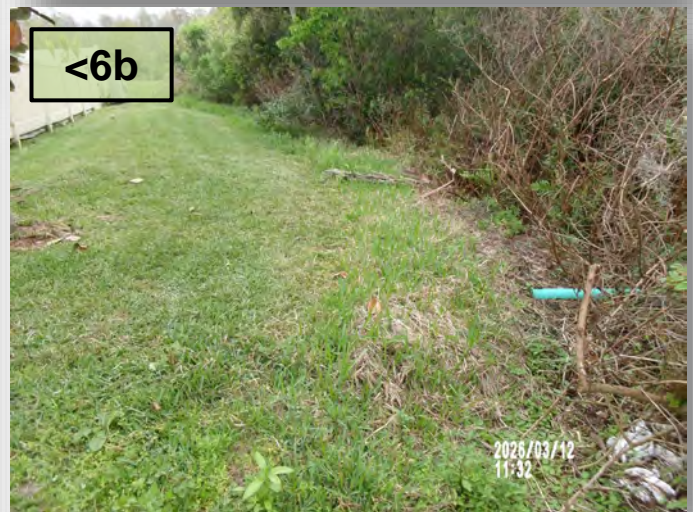
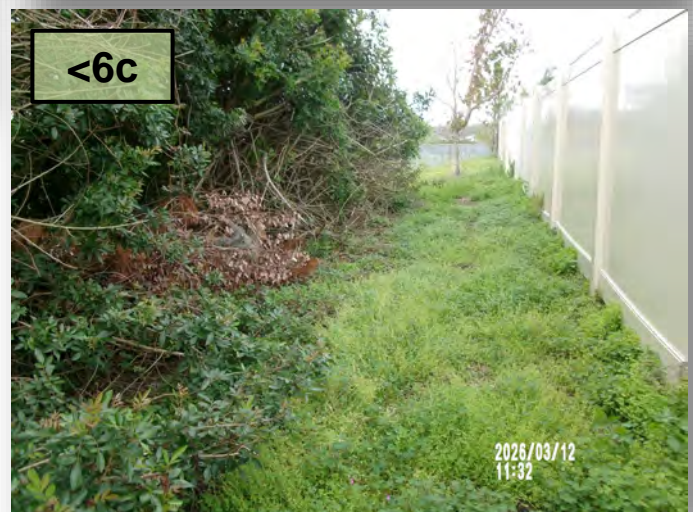
6. **Capstone Ranch Dr:** Behind the residents' houses and fences, there is a long stretch of turf between the properties and the preserve. This section has not been fully maintained, and there are areas where preserve trees, vines, and plants are beginning to encroach on the turf. These encroaching plants should be trimmed back to maintain a clear and accessible area. (Pics 6a>, 6b>, 6c>)

#6,7 and 9– The crew has been shown the area and has mowed, line trimmed and removed straps from trees. They will keep the native preserve cut back.

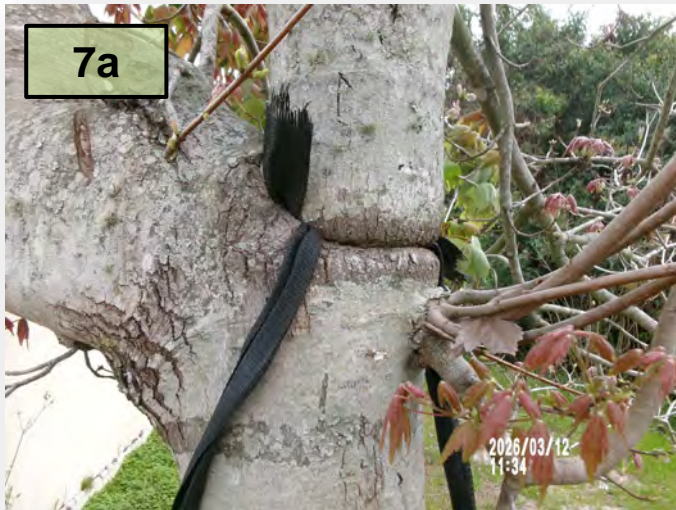
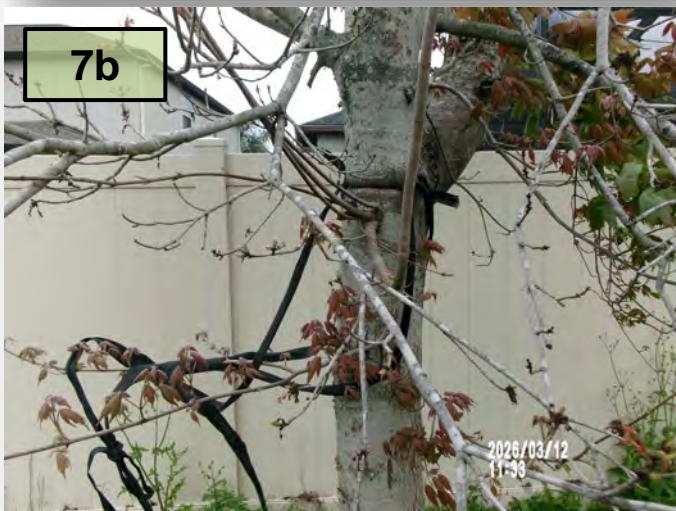
7. **Tree Straps/Supports:** Throughout the community, particularly in the turf area behind the homes on Capstone Ranch Drive, I have observed multiple trees with improper support: some are strapped too....(Nxt pg)

**(#7 Cont.)**.... tightly, some self-supporting trees still have straps that were not removed, and others have completely failed strap supports. Tree straps should not be applied too tightly, nor should they remain on a tree once it has established significant growth. The images below illustrate how improper strapping can lead to unsightly growth patterns and potentially constrict and damage the trees. (Pics 7a, 7b)

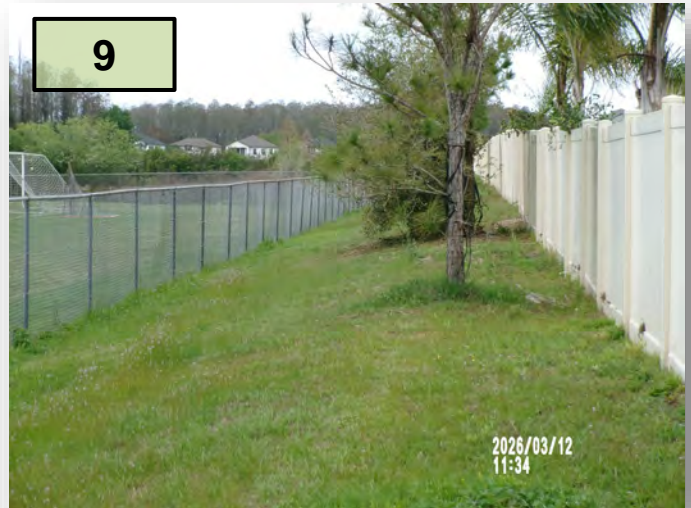
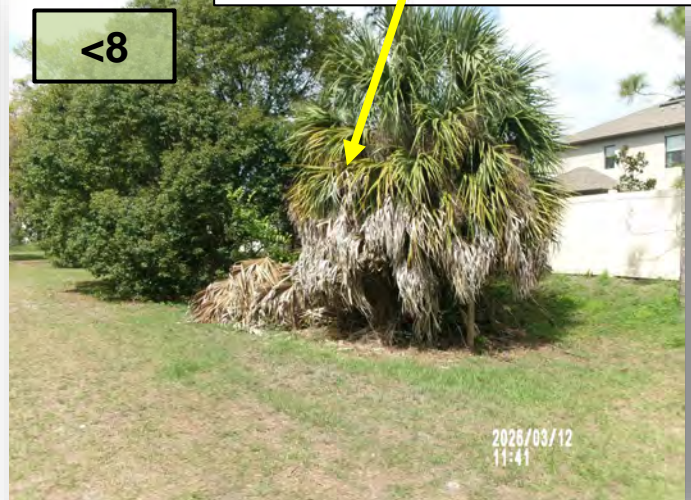
**9. Same Area as Item #8:** The section between the school fencing and the residents' vinyl fence continues to be missed during routine service. Crews are either not accessing this area or are not fully completing required line-trimming and debris-removal tasks. Please ensure this zone is included in all future maintenance cycles. (Pic 9)

**8. Capstone Ranch Dr:** Behind the homes, along the pathway that runs behind the properties, there is a Sable Palm and Saw Palmettos with an abundance of dead fronds. These should be removed to maintain a clean and well-kept appearance in the area. (Pic 8>)

#8 -Sabal Palm and Saw Palmetto cleaned up and trimmed. Crew was working in the area and will confirm that this is completed by the middle of April.

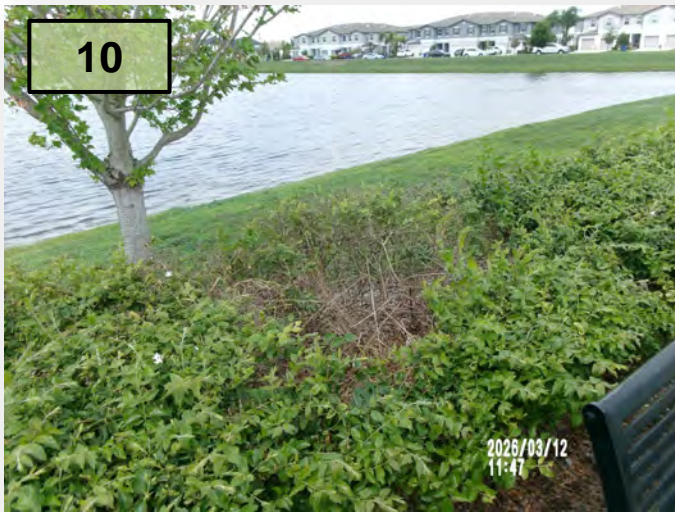
**10. Yellow Hammer Park:** Now that the weedy material previously growing within the Star Jasmine has been removed, the shrub should be trained and guided to fill in the existing void. If Fieldstone determines that the open area is too large to recover through training alone, I recommend installing additional Star Jasmine to match the surrounding plant material and achieve full, even coverage. (Pic 10)

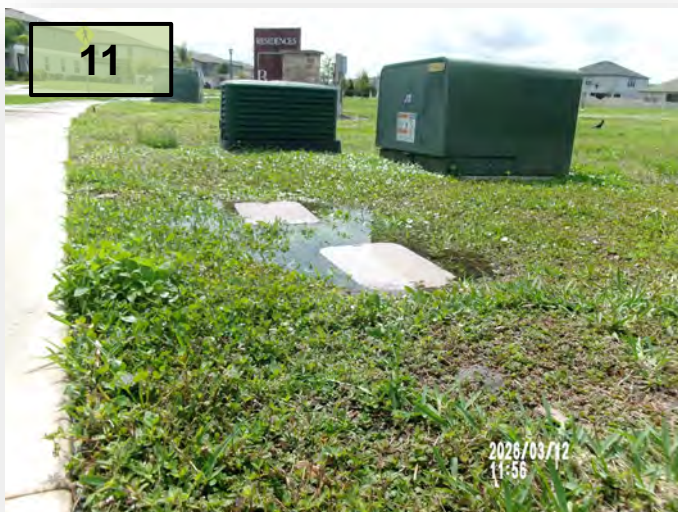
**11. Bear Landing:** A puddle of standing water was previously observed flooding one of the irrigation boxes. I contacted the account manager at that time, and they confirmed the issue would be addressed promptly. Can you please provide an update on the current status of this repair? (Pic 11)

# 11 – Irrigation on Bear Landing – repaired 3/12/26 stuck valve

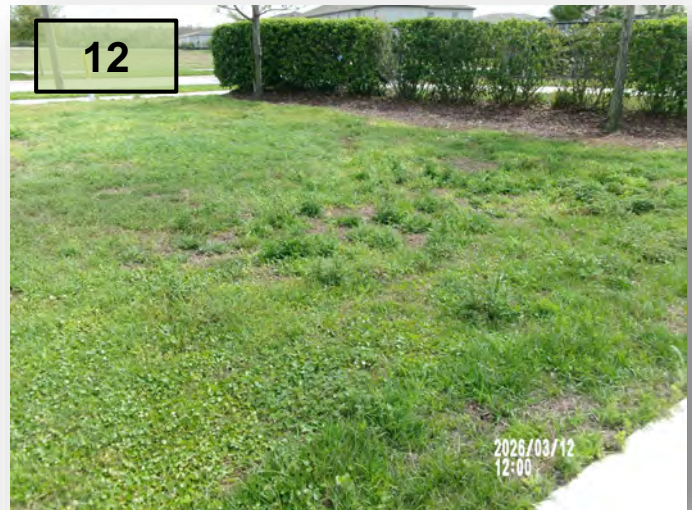
**12. Bear Landing:** There is an accumulation of turf weeds surrounding the plant bed, along with several small brown spots in the turf. These weeds should be spot-treated and removed prior to initiating a turf recovery plan to ensure effective regrowth and overall turf health. (Pic 12)

# 12 – Bear Landing- near lift station turf – Turf was treated on 3/3/26 and re-treated on 4/1/26. Will continue to monitor for improvement. Some of these weedy areas are Bahia and not irrigated.

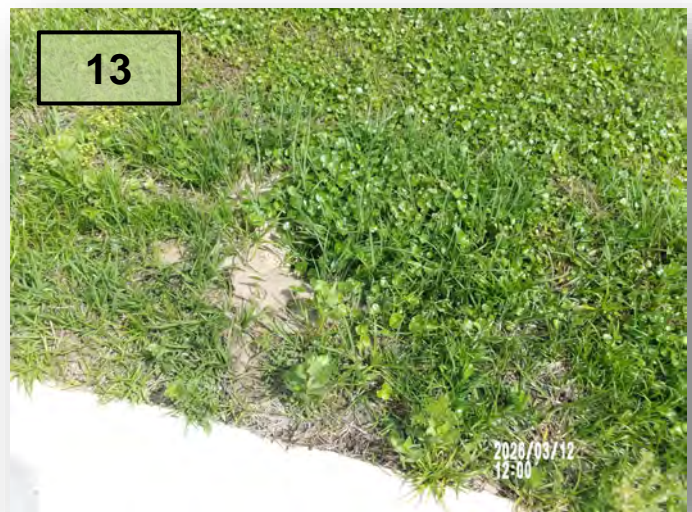
**13. Bear Landing:** Along the pathway adjacent to the concrete panels, a small hole was observed in the turf. The erosion around the area suggests a likely broken sprinkler head or an irrigation leak. Further inspection and repair are recommended. This is just behind the utility fence. (Pic 13)

# 13 – Area checked during inspection – Broken head along concrete has been replaced

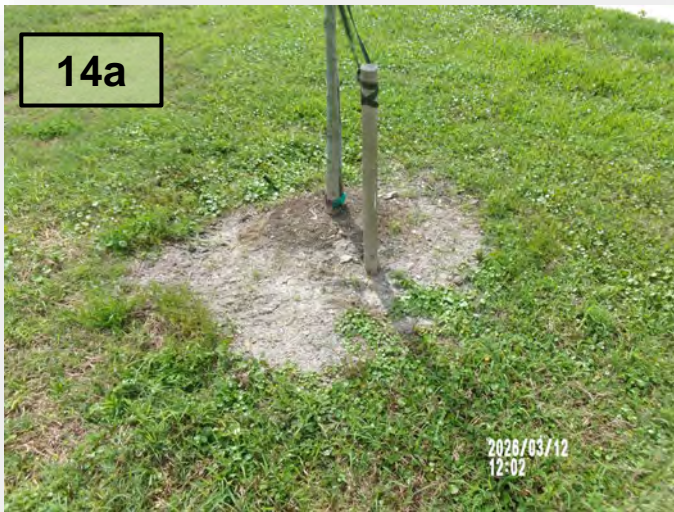
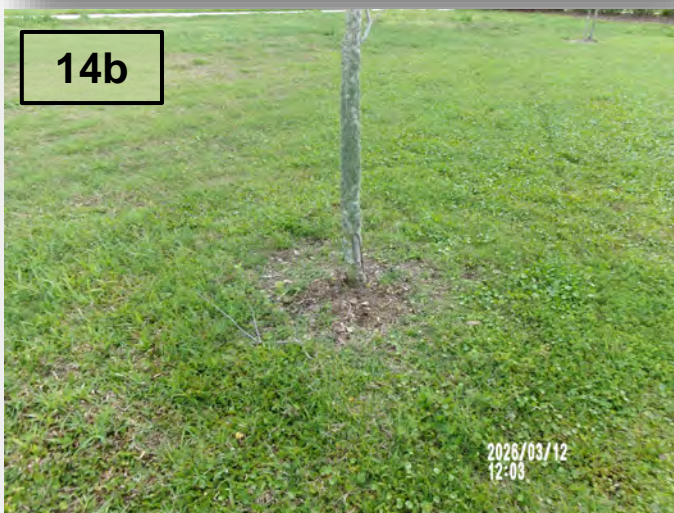
**14. Bear Landing:** The tree rings in this area require attention to maintain a clean, well-kept appearance. They need to be re-defined with a sharp edge, refreshed with new....(Nxt pg)

(#14 Cont.).... mulch, and line-trimmed to ensure uniformity across the site. (Pic 14a, 14b)

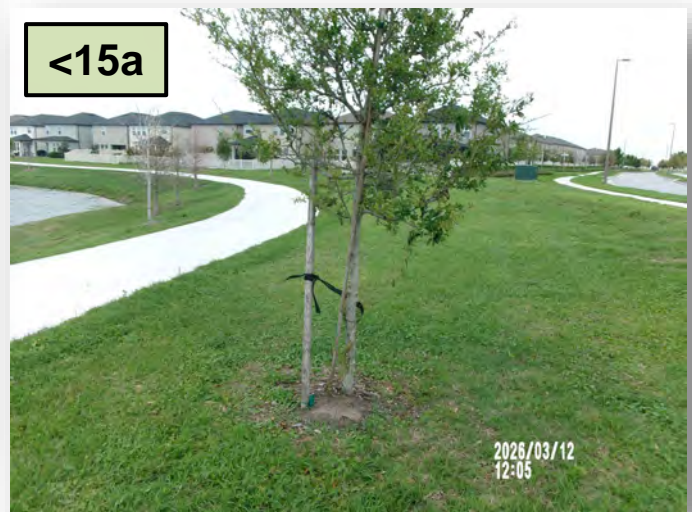
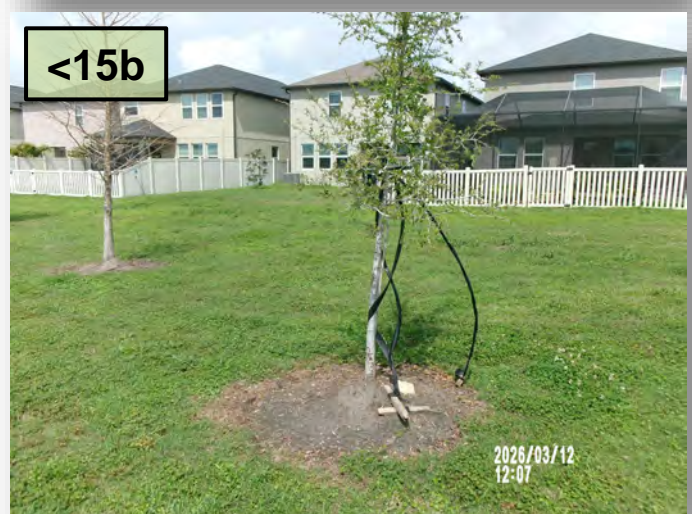
**17. Bear Landing – Birch Haven:** This bed still has not been cleaned up, detailed, or edged. This issue has been ongoing for over two months. The area requires proper cleanup, edging, and detailing to restore a neat and contained appearance. Can we get a confirmation of when this section is scheduled for maintenance? (Pic 17>)

**18. Bear Landing – Birch Haven:** The Bottlebrush tree in this location appears to be in severe decline and is unlikely to recover. I recommend removing the tree pending board approval. Once removed, we can discuss replacement options. I suggest proposing a new Bottlebrush of comparable size to match the existing tree nearby and maintain visual consistency within the landscape. (Pic 18>)

# 17 – Bear Landing and Birch Haven – Bed have been cleaned up, pre-emergent applied before mulching, replacement plants installed. Weeds have been sprayed but will continue to spray weekly.

# 18- Proposal attached

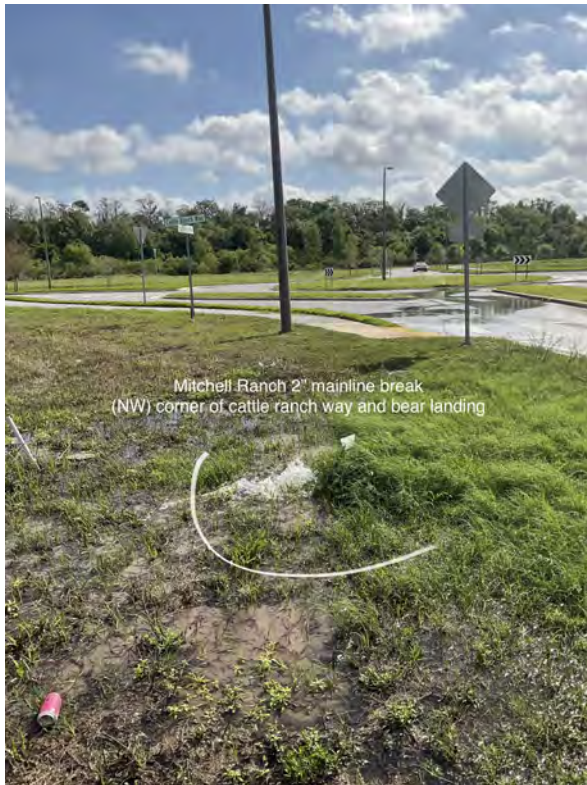
Repair 2 1/2" mainline break just west of the round about on Bear Landing  
leak identified on 3/16/26 durning inspection.
