**CEDAR HAMMOCK
COMMUNITY DEVELOPMENT DISTRICT
SEPTEMBER 8, 2020**

AGENDA PACKAGE

Cedar Hammock Community Development District

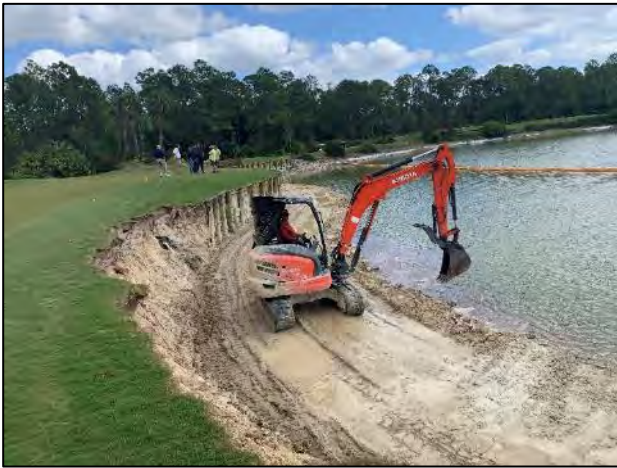
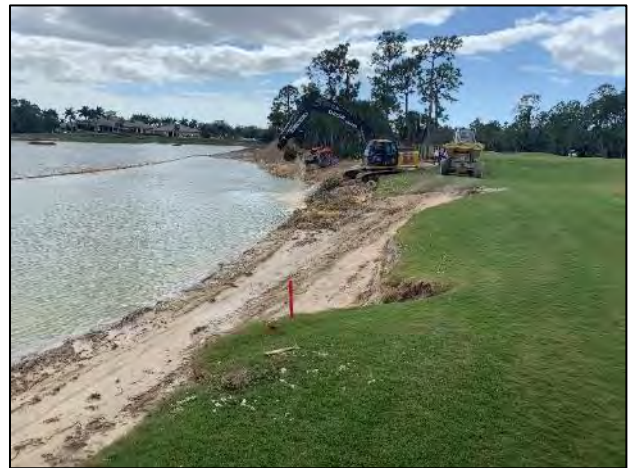
March 2, 2020

We attended a construction meeting at the project site on hole #17 with representatives from Banks Engineering, Kipp Shculties Golf Design Inc, Glase Golf and Artistic Structures Inc. to discuss the logistics of the project moving forward. Artistic Structures is a subcontractor to Glase Golf for the installation of the rock walls. We will coordinate with Travis Pritchett from Artistic Structures, Inc. during construction of the rock walls. Glase Golf was in the process of removing the timber walls and installing fill to form the shelf for the rock walls. The material was being mined out of a portion of the adjacent lake bank. The material was a mixture of sand and rock that was being used to create the shelf.

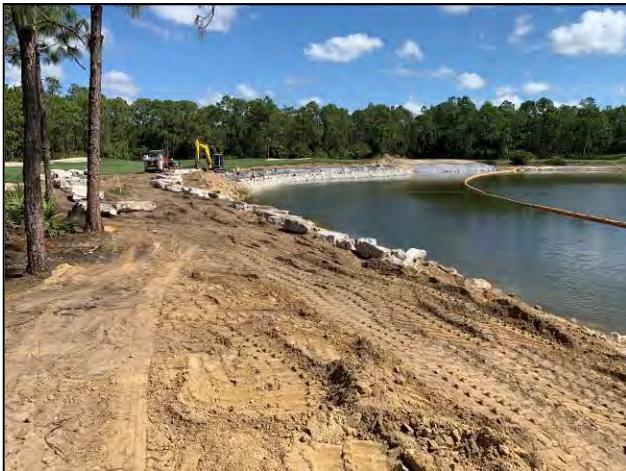
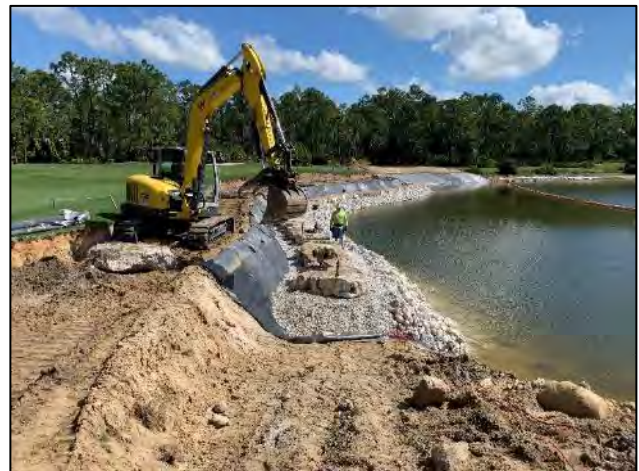
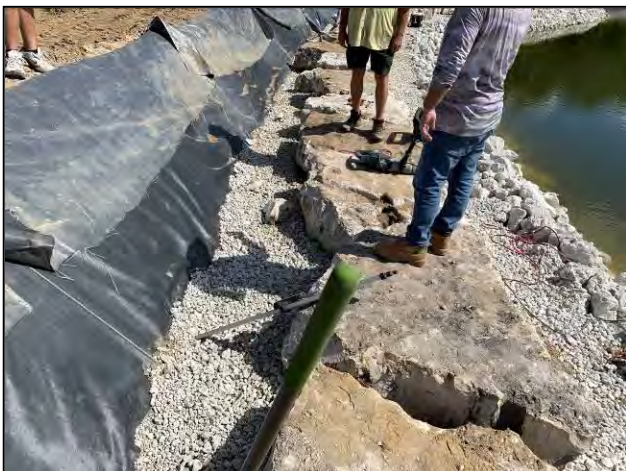
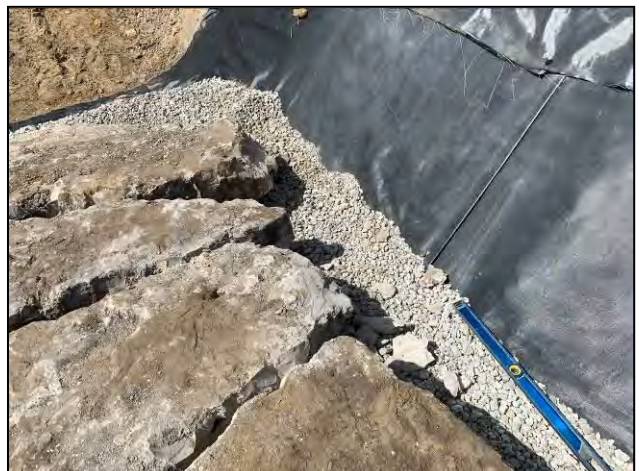
March 16, 2020

We met with Travis Pritchett with Artistic Structures (AS) and performed a visual inspection of the construction of the rock walls at hole #17. They were in the process of placing the first layer of rock for this wall which will need to be approximately 5 feet tall. The rocks vary in size and are approximately 45" wide at the base which is in accordance with our design plans. The rocks are being placed as close together as possible on top of a layer of #57 stone that was placed on top of 2 layers of FDOT Type D-2 geotextile. One layer of geotextile ends near the back of the wall and the other layer extends up on the embankment that will serve as siltation barrier between the embankment and drainage layer of stone behind the wall. AS will install small broken sections of rock or #57 stone in the larger gaps between the stones prior to installing a third layer of geotextile immediately behind the wall. The third layer will of geotextile will be installed behind the wall with enough slack to allow pushing it into the gaps between the stones to prevent the geotextile from spanning the gaps.

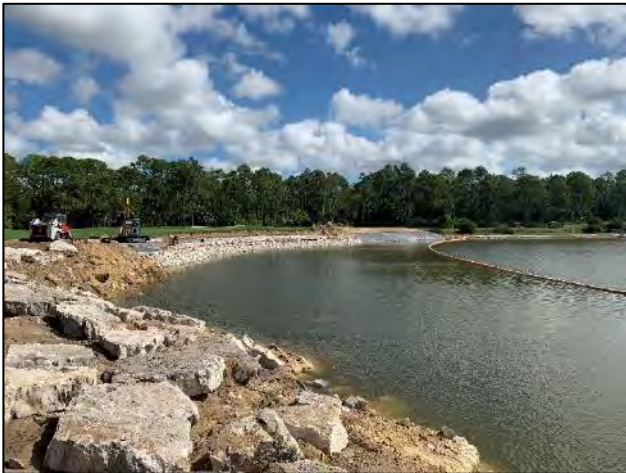
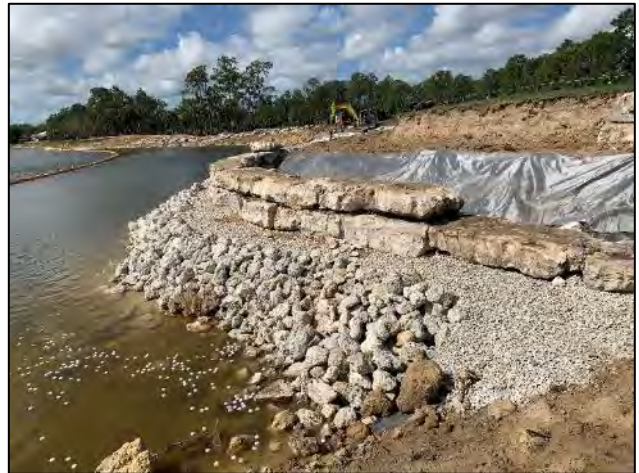
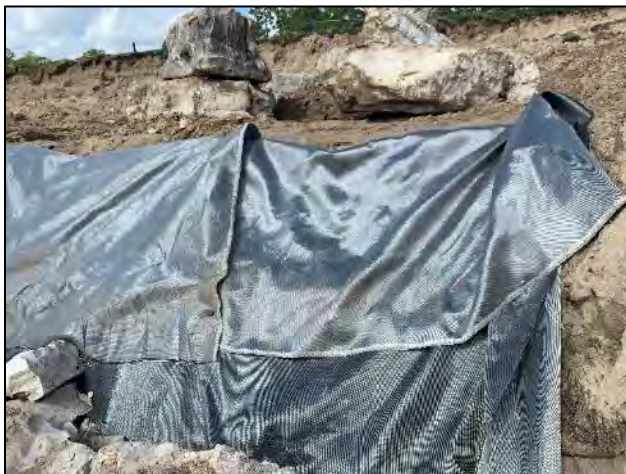
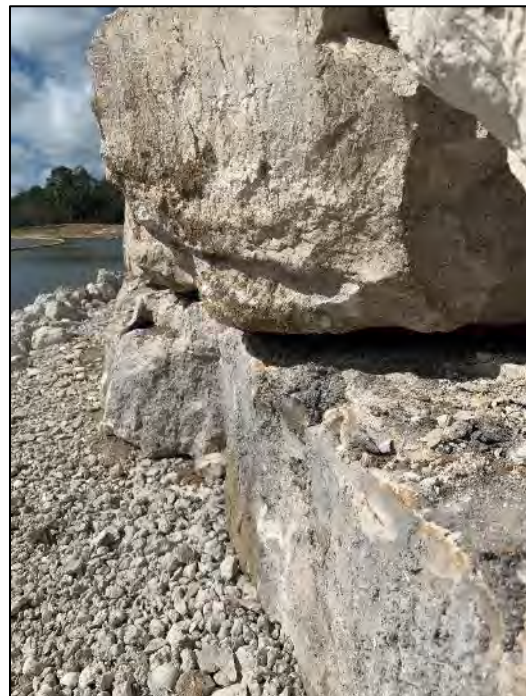
March 20, 2020

We met with Travis Pritchett with Artistic Structures (AS) and performed a visual inspection of the construction of the rock walls at hole #17. They were in the process of placing the second layer of rock for this wall. The maximum height of the rock is approximately 36" and these first two layers have no setback. AS is planning to install a total of four layers of rock which will reach a height of 5' to 5'-6".

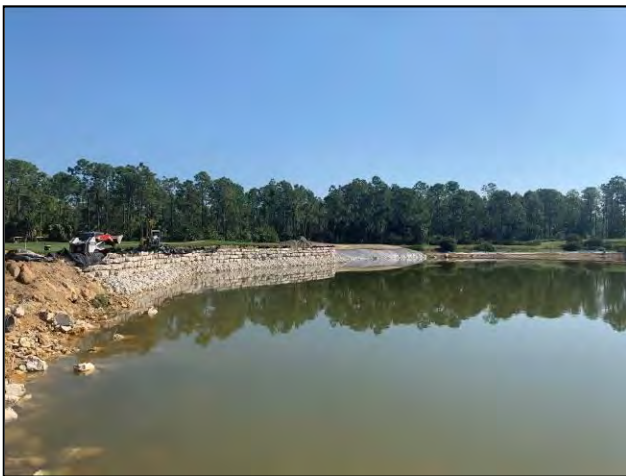
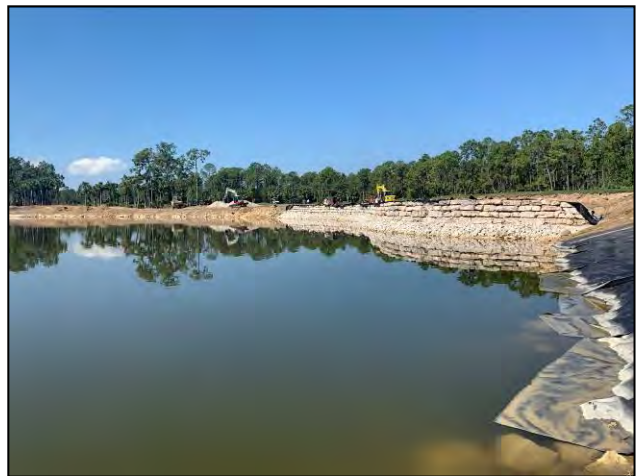
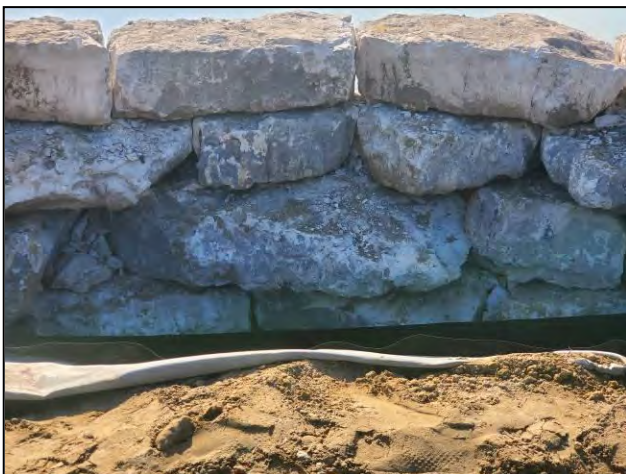
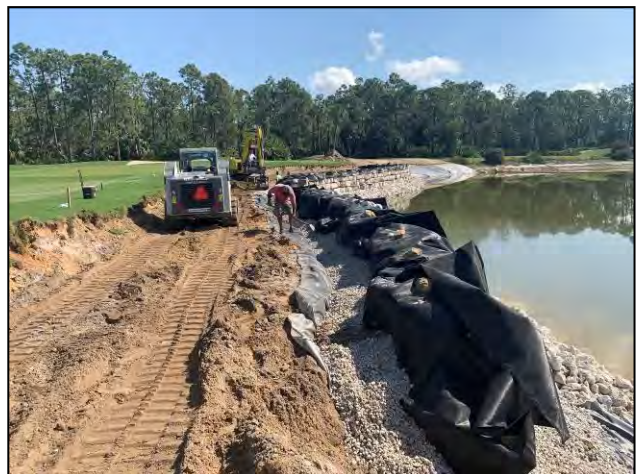
March 27, 2020

We met with Travis Pritchett with Artistic Structures (AS) and performed a visual inspection of the construction of the rock walls at hole #17. AS completed the placement of stones in between voids in the rock layers on the back face of the wall. They were in the process of placing the #57 stone drainage layer between the rock layers and the geotextile fabric at the back of the wall. The rock wall is complete and has 4 layers, the maximum height of the rock varies between 5'-0" and 5'-6" and the setback batter varies between 4" and 6" which is in close agreement with the design plans.

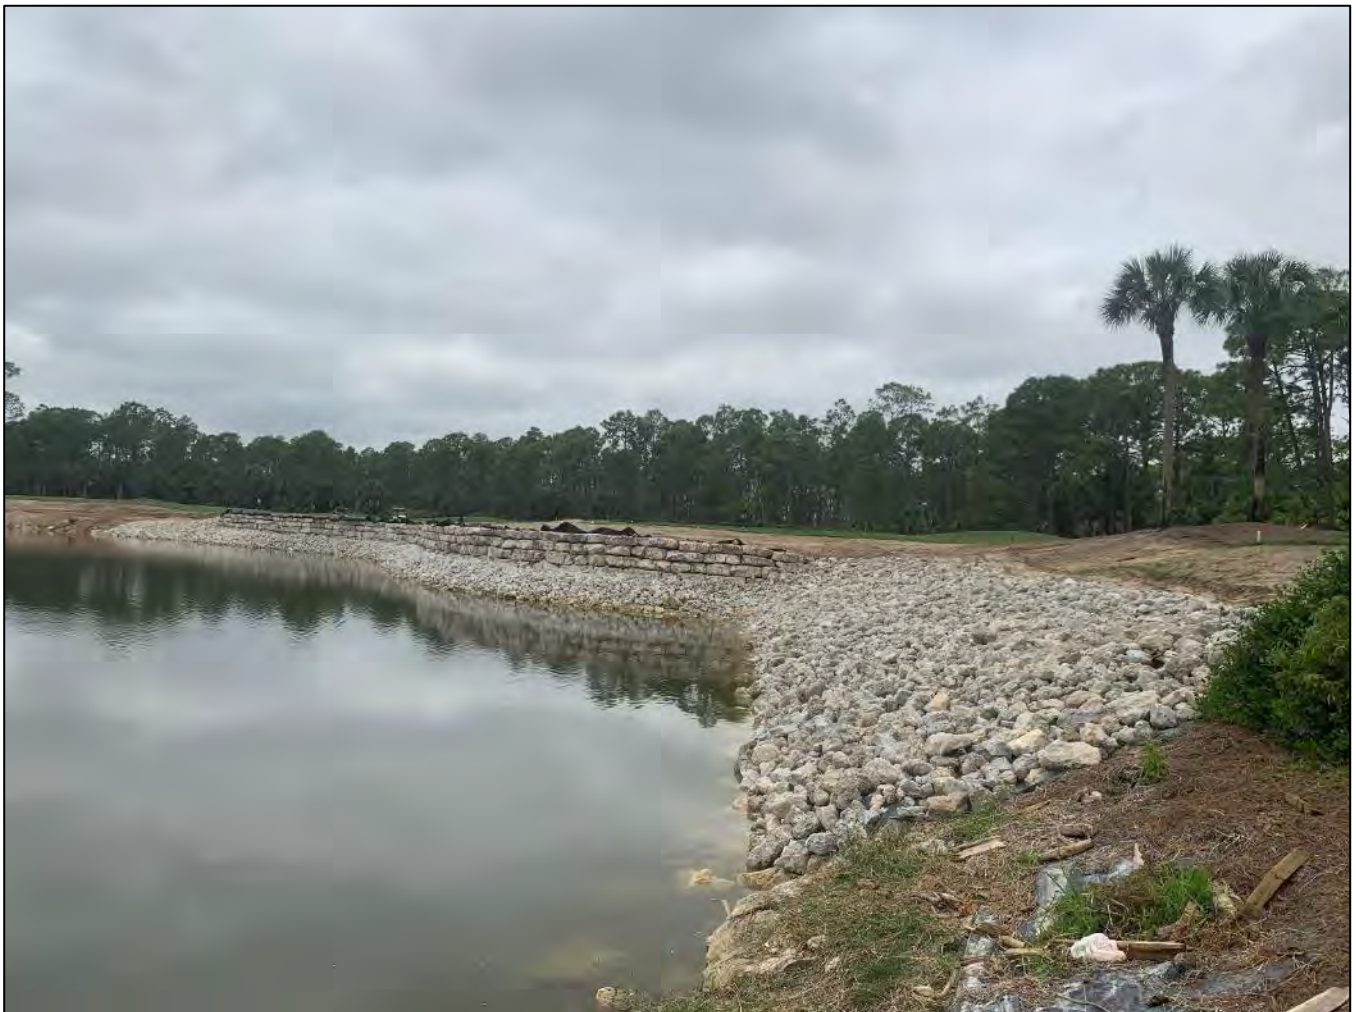
Hole #17

We met with Travis Pritchett with Artistic Structures (AS) and performed a visual inspection of the construction of the rock walls at hole #17 and hole #4. The construction for hole #17 is substantially complete and in accordance with our design plans. They were in the process of placing the first layer of rock for hole #4. The rocks vary in size and are approximately 45" wide at the base and 14" high which is in accordance with our design plans. The rocks are being placed as close together as possible on top of a layer of #57 stone that was placed on top of 2 layers of FDOT Type D-2 geotextile. One layer of geotextile ends near the back of the wall and the other layer extends up on the embankment that will serve as siltation barrier between the embankment and drainage layer of stone behind the wall.

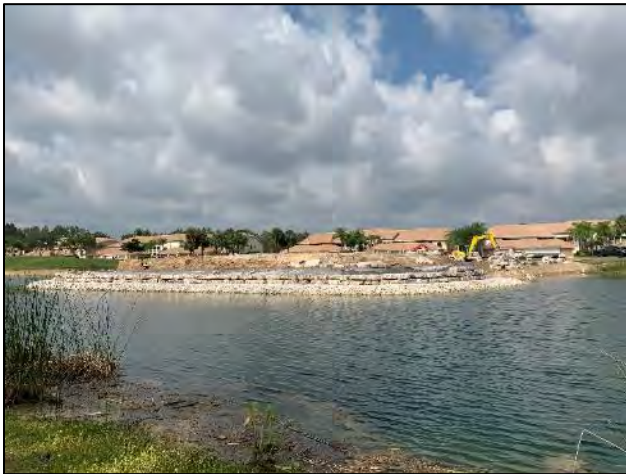
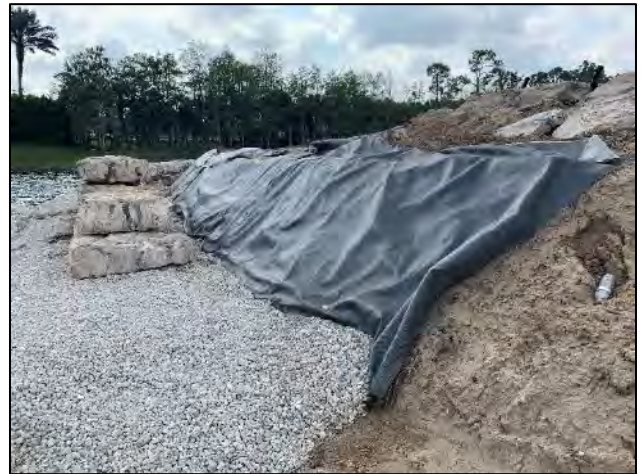
April 10, 2020

We met with Travis Pritchett with Artistic Structures (AS) and performed a visual inspection of the construction of the rock walls at hole #4. They were in the process of placing the third layer of rock for this wall. The maximum height of the rock is approximately 47" and the setback batter is approximately 2.5" which is in close agreement with the design plans. AS is planning to install a total of five layers of rock which will reach a height of 6' to 7'.

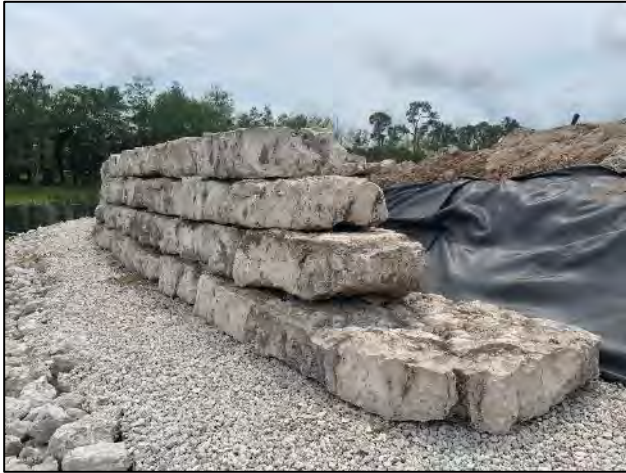
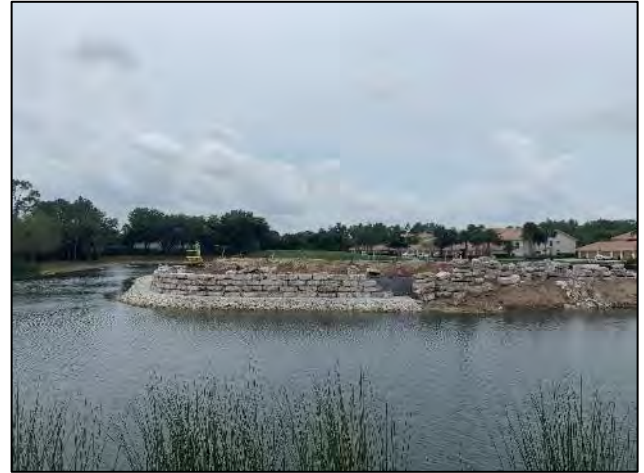
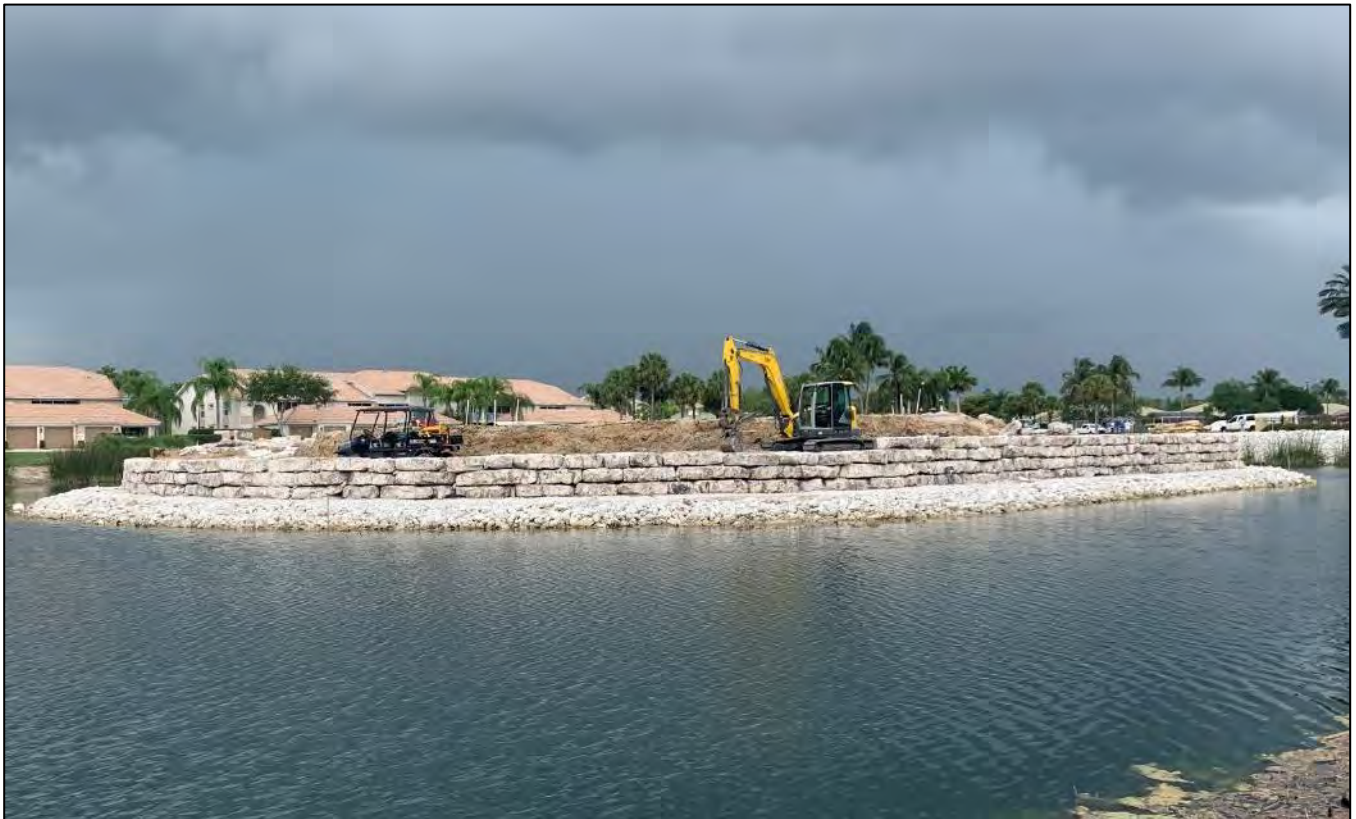
April 16, 2020

We met with Travis Pritchett with Artistic Structures (AS) and performed a visual inspection of the construction of the rock walls at hole #4. They were in the process of placing the fourth layer of rock for this wall. The maximum height of the rock is approximately 5' to 5'-2" and the setback batter is approximately 5" which is in close agreement with the design plans.

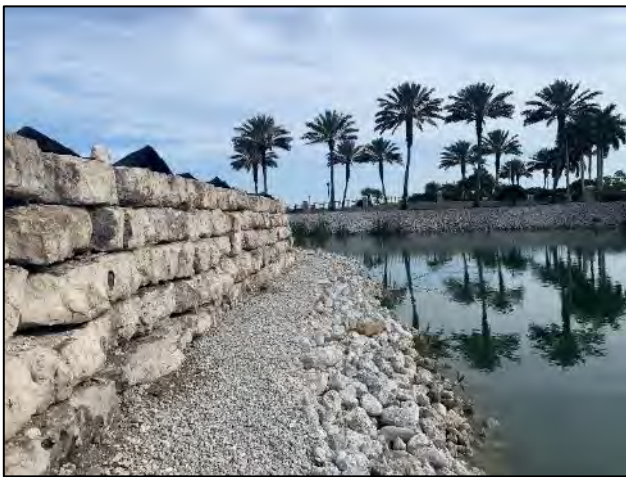
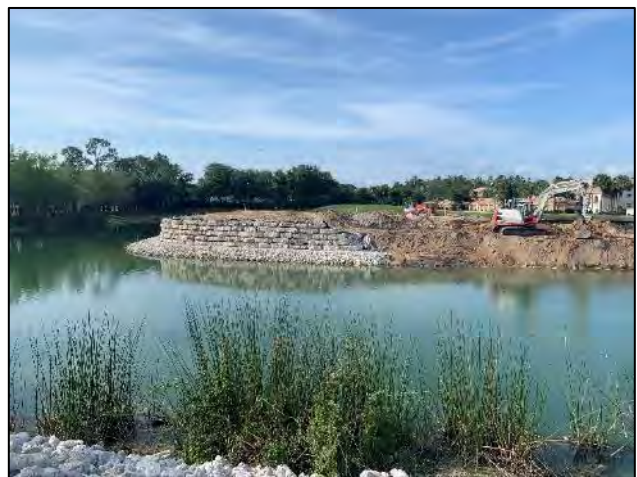
*Hole #4*

We met with Travis Pritchett with Artistic Structures (AS) and performed a visual inspection of the construction of the rock walls at holes #4 and #5. The rock wall at hole #4 has a total of 5 layers, the maximum height of the rock varies between 6'-0" and 7'-0". At hole #5, the rocks are being placed as close together as possible on top of a layer of #57 stone that was placed on top of 2 layers of FDOT Type D-2 geotextile. One layer of geotextile ends near the back of the wall and the other layer extends up on the embankment that will serve as siltation barrier between the embankment and drainage layer of stone behind the wall. They were in the process of placing the second layer of rock for this wall.

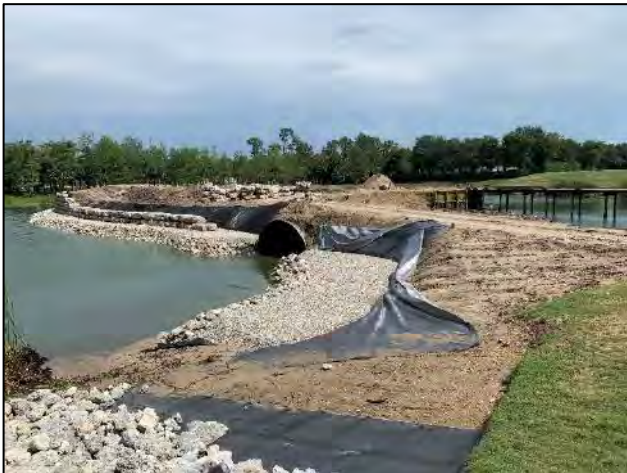
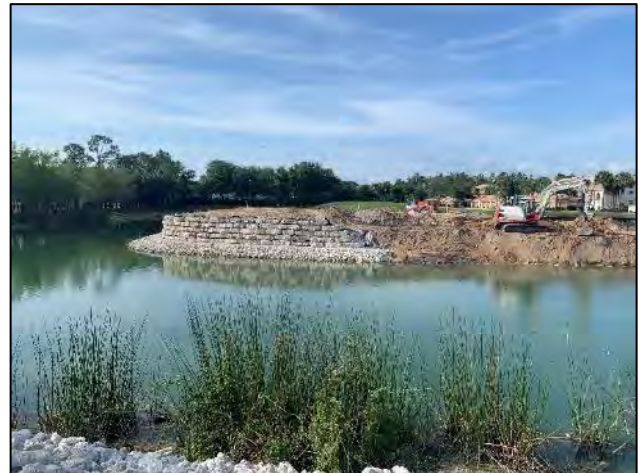
Hole #4

We met with Travis Pritchett with Artistic Structures (AS) and performed a visual inspection of the construction of the rock walls at holes #4 and #5. The aluminum tubes have been installed at both locations and fill has been placed. The rock wall at hole #4 has a total of 5 layers and the rock wall at hole #5 has a total of 3 layers.

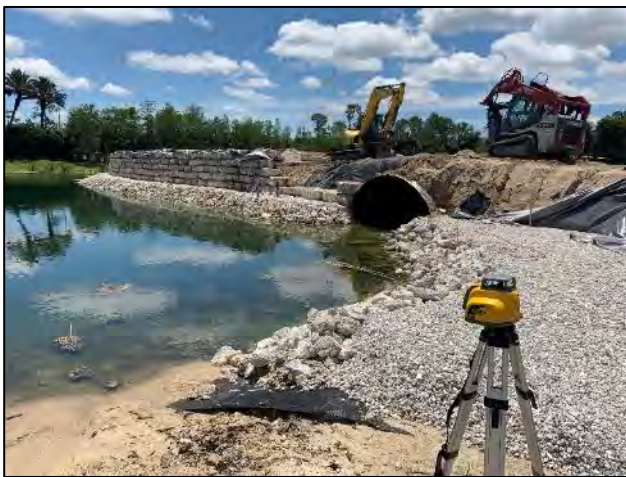
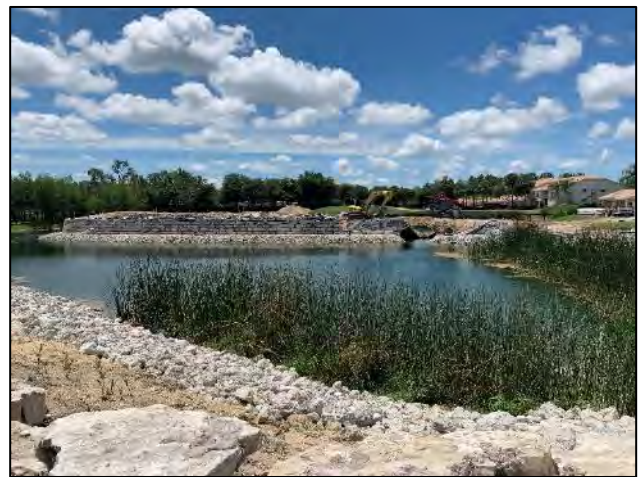
*Hole #4*

We met with Travis Pritchett with Artistic Structures (AS) and performed a visual inspection of the construction of the rock walls at holes #4 and #5. The second aluminum tube has been installed at hole #5 and fill has been placed. The rock wall at hole #4 has a total of 5 layers with a maximum height of approximately 6' to 7' with 5" of setback. The rock wall at hole #5 has a total of 3 layers with a maximum height of approximately 4" of setback.

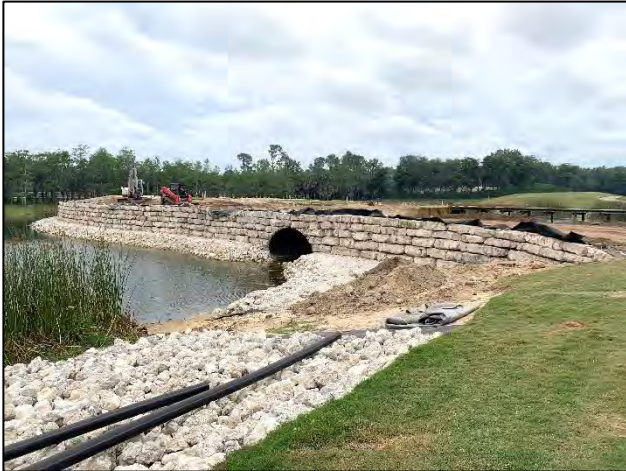
Hole #4

We met with Travis Pritchett with Artistic Structures (AS) and performed a visual inspection of the construction of the rock walls at holes #4 and #5. The rock walls appear to have been constructed in accordance with our design plans.

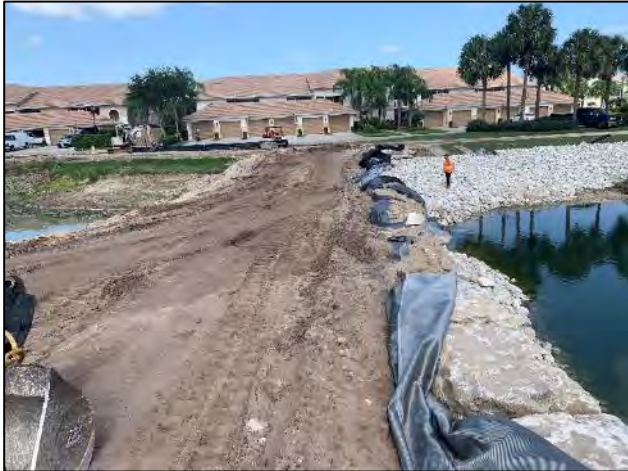
Hole #4

We met with Travis Pritchett with Artistic Structures (AS) and performed a visual inspection of the construction of the rock walls at holes #4 and #5. The rock walls appear to have been constructed in accordance with our design plans. There was damage that occurred to the installation of the aluminum pipe at hole #4 by Glase Golf.

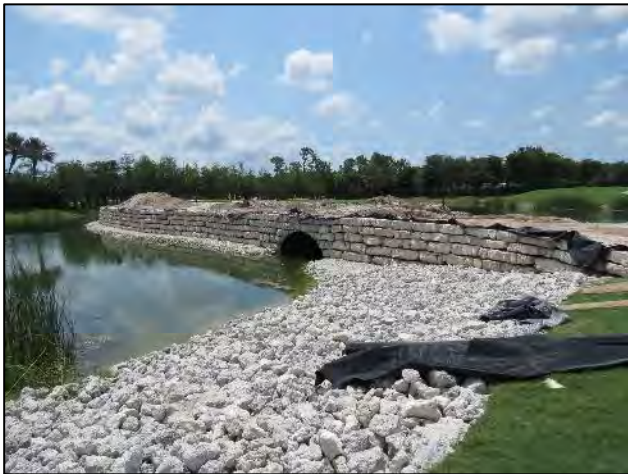
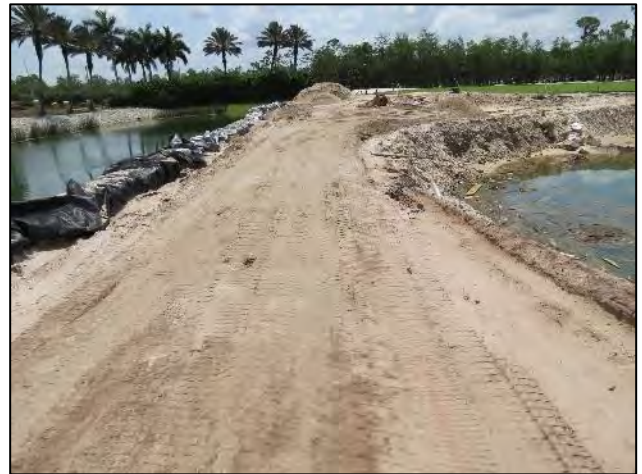
Hole #4

We met with Travis Pritchett with Artistic Structures (AS) and performed a visual inspection of the construction of the rock walls at holes #4 and #5. The rock walls appear to have been constructed in accordance with our design plans.

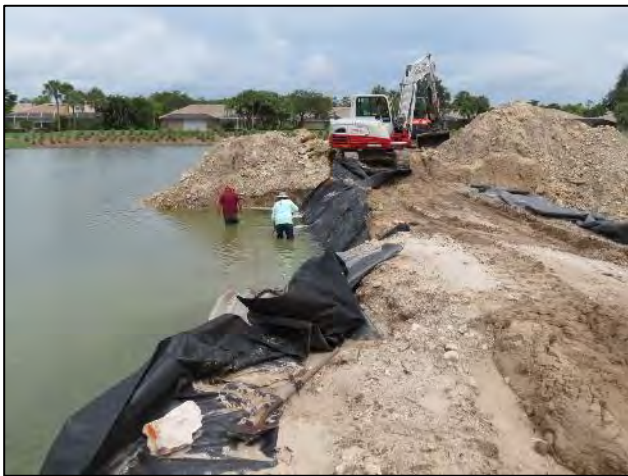
*Hole #7*

We met with Travis Pritchett with Artistic Structures (AS) and performed a visual inspection of the construction of the rock walls at holes #4, #5 and #7. The rock walls at hole #7 are being constructed by Glase Golf and are not in accordance with our design plans related to the required front face batter of 5%. Some of top stones hang over the lower layers of rock. We were unable to measure the exact batter because the walls are submerged. We were also not able to measure the sizes of the rock at the base because they were already backfilled. There was minor damage that occurred to the installation of the aluminum pipe at hole #7 by Glase Golf. The rock walls at #4 and #5 appear to have been constructed in accordance with our design plans.

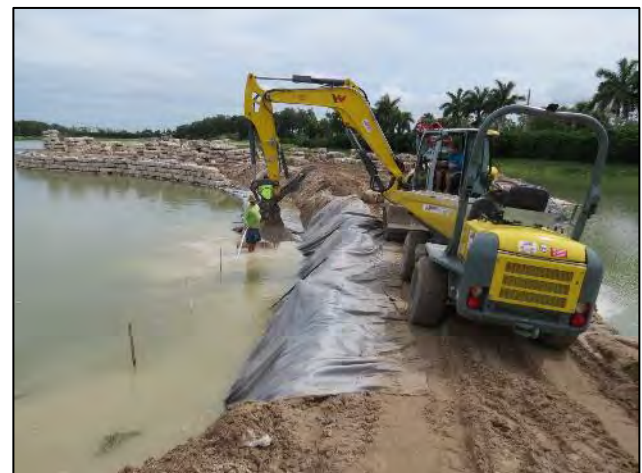
*Hole #5*

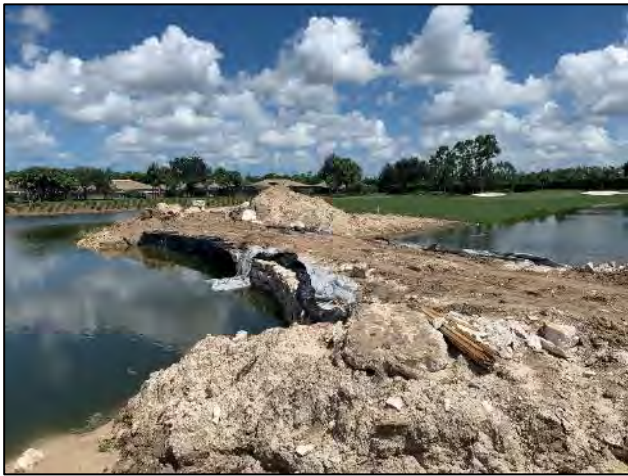
We met with Travis Pritchett with Artistic Structures (AS) and performed a visual inspection of the construction of the rock walls at holes #4, #5 and #7. The rock walls at hole #7 that are being constructed by Glase Golf and are still not in accordance with our design plans related to the required front face batter of 5%. The rock walls at #4 and #5 appear to have been constructed in accordance with our design plans.

*Hole #7*

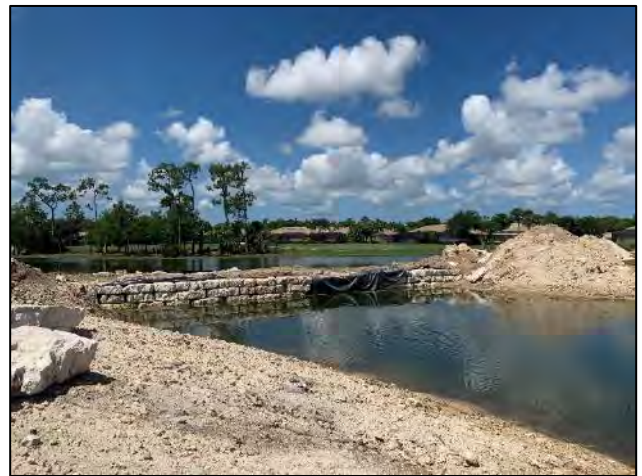
*Hole #7*

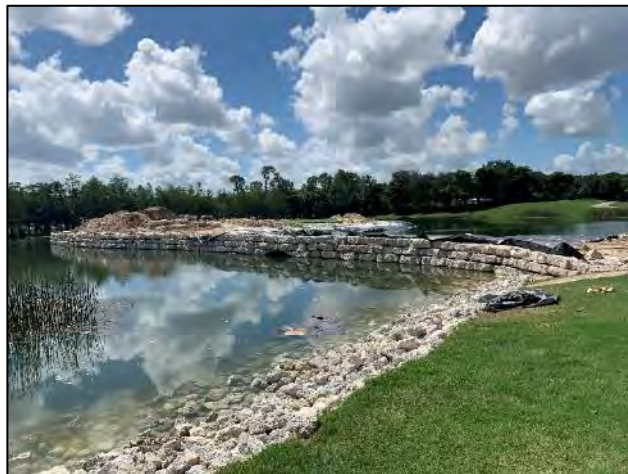
*Hole #5*

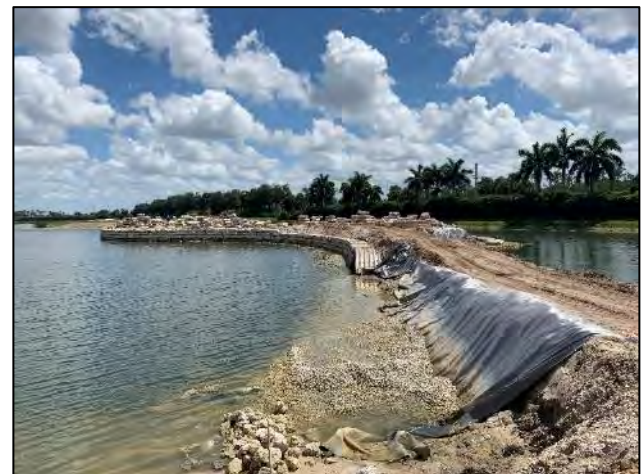
*Hole #5*

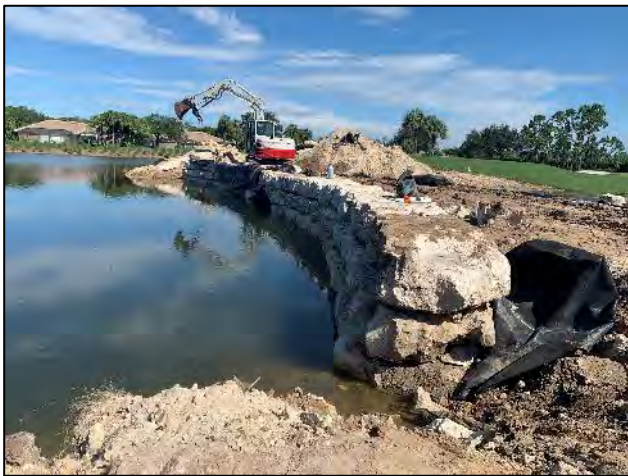
We met with Travis Pritchett with Artistic Structures (AS) and performed a visual inspection of the construction of the rock walls at holes #4, #5 and #7. The rock walls at hole #7 are being constructed by Glase Golf. The south side layer of rocks have been placed in accordance with our design plans, but the north side layer of rocks are not placed in accordance with our design related to the required front face batter of 5%. The rock walls at #4 and #5 appear to have been constructed in accordance with our design plans. The rock walls at #5 range between 1 and 4 layers, the maximum height of the rock varies between 5'-0" and 5'-6" and the setback batter varies between 4" and 6" which is in close agreement with the design plans.

Hole #7

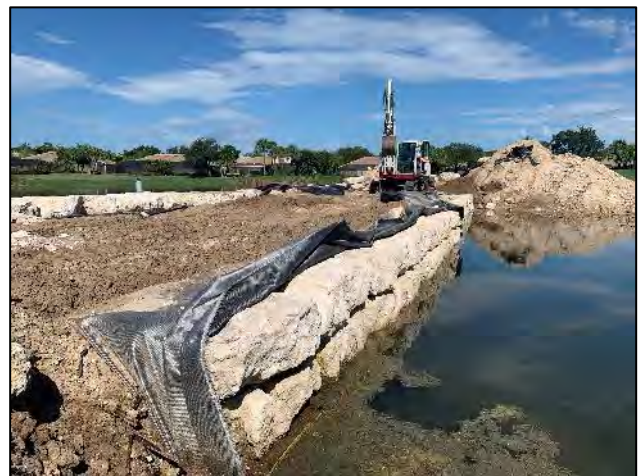
Hole #7

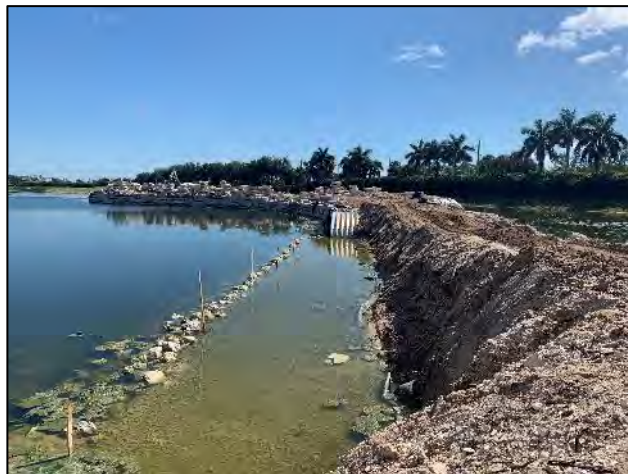
Hole #5

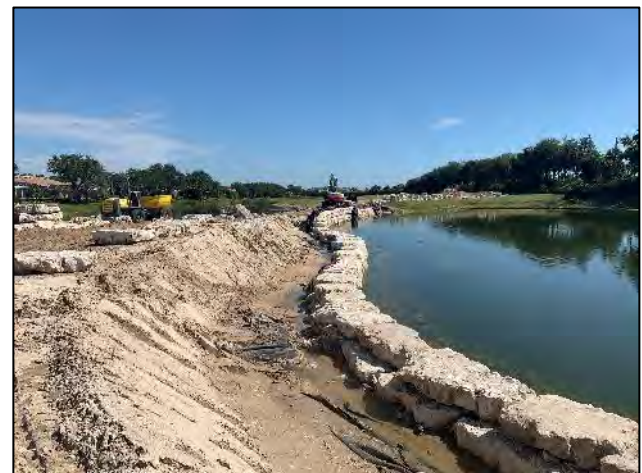
Hole #5

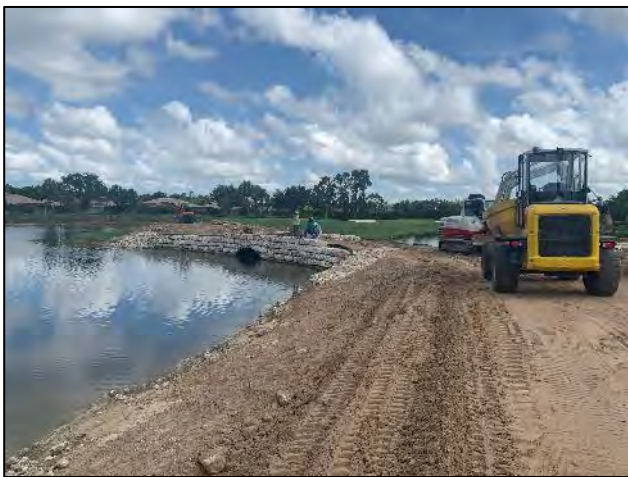
We met with Travis Pritchett with Artistic Structures (AS) and performed a visual inspection of the construction of the rock walls at holes #4, #5 and #7. The rock walls at hole #7 are being constructed by Glase Golf. The rock layers have been placed in accordance with our design plans related to the required front face batter of 5%. The current rock height above the aluminum pipe is approximately 34" at hole #7, 33" at hole #4 and there is no rock that has been placed on either of the aluminum pipes at hole #5.

*Hole #7*

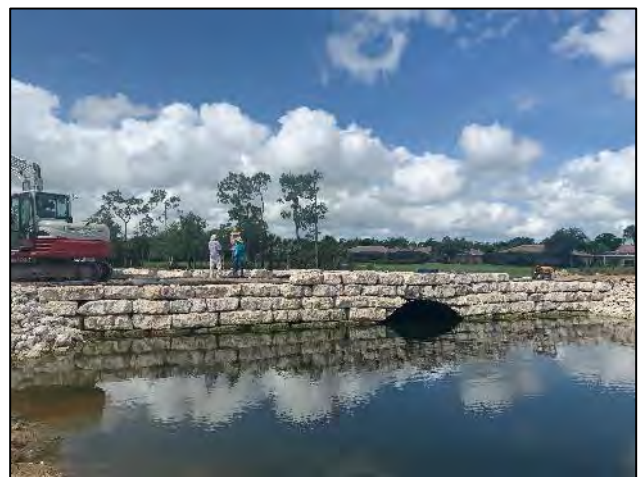
*Hole #7*

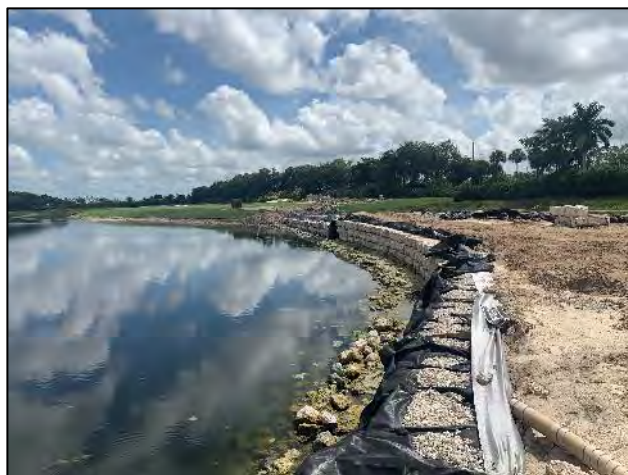
*Hole #5*

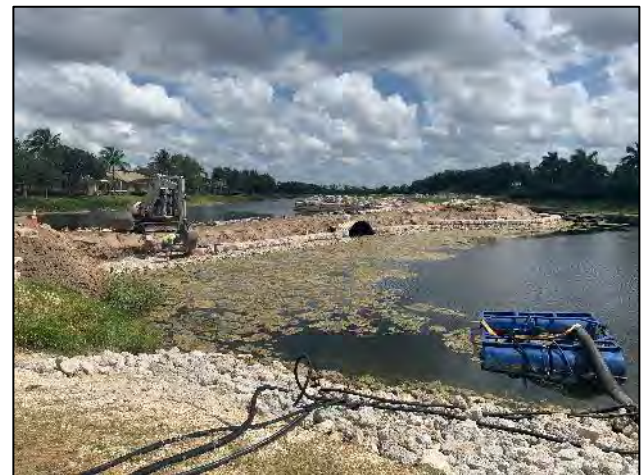
*Hole #5*

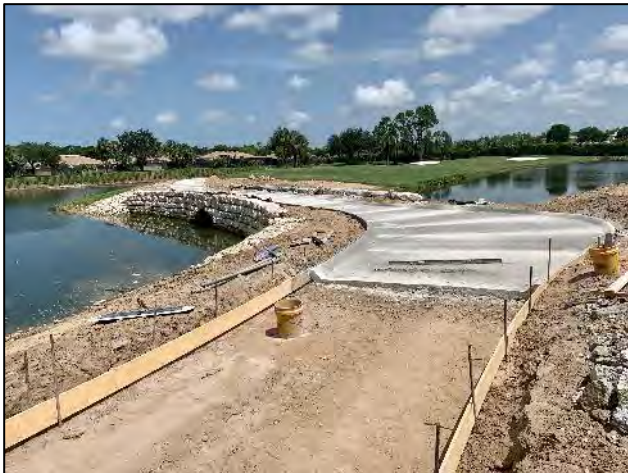
We met with Travis Pritchett with Artistic Structures (AS) and performed a visual inspection of the construction of the rock walls at holes #4, #5 and #7. The rock walls at hole #7 being constructed by Glase Golf are substantially complete and appear to have been constructed in accordance with our design plans. The current rock height above the aluminum pipe is approximately 34" at hole #7, 33" at hole #4 and there is no rock that has been placed on either of the aluminum pipes at hole #5.

Hole #7

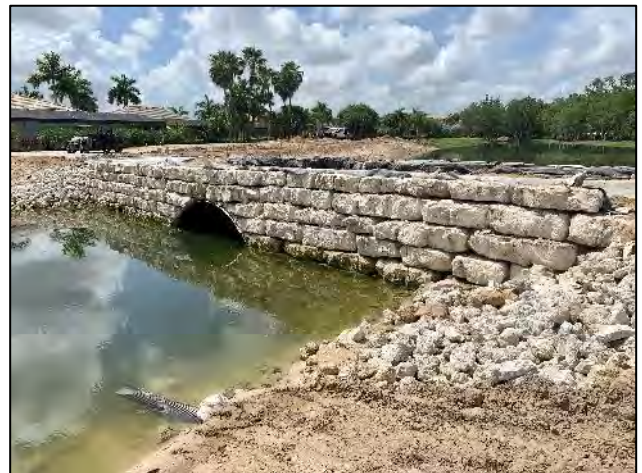
Hole #7

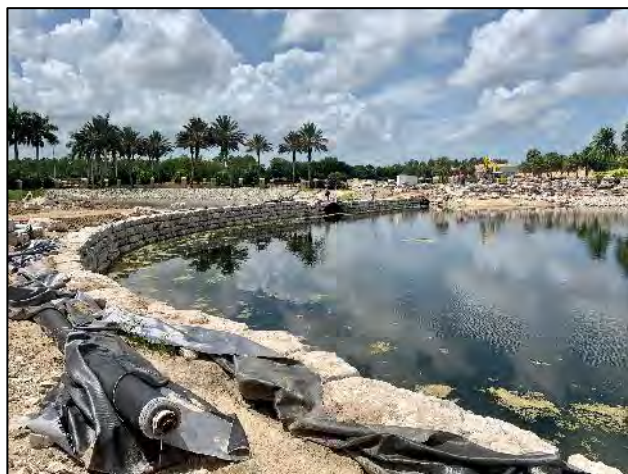
Hole #5

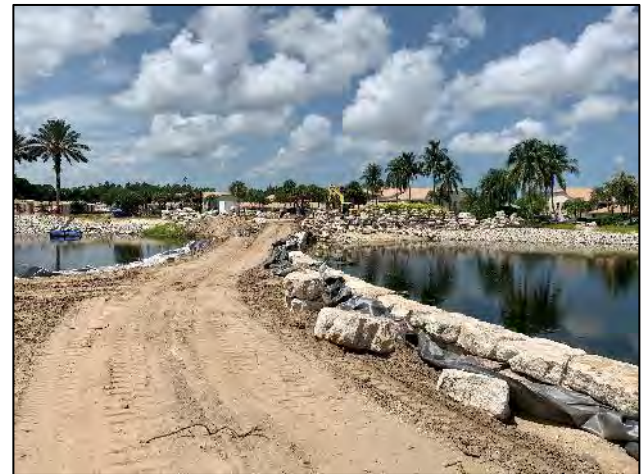
Hole #5

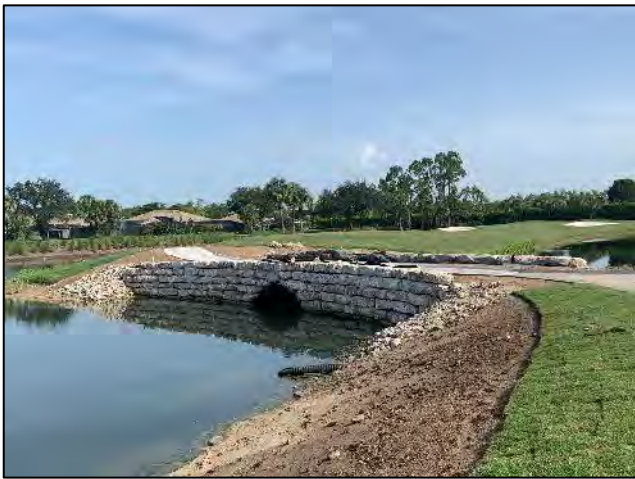
We met with Travis Pritchett with Artistic Structures (AS) and performed a visual inspection of the construction of the rock walls at holes #4, #5 and #7. The rock walls at hole #7 constructed by Glase Golf are complete and appear to have been constructed in accordance with our design plans. The rock walls at hole #5 currently have between 2 and 4 layers of rock. The current rock height above aluminum pipe #1 at hole #5 varies between 16" and 18" and the current rock height above pipe #2 is 16" on the west side no rock has been placed above the east side. AS plans to install one additional rock layer on both pipes at hole #5 in the area surrounding the pipes. The current rock height above the aluminum pipe is approximately 33" at hole #4 on the north side and there is no coverage on the south side.

*Hole #7*

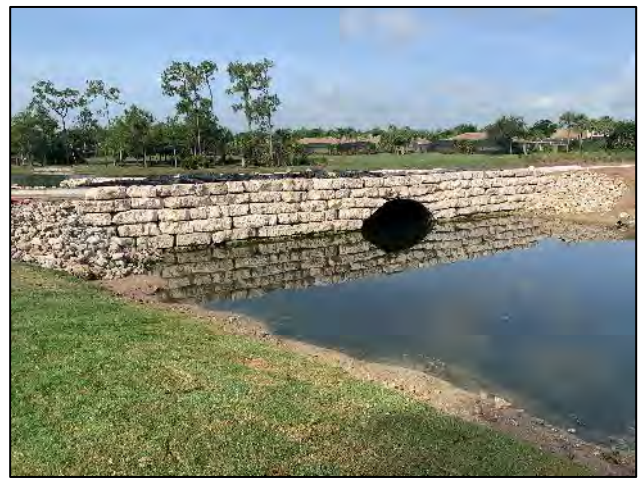
*Hole #7*

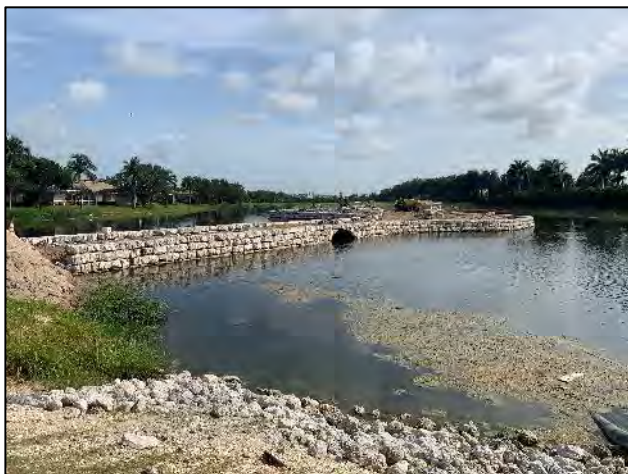
*Hole #5*

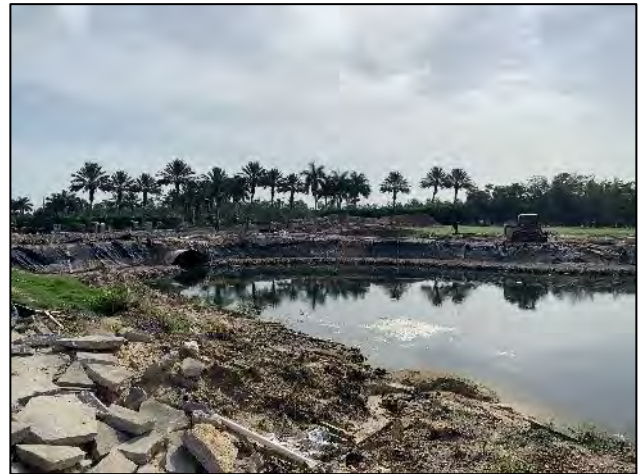
*Hole #4*

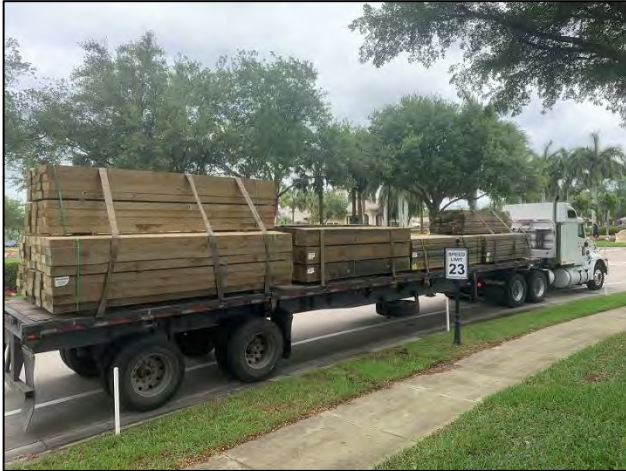
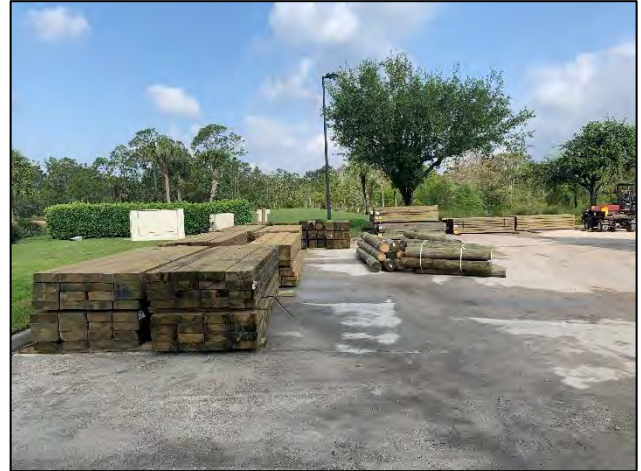
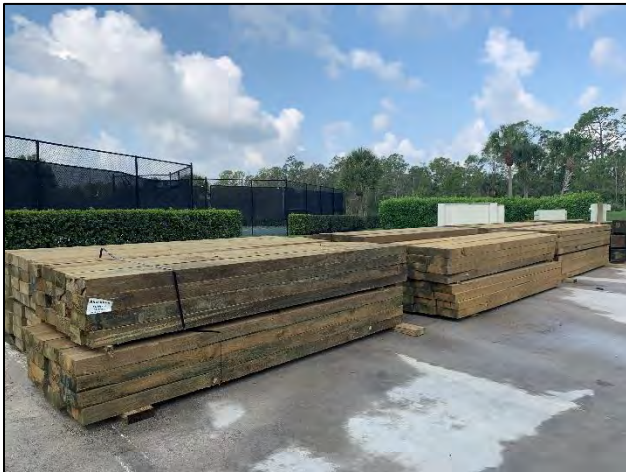
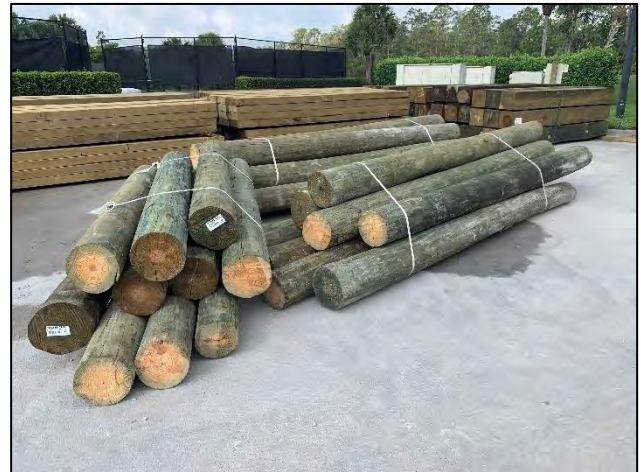
April 6, 2020

We met with Travis Pritchett with Artistic Structures (AS) and performed a visual inspection of the timber being delivered for the construction of the golf cart bridges and reviewed the delivery tickets. The timber meets the requirements specified in our design plans. The timber is being stored temporarily in the clubhouse parking lot.

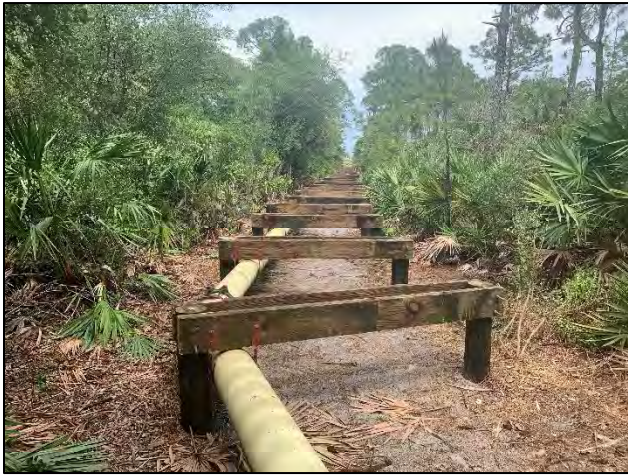
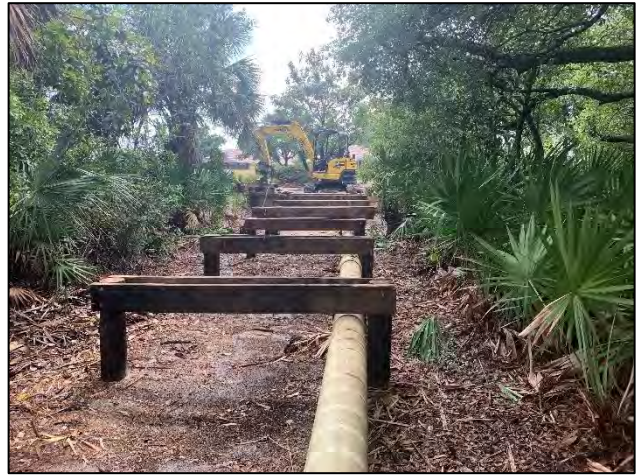
April 30, 2020

We met with Travis Pritchett with Artistic Structures (AS) and performed a visual inspection of the timber bridge construction at hole #9. AS has removed all of the stringers and deck boards from the previous bridge. They installed the piles and cap beams for the abutment and first span. The timber size and spacing is in accordance with our design plans.
