**CEDAR HAMMOCK
COMMUNITY DEVELOPMENT DISTRICT
SEPTEMBER 8, 2020**

AGENDA PACKAGE

Cedar Hammock Community Development District

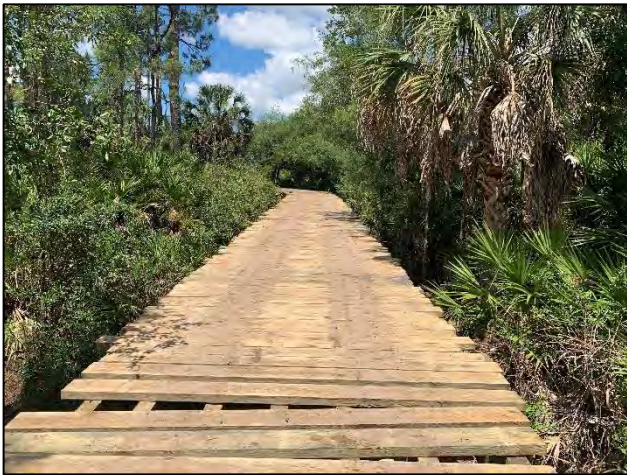
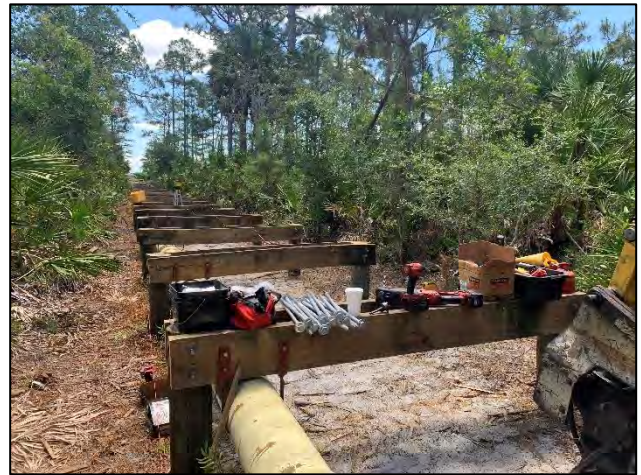
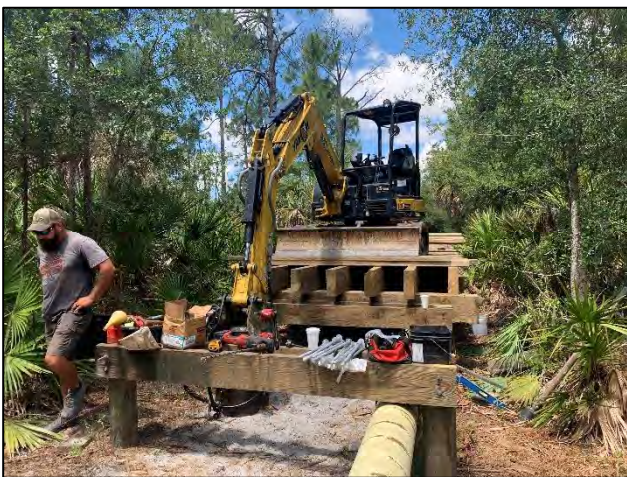
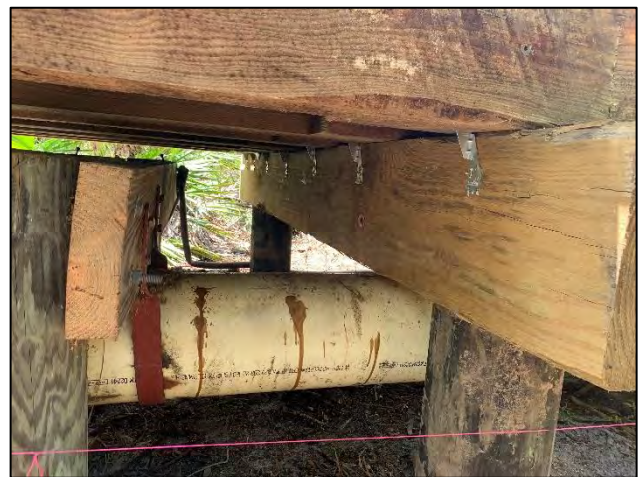
May 6, 2020

We met with Travis Pritchett with Artistic Structures (AS) and performed a visual inspection of the timber bridge construction at hole #9. AS has installed the piles and cap beams for more than 50% of the bridge. The timber size and spacing is in accordance with our design plans. AS informed us that they received approval from Cedar Hammock CDD to leave the previous piles and cap boards in place to avoid leaving the utility pipe temporarily unsupported. The existing hangers will also remain in place. The pipe will be attached to the new piles and cap beams in accordance with the design plans. AS anticipates completion of the pile and cap beams for this bridge within the next 4-5 working days.

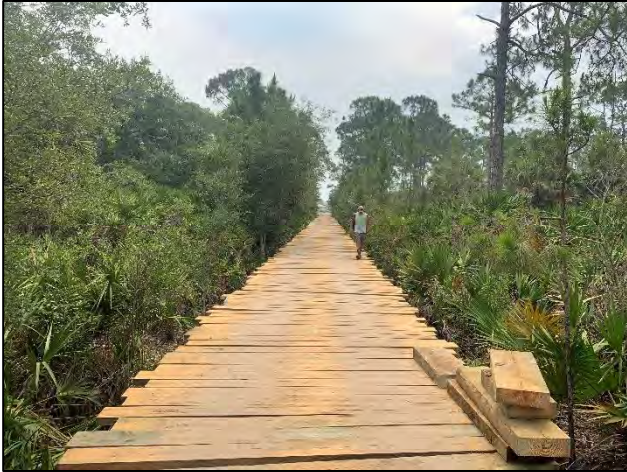
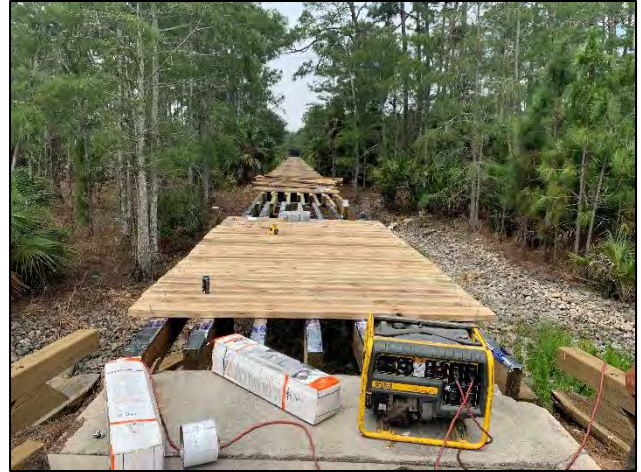
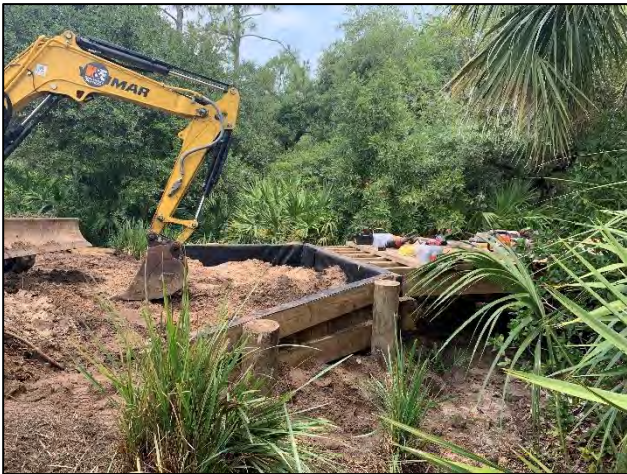
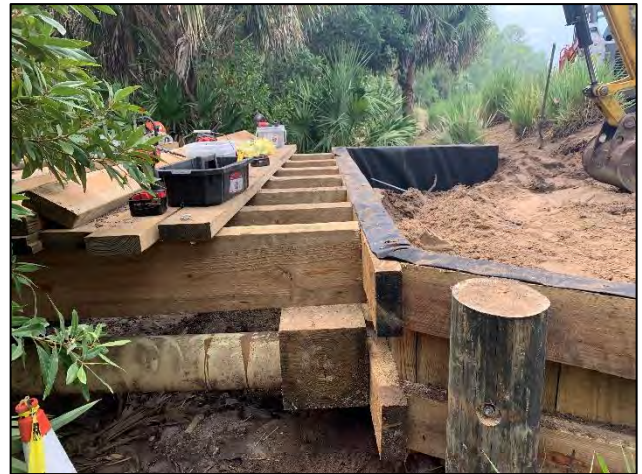
May 14, 2020

We met with Travis Pritchett with Artistic Structures (AS) and performed a visual inspection of the timber bridge construction at hole #9. AS finished installing the piles and cap beams for the bridge. The abutment and wingwalls at the begin bridge have been installed. The timber size and spacing is in accordance with our design plans. AS anticipates completion of this bridge within 7 working days.

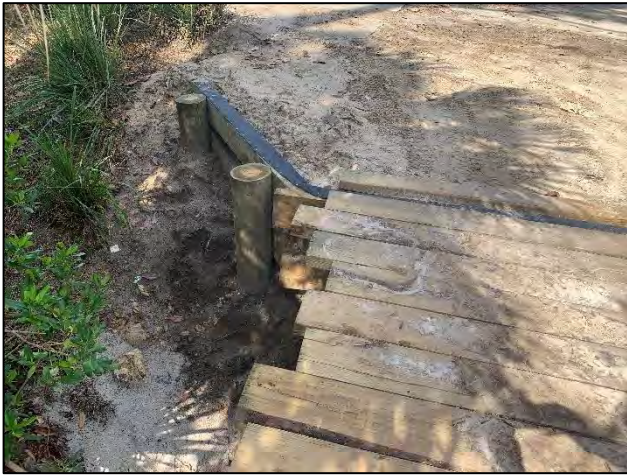
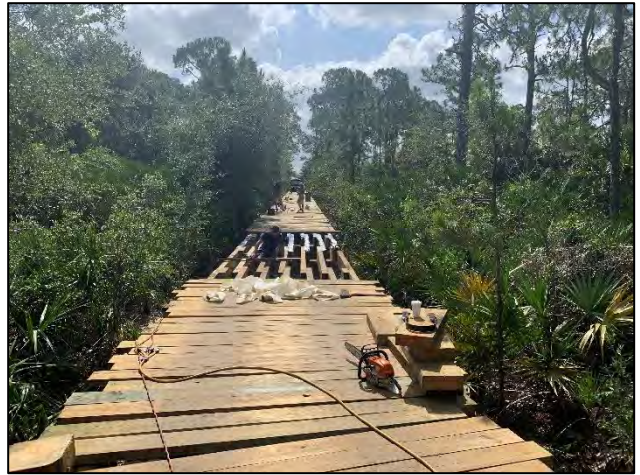
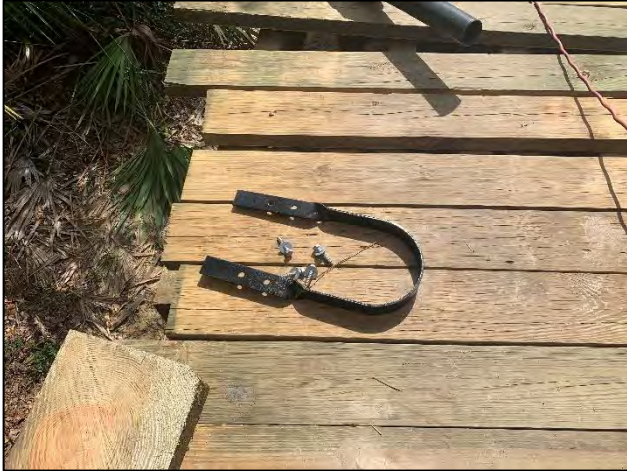
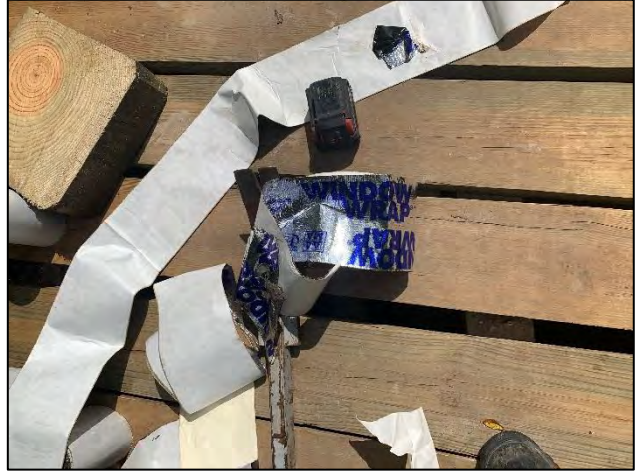
May 21, 2020

We met with Travis Pritchett with Artistic Structures (AS) and performed a visual inspection of the timber bridge construction at hole #9. AS has completed installation of the substructure of the bridge. The timber sizes and spacing is in accordance with our design plans. AS is finalizing the installation of the deck boards.

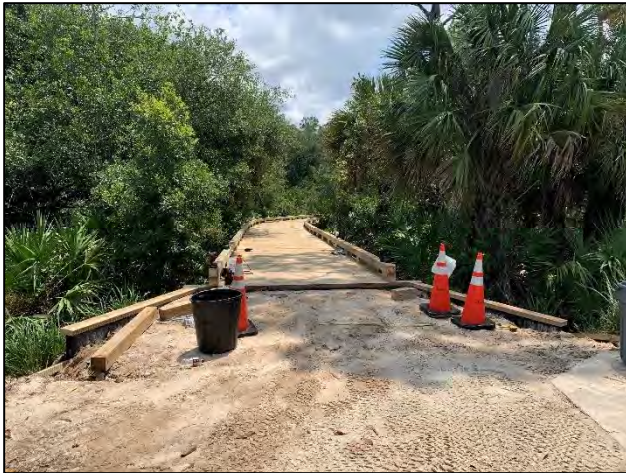
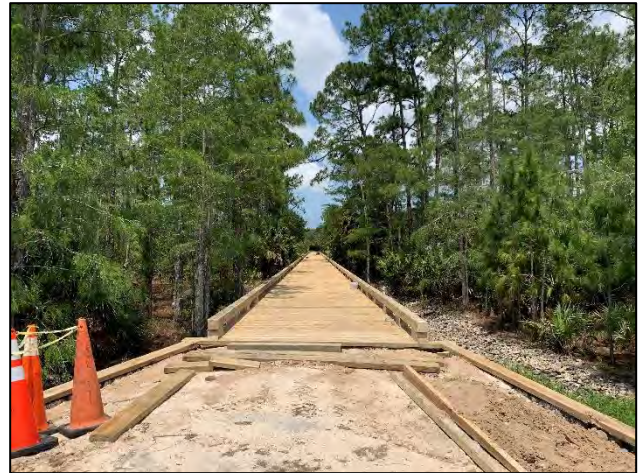
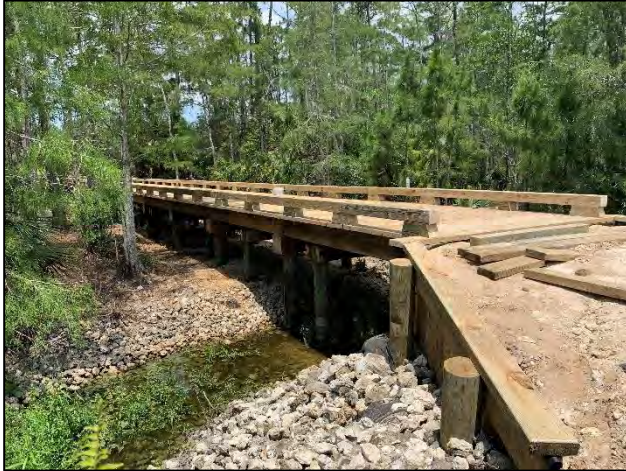
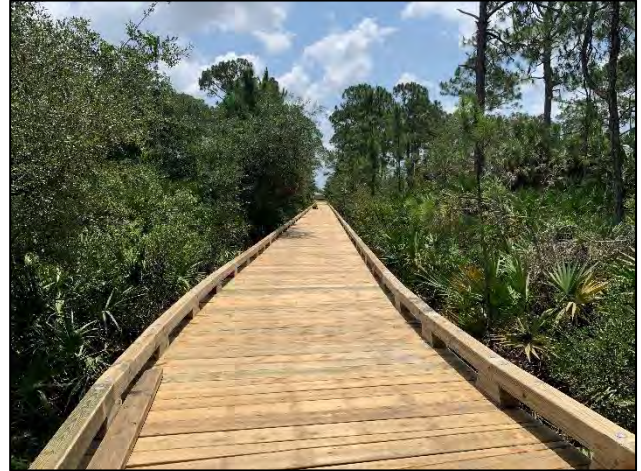
May 28, 2020

We met with Travis Pritchett with Artistic Structures (AS) and performed a visual inspection of the timber bridge construction at hole #9. AS has completed installation of the superstructure of the bridge. The timber sizes and spacing is in accordance with our design plans.

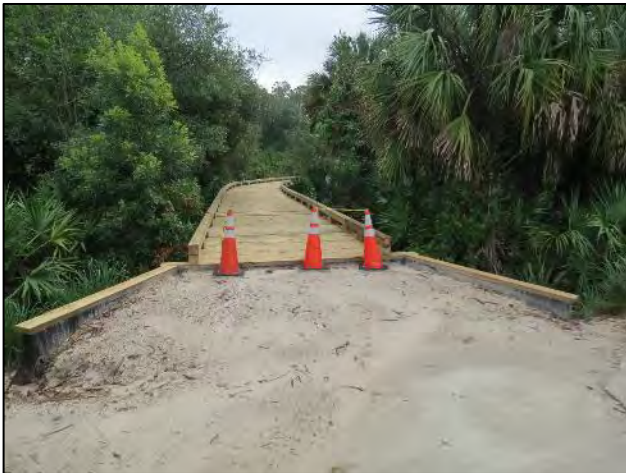
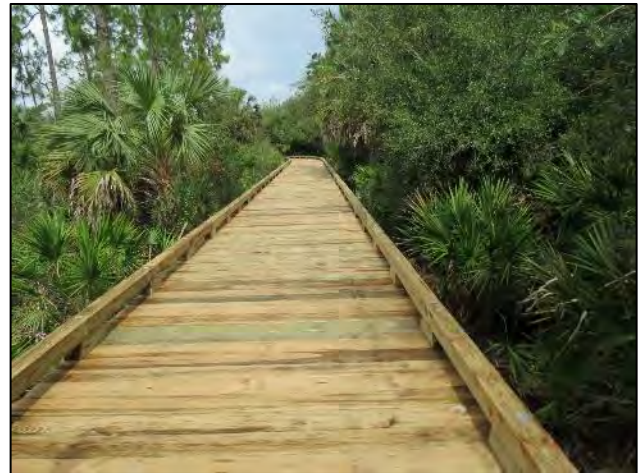
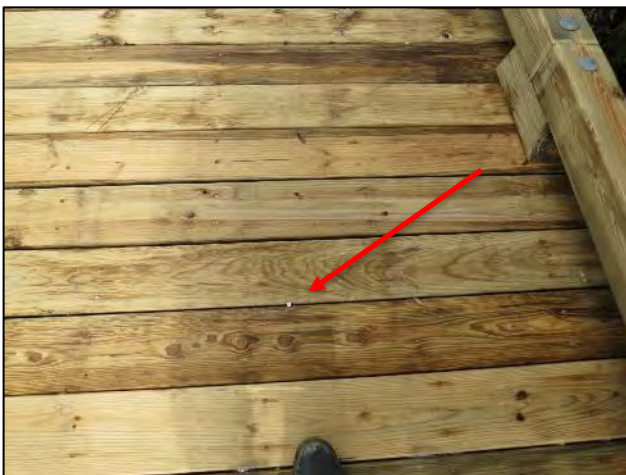
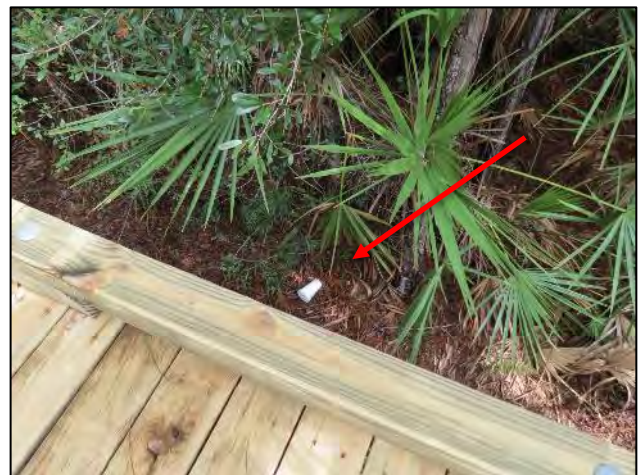
June 4, 2020

We met with Travis Pritchett with Artistic Structures (AS) and performed a final visual inspection of the timber bridge construction at hole #9. AS has completed installation of the bridge and it appears in accordance with our design plans. There is some damage to the concrete sidewalks that requires repair work when the cart paths are poured. There are screws and nails that were used for spacing during installation of the deck that are lodged between the deck boards that require removal. Additionally, there is miscellaneous garbage on the work site that needs to be removed. We spoke to Travis about these issues and he said he will take care of it.

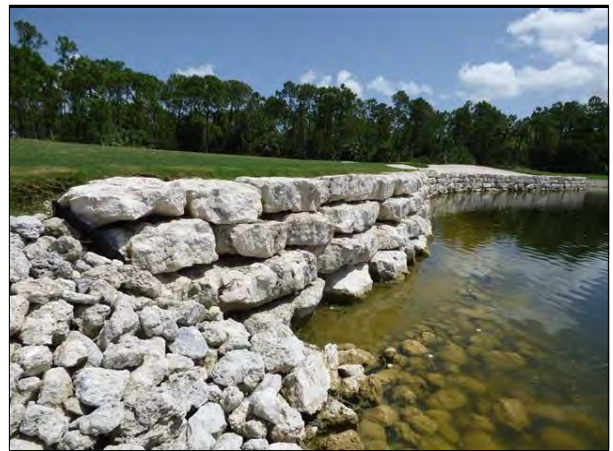
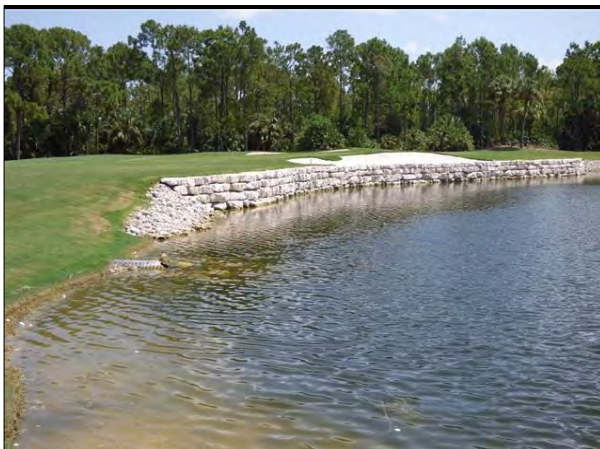
Cap Rock Bulkhead, Hole 17

Cedar Hammock has used bulkheads to stabilize their pond banks and golf course islands in some areas. The original installation of bulkheads was wooden timbers, as low as 4 feet in height and up to 10 feet in height. The District is in the middle of large scale renovation project to replace most bulkheads. The bulkheads on holes 4, 5, 16, and 17 are being replaced with cap stone bulkheads, which is a more durable material with a longer lifespan. The existing wooden timber bulkheads on hole 2, the putting green, and the driving range are not included in this project and are considered to be in fair condition. For the purpose of this report, it is assumed the existing wooden timber bulkheads not in the renovation project

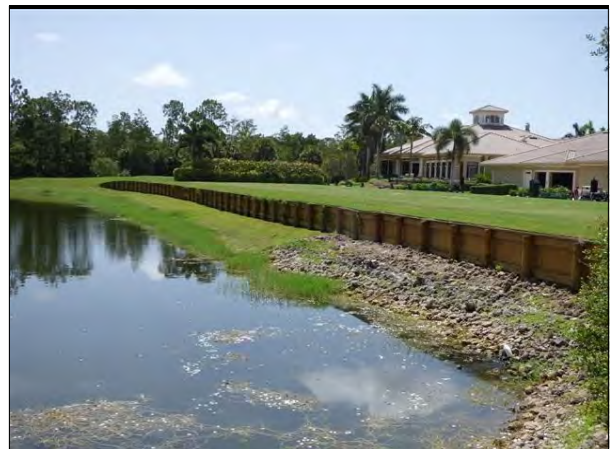
Wooden Timber Bulkhead, Driving Range

will be replaced with a similar material.

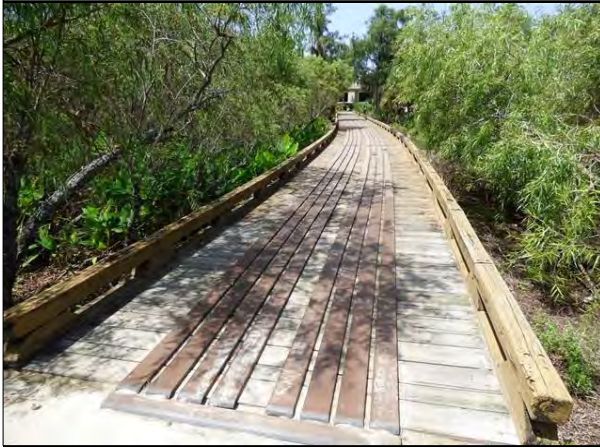
Wooden Cart Bridge, Hole 18, Will be Replaced

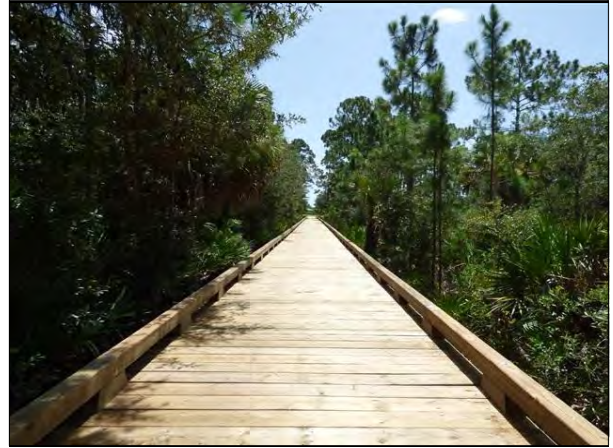
Wooden Cart Bridge, Hole 9, New

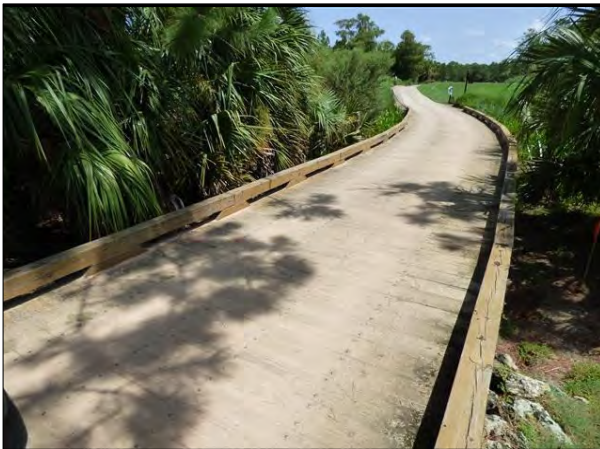
Wooden Cart Bridge, Hole 17

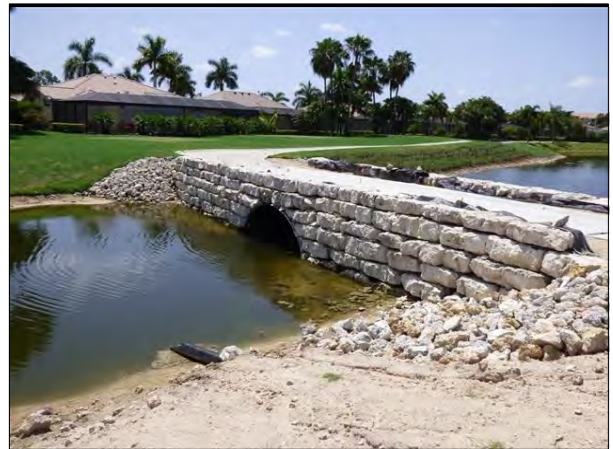
Rock Wall Bridge and Culvert, Hole 7

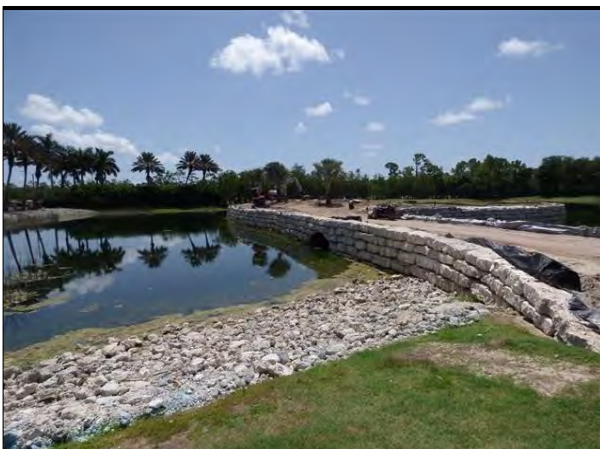
Rock Wall Bridge and Culvert, Hole 4

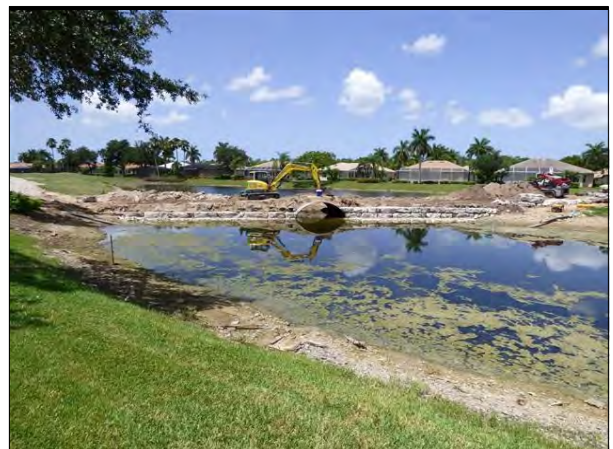
Rock Wall Bridge and Culvert, Hole 5

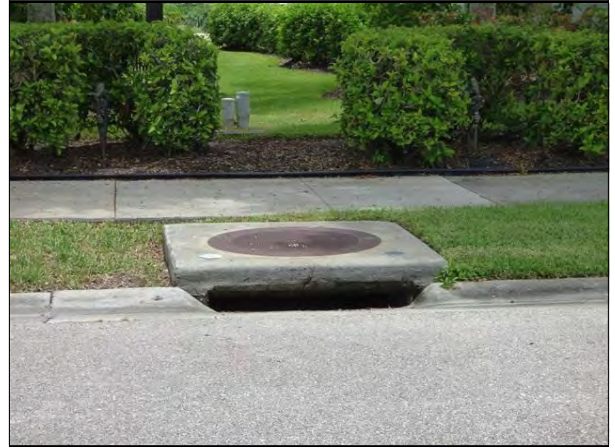
Stormwater Drainage Curb Inlet

In general, the drainage system including drainage structures and drainage pipes have a long lifespan. These improvements, however, may encounter problems from natural causes such as settlement or tree roots and man made causes such as excavations or poor original design or poor construction. It has therefore been deemed necessary to set up a reserve for repair and replacement of the District-owned drainage improvements.

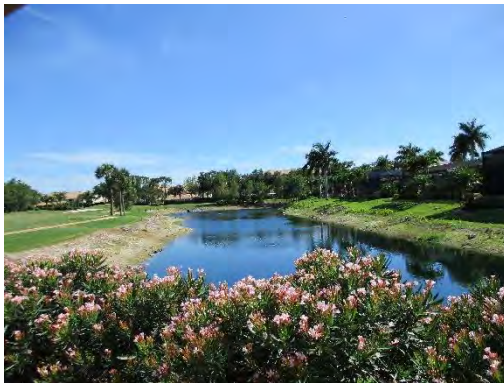
- i. **Aeration:** No issues observed. All aerators appeared to be working.

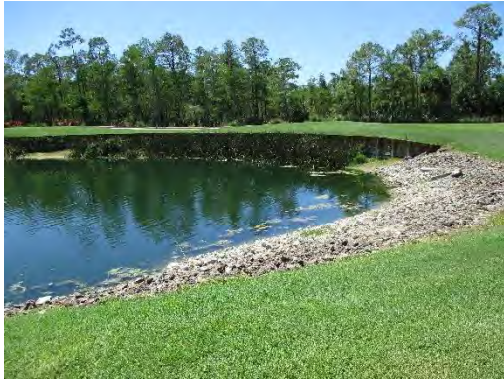
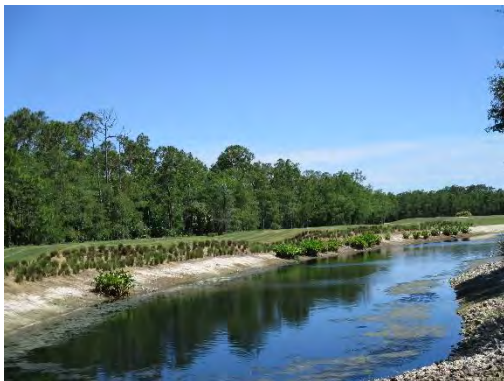
b. **Algae on Lakes:** 2, 3, 5, 8, 14, & 15. Lake 5 was observed at medium density.

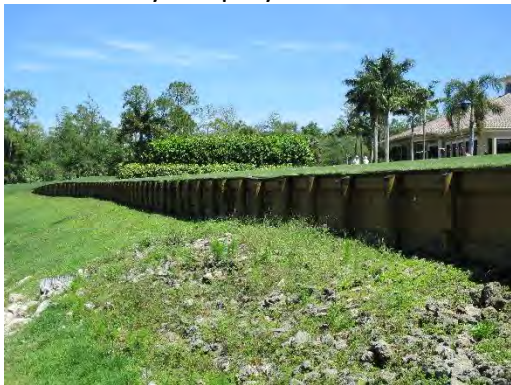
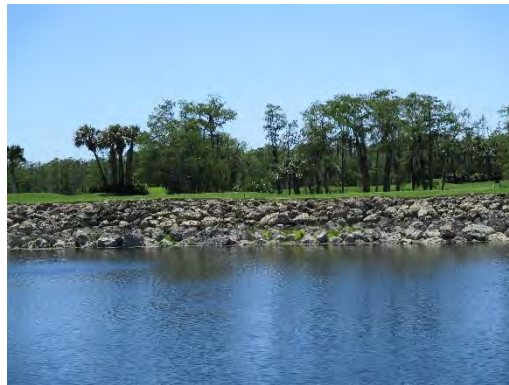
- i. Various weeds observed on the south bank of lake 1 and the west bank of lake 5 should likely be sprayed out.

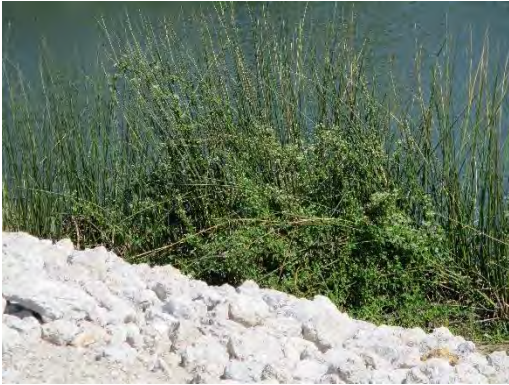
- i. Alligator weed in Lakes: No issues observed.
- ii. Cattails in Lakes: No issues observed.
- iii. Climbing Hemp Vine in Lakes: 16.

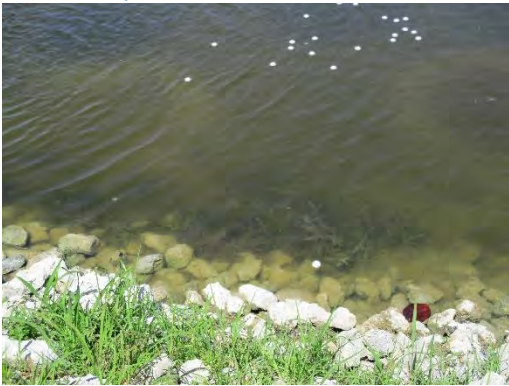
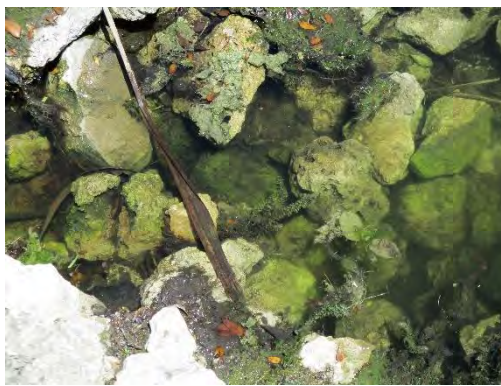
v. Hydrilla in Lakes: 1 & 3.

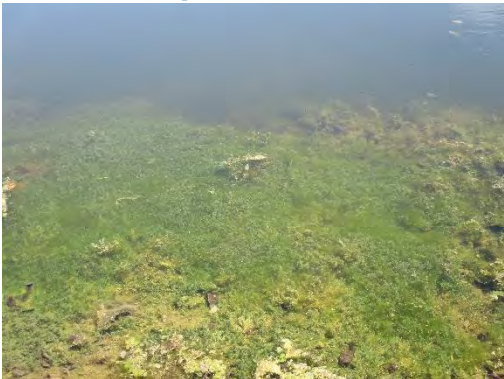
vi. Muskgrass (Chara) in Lakes: 5.

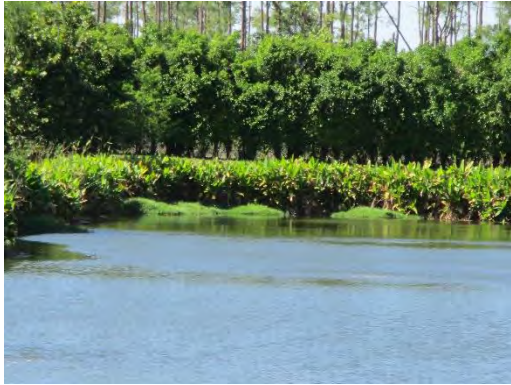
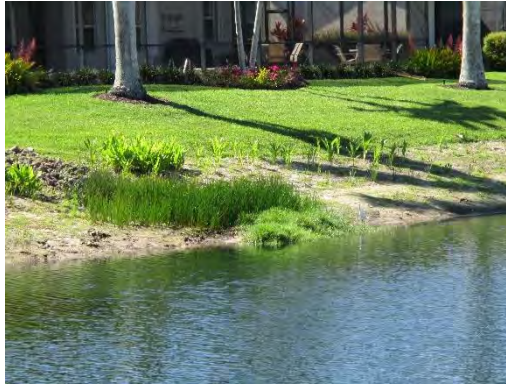
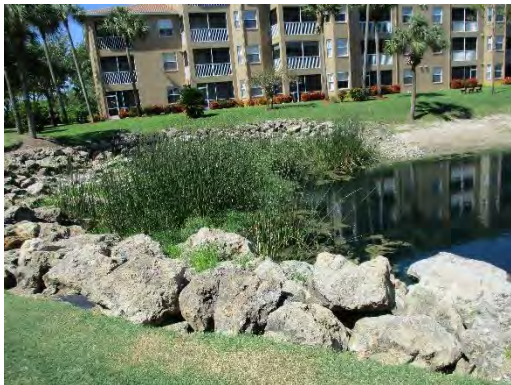
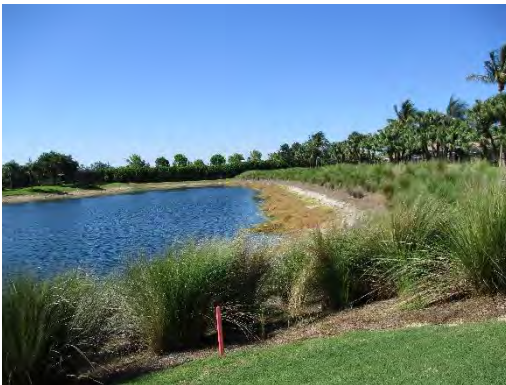
x. Torpedo Grass in Lakes: 8, 13, & 15. Spraying has recently been completed on the south bank of lake 10.

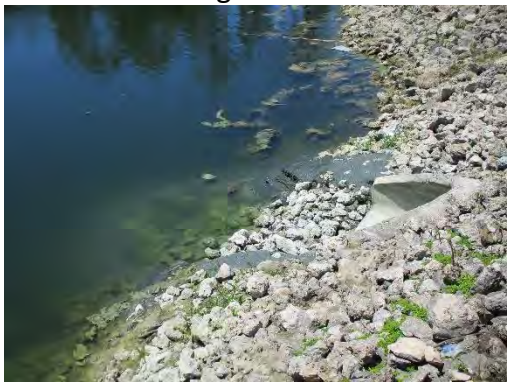
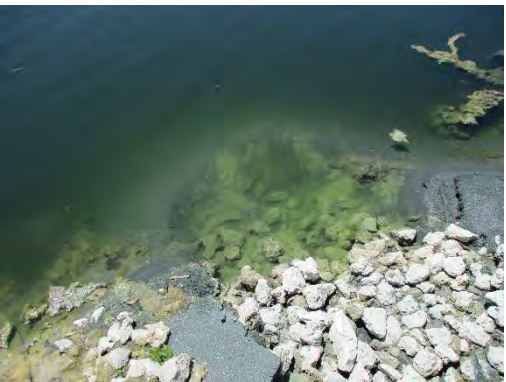
i. **Illicit Discharge:** There is a lot of runoff from the Har-Tru courts into lake 2. Though this is a natural material it may have an impact on the lake. Steps may need to be taken to better filter the material coming from the tennis court drain.

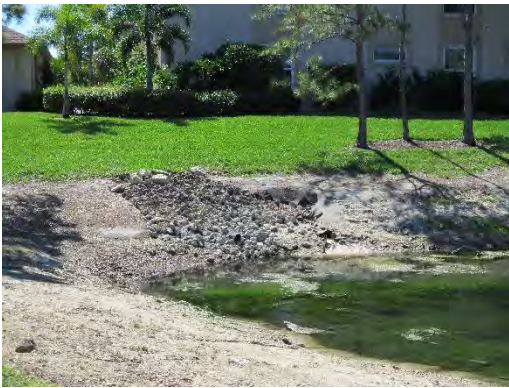
a. **Lake 5:** Erosion continues to worsen on lake 5 adjacent to 8560 Cedar Hammock Circle.

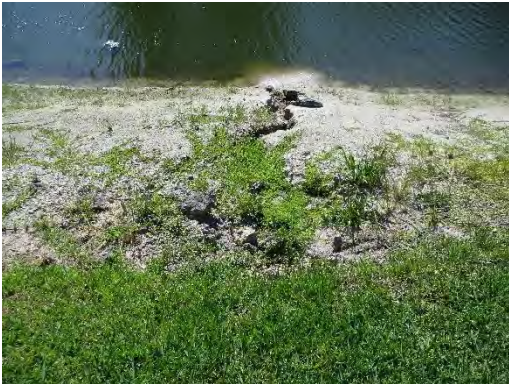
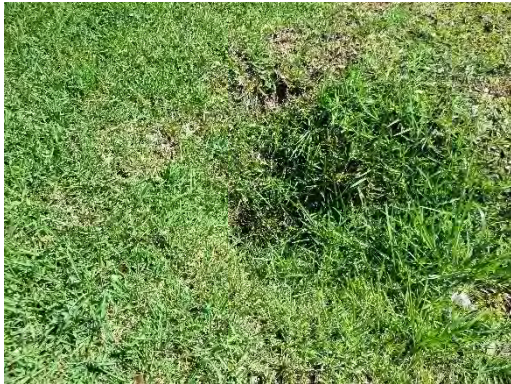
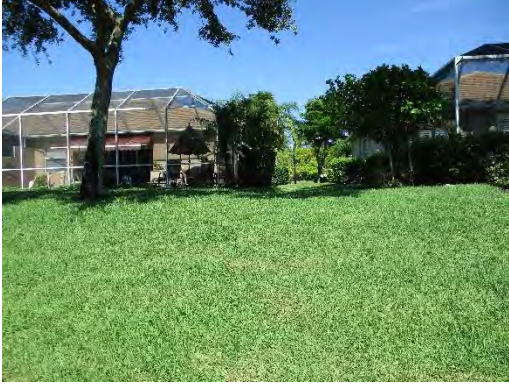
b. **Lake 8:** Erosion was observed on the east bank. One area was found directly in the drainage easement between 3793 & 3797 Buttonwood Way has a deep hole that should be filled in to avoid a safety issue as it was a deep hole.

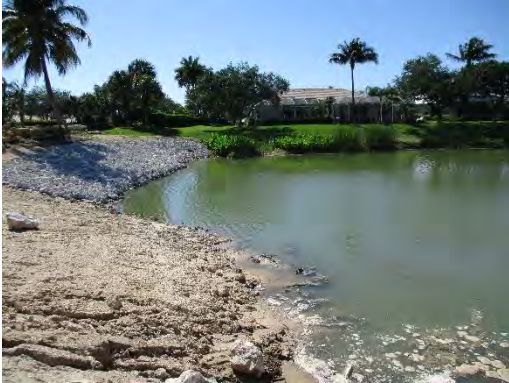
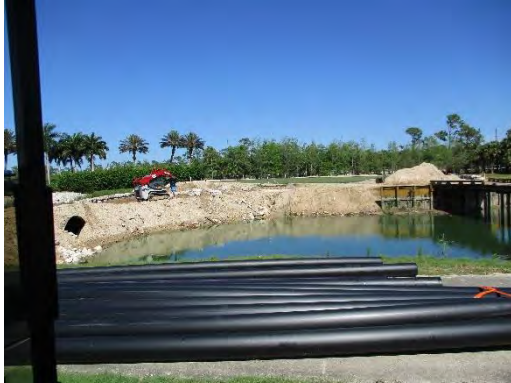
- c. **Lake 11/16:** Turbidity barriers were not observed being used in the lakes. This was reported to Banks Engineering, however, due to the fact that the stormwater system was not flowing off site Mr. Marshall did not have any issue with the absence of these barriers.

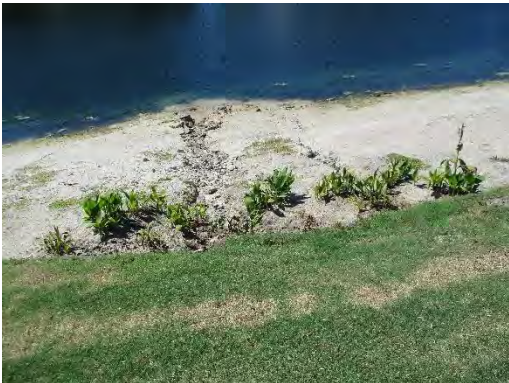
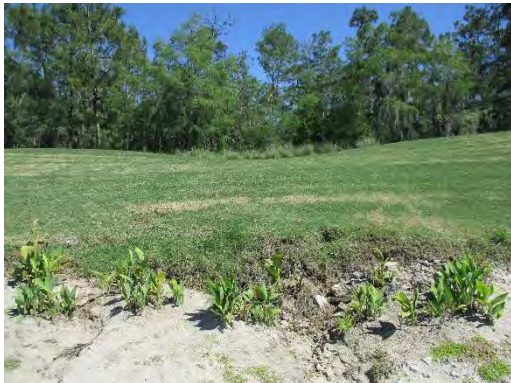
- d. **Lake 14:** Erosion from golf course run off was observed on the east bank of lake 14.

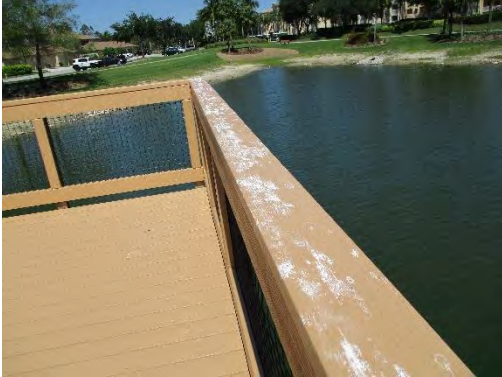
No integrity issues observed, a cleaning may be necessary.

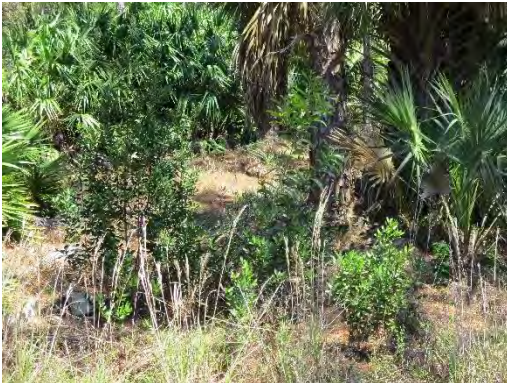
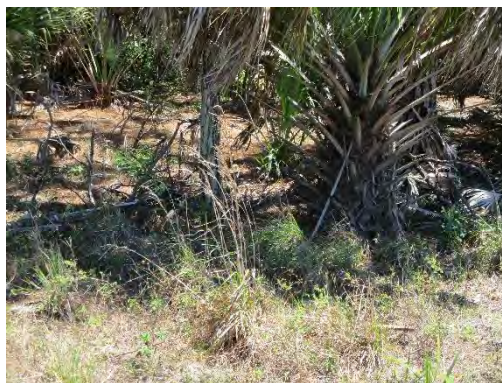
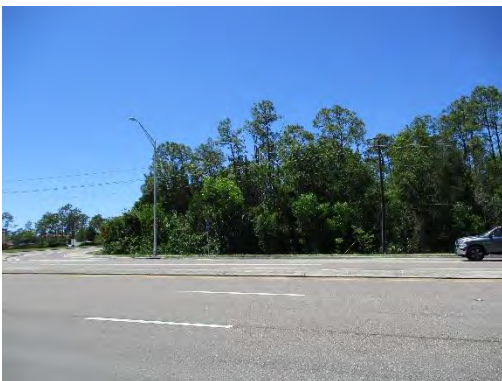
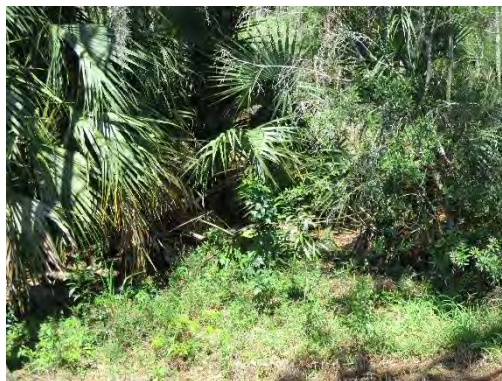
- a. Invasive vegetation was observed along the preserves of Davis Blvd. in C2. It seems that the main reason for these saplings occurring is the seed source on adjacent properties along Davis Blvd. Additionally, Brazilian pepper and earleaf acacia saplings were observed in the southern portion of C2 east of the fairway for hole 1.

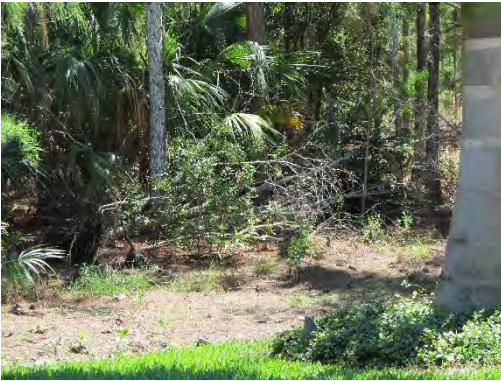
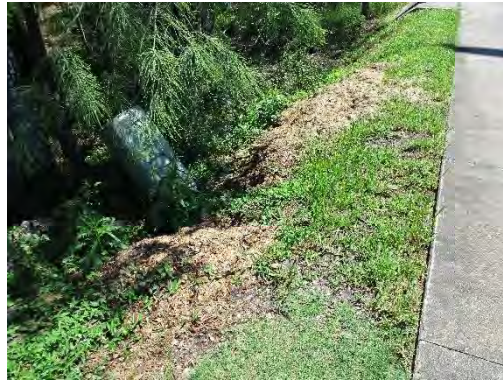
- b. Earleaf acacia saplings were observed in C3 that should be removed. Grass clippings were observed dumped adjacent to the Davis Blvd. sidewalk in C3.

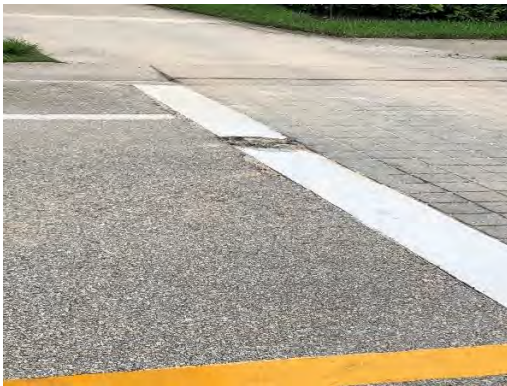
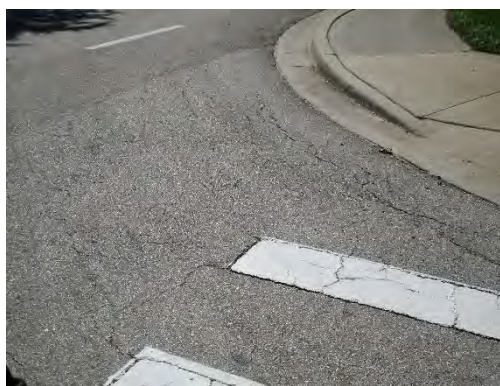
- a. **Asphalt:** A pothole has formed across Cedar Hammock Boulevard east of the crosswalk between holes #15 & #16. The apron for Cordgrass Way is beginning to show signs of alligator cracking.

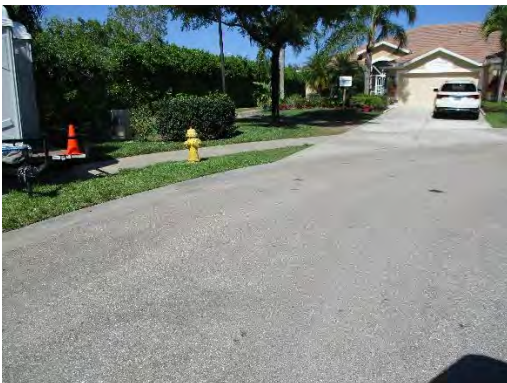
- b. **Markers:** There is a missing fire hydrant marker near 4024 Cordgrass Way at the cul-de-sac that should be replaced.

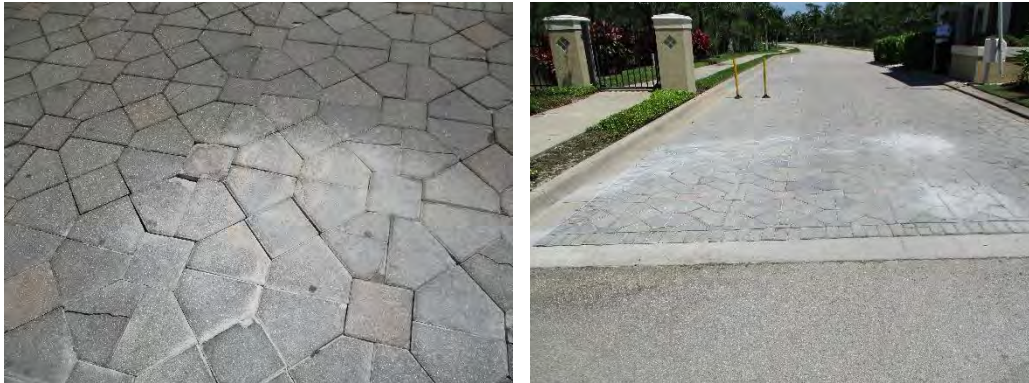
- c. **Pavers:** It appears that sand was recently added to the exit side of the Davis Boulevard entrance. Many of the pavers in this area are chipped or cracked. Replacement may be necessary in the future.

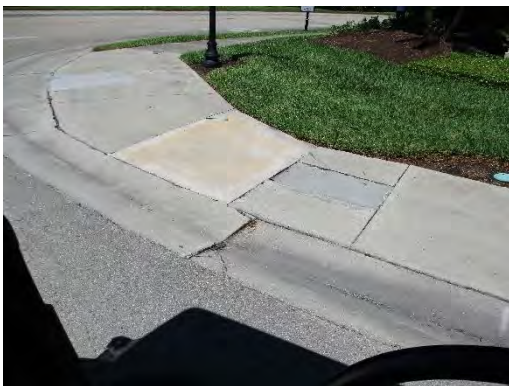
- a. **3574 Cedar Hammock Court:** There appears to be the possibility of a trip hazard that may need to be addressed at the beginning of the roadway on the east side of the road. The sidewalk and gutter pan may need to be addressed.

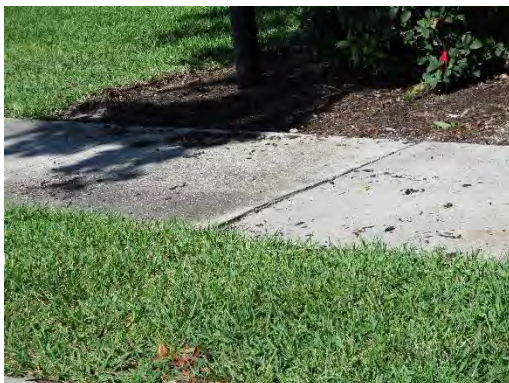
- b. **3886 Cedar Hammock Court:** There is a slight lip in the sidewalk that may need to be ground down to avoid a trip hazard.

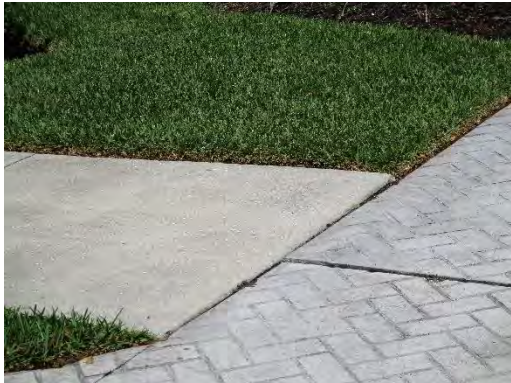
- c. **3860 Wax Myrtle Run:** The sidewalk north of the driveway has a slight lip and may need to be ground down to avoid a trip hazard.

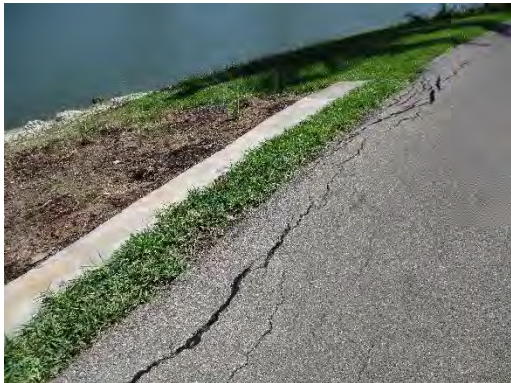
- d. **Walking Path:** The walking path around lake 7 inside Cedar Hammock Circle is cracking on the edge west of the pool. Filler or sealant may be needed to prevent further cracking or erosion of the base material.

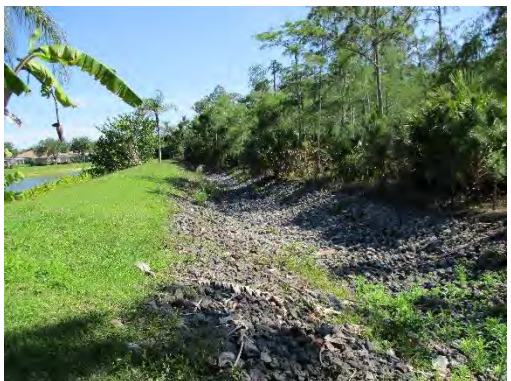
- a. **Canals:** The eastern swale of C-2 should be sprayed to keep it free of weeds and any vegetative growth so that water flow will not be impeded.

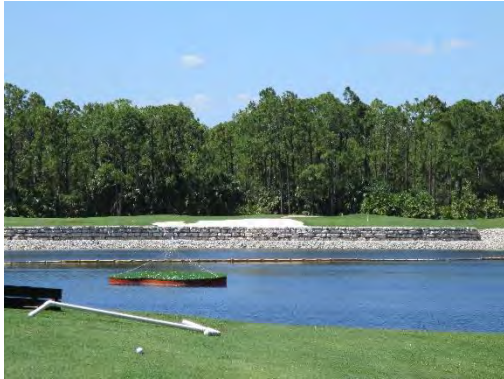
- c. **Bulkheads:** The bulkhead on hole 17 has been completed. The bulkheads for holes 4 & 5 have been started.

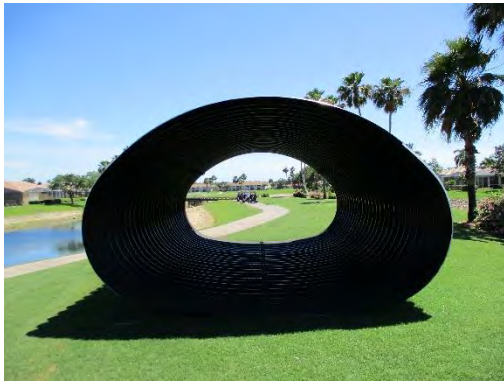
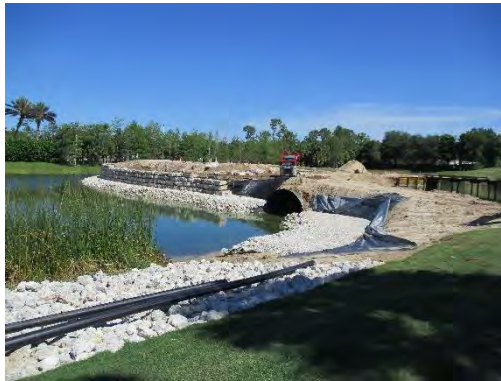
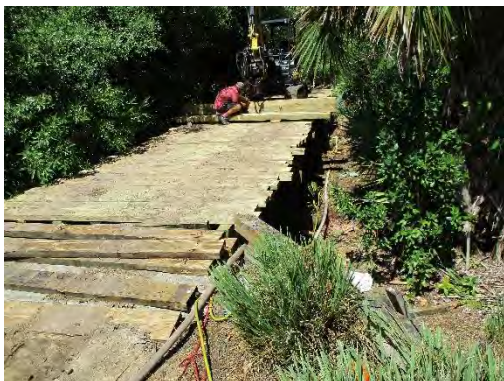
- d. **Bridges:** Work was underway on replacing the bridges to holes 4 & 5 with the new culverts. Damage has been reported by Bridging Solutions to the culverts installed in these locations and Glase Golf has been notified. The culvert for lake 3/hole 10 remains undamaged and a request has been submitted to Glase Golf to ensure they are properly handing/rigging the culvert as it is moved into place. Work was underway on the bridge from hole 9 to the Clubhouse.

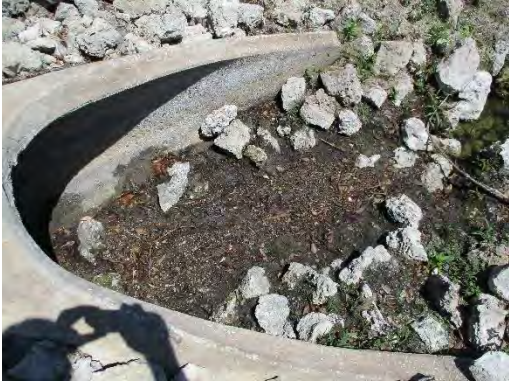
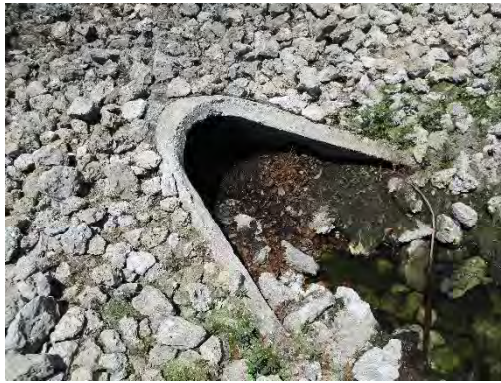
- e. **Drains:** Various drain pipes were observed with the low water levels. The pipes visible appeared to be clear with minor debris noted inside the pipes. The Board may want to consider

a cleanout in time as the debris continue to buildup. The pipes will continue to be monitored for any issues.

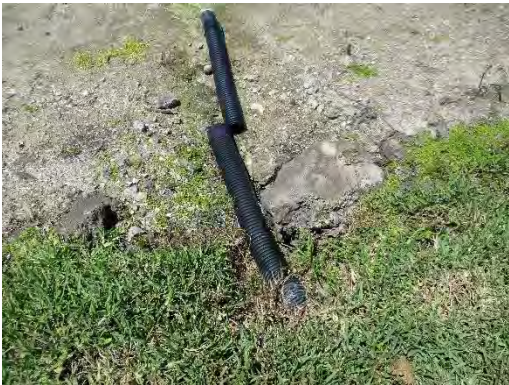
- i. **Lake 2:** A drain pipe on the southeast side of the lake has come unattached and should be reconnected to prevent erosion to the littoral shelf.

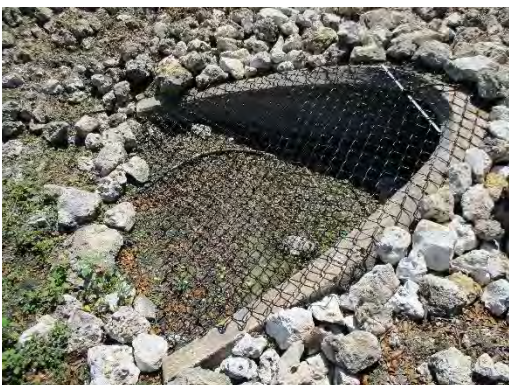
- f. **Interconnect Pipes:** Coverings over the interconnect between lakes 2 and 3 were observed on the lake 3 side in preparation for the installation of carp into the lakes as approved by the Board previously.

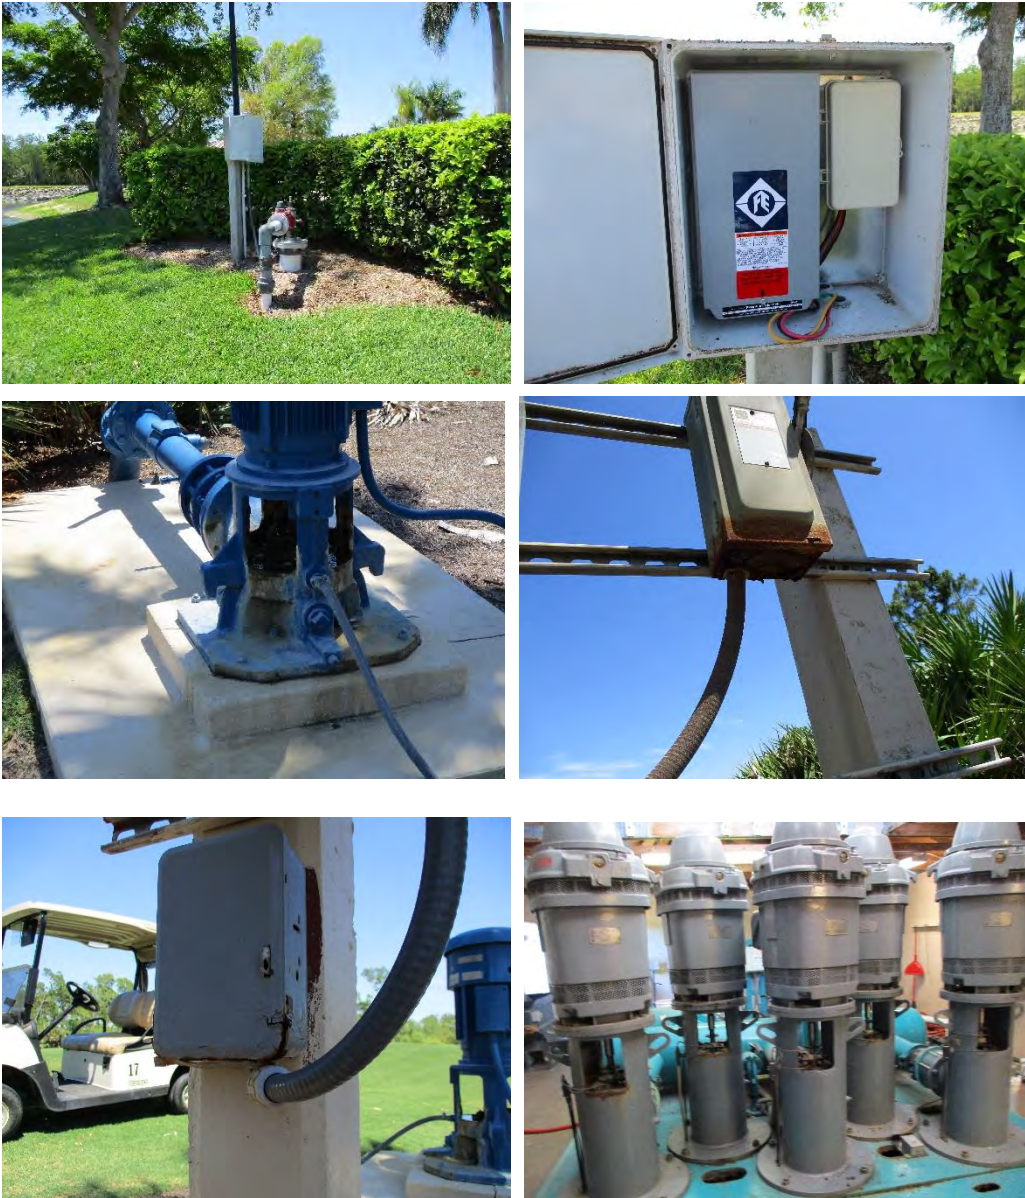
The wells and irrigation equipment were reviewed. There is some rusting visible that may need to be addressed on the eastern well to lake 1.
