Cedar Hammock Community Development District

**July 14, 2026
Agenda Package**

CEDAR HAMMOCK CDD

LAKE BANK EROSION AND STABILIZATION ANALYSIS

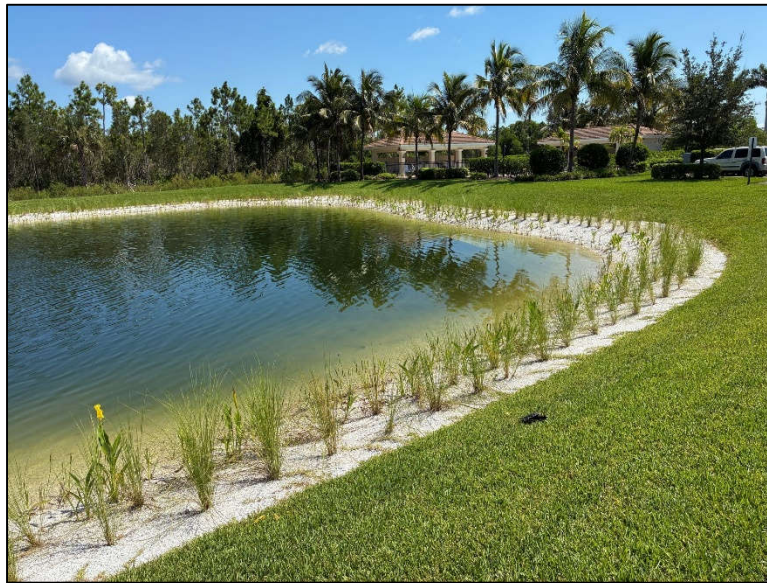
A mechanically regraded lake bank involves importing and placing additional fill material along the lake's edge to restore the original, permitted slope profile. This approach offers immediate remediation of current issues such as washouts, rills, and abrupt elevation changes between the vegetated area and the exposed bank. Despite its effectiveness in quickly addressing these concerns, the solution is inherently temporary; frequent maintenance is required, especially during periods of heavy rainfall or where runoff and outfall sources are not properly redirected below the lake's low-water line. The longevity and stability of the reconstructed slope can be significantly improved by establishing vegetation, as plant root systems help reinforce the soil. However, ongoing upkeep of these plantings is necessary to ensure their effectiveness in bank stabilization.

Figure 1. Vegetated Regraded Lake Bank. (Seabreeze Erosion Solutions, 2025)

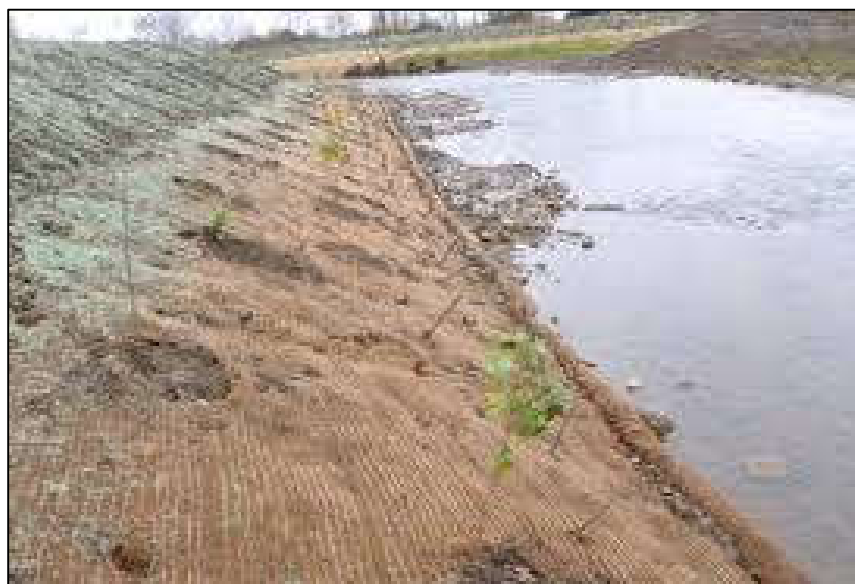
Erosion Control Mats or Blankets are flexible, open-weaved mat-like structures that are rolled or placed along a lake bank and physically secured to the existing grade. The mats are commonly made of synthetic, biodegradable, or organic materials to encourage vegetation to grow through the mat and stabilize the bank through a natural root and vegetation layer. A variation of an erosion control mat can comprise concrete and steel with vegetation impregnated between the concrete cells. This option may require the removal of existing vegetation, regrading of the embankment, and imported fill to achieve the slope warranted. Depending on the material, the Erosion Control Mat typically provides more protection than Regraded Lake Banks.

Figure 2. Biodegradable Erosion Control Mat. (Erosion Control Products, n.d.)

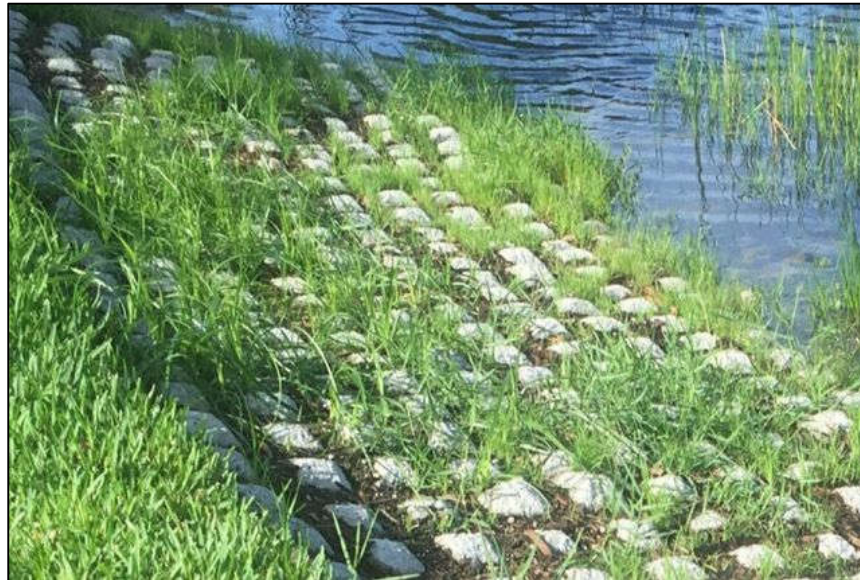
Figure 3. Vegetated Concrete Mat, Flexamat. (Seabreeze Erosion Solutions, n.d.)

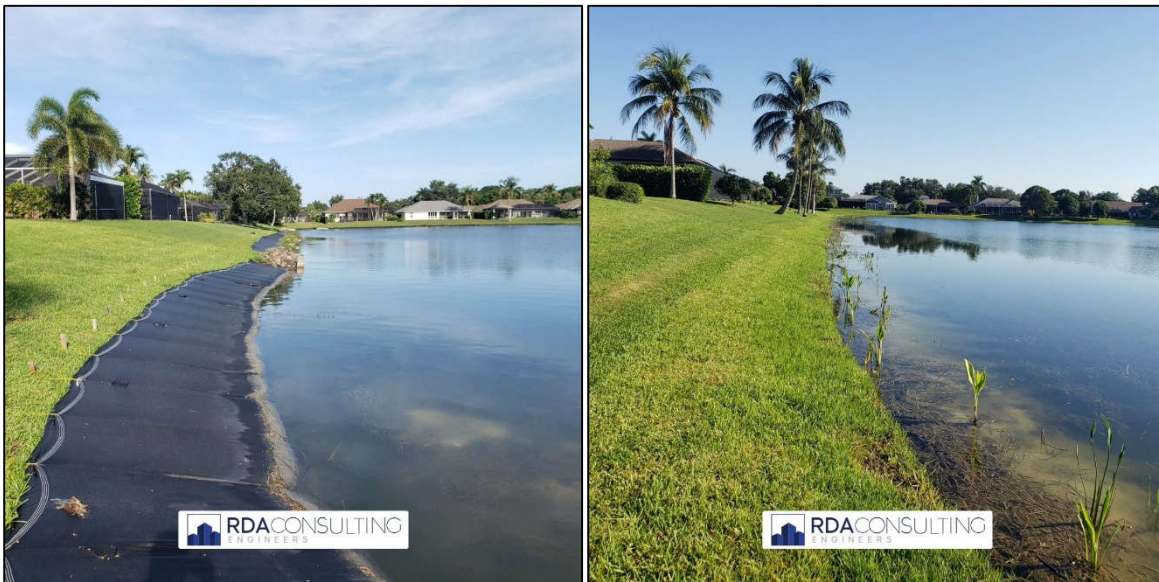
Erosion Control Wraps are a common stabilization method for wet detention lake bank erosion in southwest Florida. The polyethylene mesh sock is anchored near the top of the bank and extended past the water line, and then folded over to be anchored again at the top of the bank. Sediment is filled within the mesh made “pockets.” After installation, the Erosion Control Sock is seeded, sodded, or planted with vegetation to mimic a natural shoreline. The sediment can be dredged from eroded soil within the lake to reduce the import of fill. This option provides a higher level of erosion protection than regraded lake banks and similar protection as Erosion Control Mats and Geocell Systems.

Figure 5. Erosion Control Wraps During and After. (RDA Consulting Engineers, 2026).

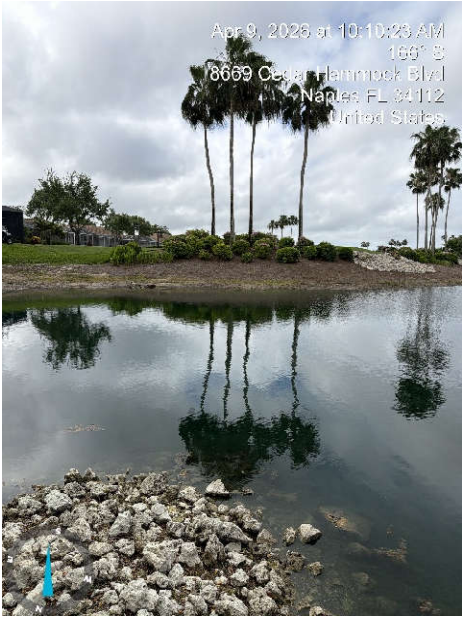
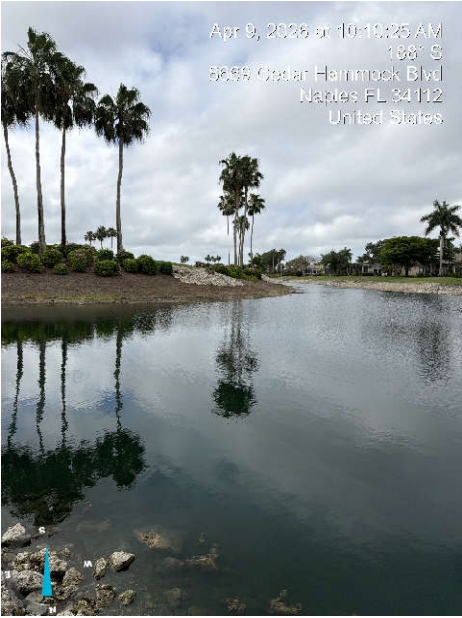
Images 6 & 7

Lake 3	Lake L-13	MAJOR EROSION	Photos: 0-21 5: Noticeable erosion and drop-offs along the vegetation. Rip-rap appears to be installed without filter fabric. 9: Moderate erosion along the bank can lead to further degradation of the bank and the formation of drop-offs. Irrigation pipes are exposed 10: Drop-offs along vegetation and moderate erosion 13: ADS drainage pipe appears to be clogged with sediment and erosion along the bank below the vegetation. 16: Outfall at the northwest corner appears to have an obstruction. 19: Erosion around rip-rap, rip-rap appears to be installed without filter fabric, small drop-off forming on South end of bank along vegetation
Lake 5	Lake L-1	MAJOR EROSION	Photos: 22-70 27: Rip-rap appears to be installed without filter fabric and slope degradation and drop-off from vegetation along the bank. 34: Erosion and slope degradation. 39: Large drop-off from vegetation to bank on the southwest side, Limestone rock exposure. PVC pipe exposure along the northeastern lake bank. 41: Limestone rock exposure. 44: Vegetation removal appears to have caused some erosion. 48: Minor drop-off from vegetation. 49: Lake bank appears to have a severe washout with PVC pipe exposure. Rip Rap appears to be installed without filter-fabric material. 53: Major slope degradation and drop-off from vegetation 59: Major slope degradation, Limerock exposure 60: Rip-rap appears to be installed without filter fabric; some erosion has occurred 61: Major slope degradation. 65: Moderate drop-off between vegetation and rip-rap. 68: Major slope degradation. 70: Multiple pipes installed at High Water Line creating erosion and washouts. One outfall pipe appears to be obstructed. Rip-Rap does not appear to be placed with filter-fabric.

For areas with moderate to severe erosion, implement more extensive interventions. Slope regrading with suitable infill materials, followed by the installation of erosion control products such as mats or Geocell systems, is recommended. These systems should be securely staked and vegetated with appropriate native species to reinforce long-term stability. Where riprap is used, ensure it is placed over filter fabric and adheres to regulatory limits on hardened shoreline as specified by the South Florida Water Management District Environmental Resource Permit (SFWMD ERP). Alternative methods may include slope reconstruction using Erosion Control Wraps filled with dredged lake sediment. Selection of remediation techniques should be based on site-specific conditions and all applicable regulatory requirements.

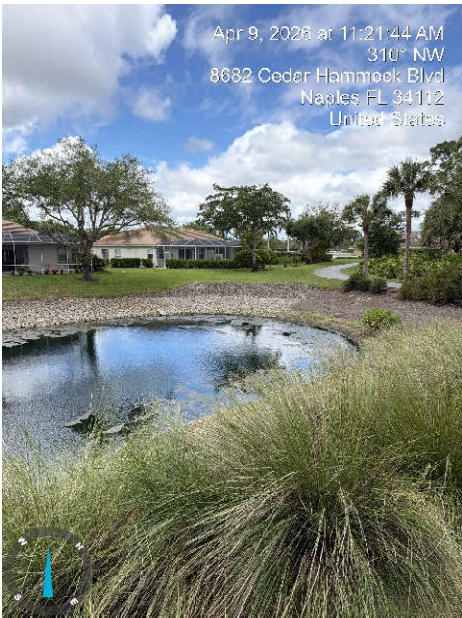
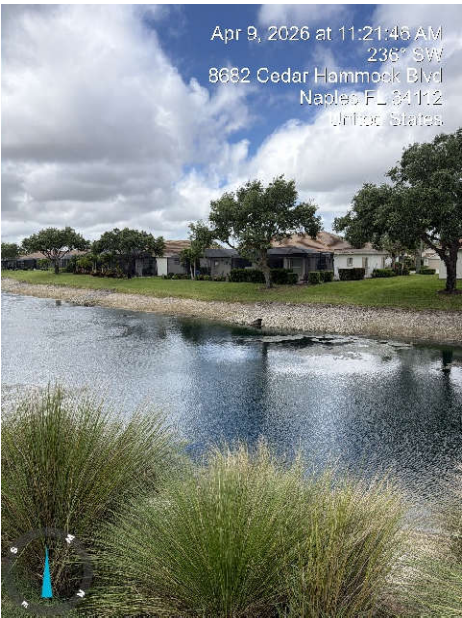
Images 96 & 97

Lake 4	Lake L-14	MODERATE EROSION	Photos: 96-103 97: Slope degradation and drop-offs at vegetation line of the southwestern bank is present. It appears rip rap has been placed along portions of the southwestern bank. If rip rap was placed without filter fabric, degradation will continue rapidly.
Lake 6	Lake L-12	MODERATE EROSION	Photos: 104-113 106: Rip-rap appears to be installed without filter fabric 107: Lake bank has moderate erosion and drop-offs along vegetation. 109-112: Rip-rap appears to be installed without filter fabric and moderate degradation is present.
Lake 8	Lake L-16	MODERATE EROSION	Photos: 166-173 166: Minor rills and drop-offs along vegetation near rip-rap. 168: Rip-rap appears to be installed without filter fabric, minor slope degradation.
Lake 9	Lake L-10	MODERATE EROSION	Photos: 158-161 158: Rip-rap appears to be installed without filter fabric. 161: Moderate washouts along eastern bank.
