**ENTERPRISE COMMUNITY  
DEVELOPMENT DISTRICT**

**AGENDA PACKAGE**

# BOARDWALK EVALUATION

for the Enterprise CDD:  
a Structural Condition Assessment

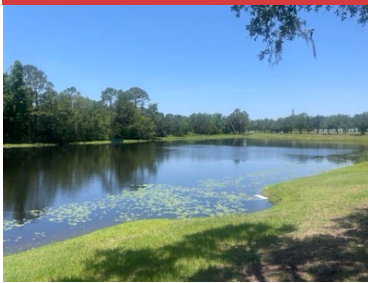
### **OBSERVATION 1**

Pond between Nine Story and Hospital. No visible algae bloom, extremely clear.

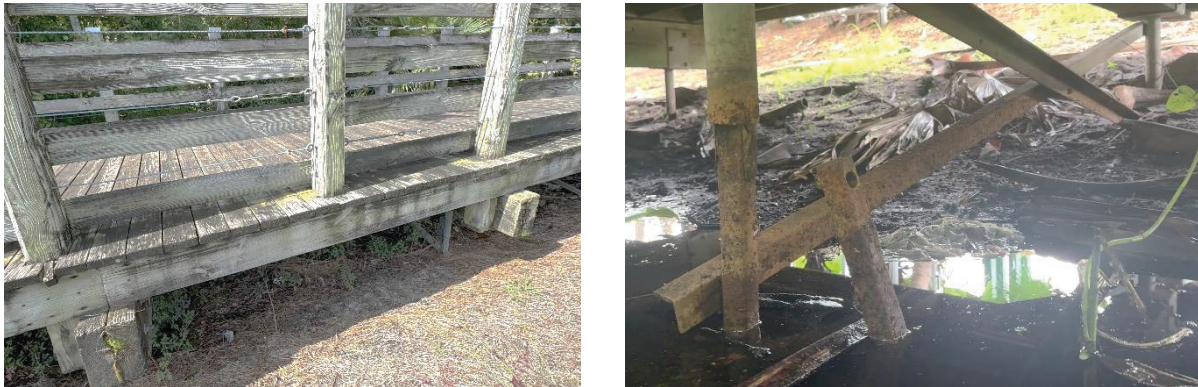
The boardwalk sits within a transition zone between dry, landscaped areas on the north side and wetlands on the south side (photo #1). The environmental conditions around the boardwalk are considered harsh for the steel and wood materials used to construct the boardwalk substructure and superstructure. The north side of the boardwalk closest to US 192 has little shelter from the weather as it is adjacent to maintained areas of low grass and landscaping. This side therefore is exposed to prolonged periods of sunlight, rainfall, potentially irrigation water, and possible chemical landscape treatments. The south side abuts a heavily forested wetland that appears to be infrequently maintained and is shaded and moist for significant portions of the day.

**Photo 1:** Galvanized steel helical piles in dry land vs. wetland (from left to right)

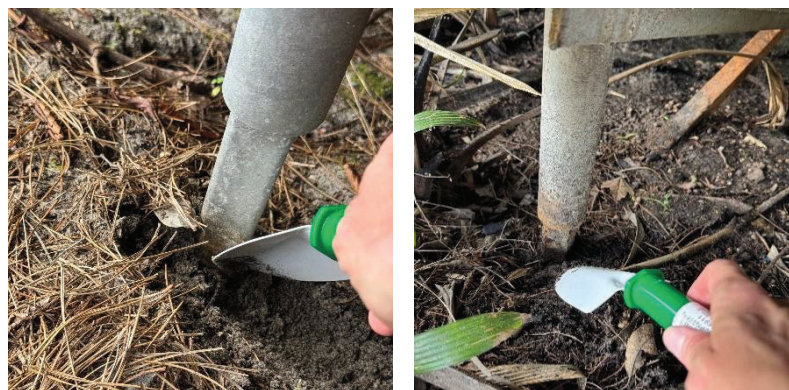
A handful of helical piles and braces exhibiting surface corrosion were selected for excavation to investigate the extent of corrosion beneath the soil / typical wetland bed at the surface. Excavation was performed using a hand trowel (photo 4).

**Photo 4:** Excavation of steel helical piles and braces using a hand trowel

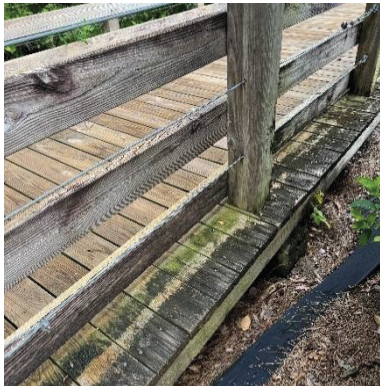
Many of the deck boards appeared to be slightly weathered, with few that were warped and rotted. Relative to other components of the boardwalk, accelerated deterioration is to be expected for the deck planks given their flat-wise exposure to the elements and frequent foot, bike, and other traffic. It is unclear if some decking is original to the boardwalk’s construction or is simply many years old. Given the regular replacement of decking boards and the aggressive environmental conditions, it is likely that even heavily weathered boards are not original but simply aging. It appears that the typical fasteners being used for deck board fastening to the supporting joists are stainless-steel screws. We understand that the deck boards are routinely power-washed during scheduled maintenance, and the west end of the boardwalk deck appeared to have been power-washed recently (photo 5).

**Photo 5:** Pressure washed deck planks on west end of boardwalk

The frequent replacement of deck boards on the boardwalks is understandable despite being preservative treated as these flat-wise 2x boards are directly exposed to large amounts of rain, sun, insects, and high humidity. They are also heavily trafficked with pedestrians, and potentially by bicycles, and other transportation vehicles.

It is likely that the ongoing, constant maintenance will continue to be required to keep the decks safe and serviceable if the current wood (a preservative treated southern pine or similar) is used for deck plank replacement. Alternatives to treated southern pine that may increase the longevity of the deck planks include a composite material or a harder wood (potentially even a true hardwood).

These alternatives need to be considered with respect to cost and effort. Constantly replacing the boards is laborious and time-consuming, and it accelerates the deterioration of the supporting joist framing, as additional screw penetrations split and bore into the tops of the existing joists. The replacement of the wood comes with a material cost as well. Another alternative to reduce the frequency of replacement is to periodically treat the decking with a water sealer product per manufacturer recommendations. One such product is Thompson’s WaterSeal. This may be the lowest cost option for addressing deterioration of deck boards.

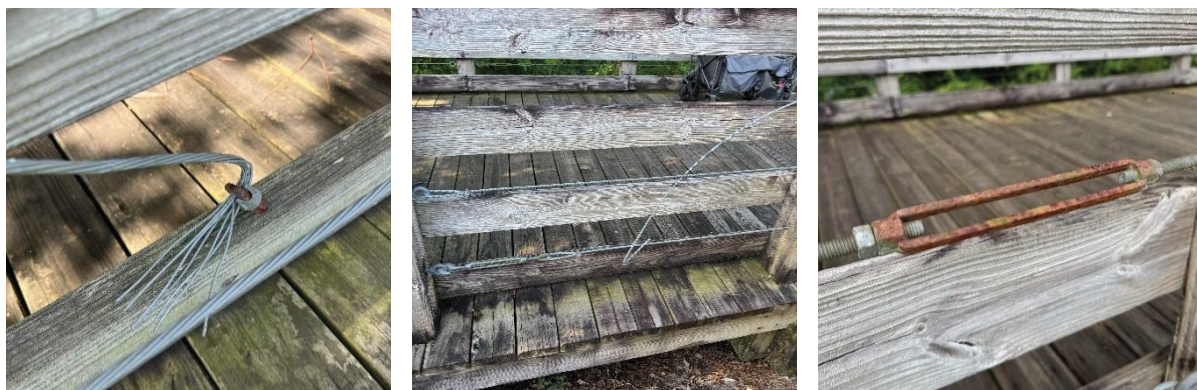
The supplemental cable railing had repeated instances of deterioration or localized failures. There is visible surface rust on the turnbuckles and clamps; some of the cables have broken or have detached from the posts and are missing their connectors; and some cables are loose but still intact (photo 6).

**Photo 6:** Loose cable rails and connectors with surface rust

The cable railing elements that alternate with the wood rails have deteriorated/failed in several different ways. Some of the cables have frayed and subsequently snapped, likely due to prolonged exposure to the elements and resulting corrosion. In other locations, either the clamps or hooks that are inserted in the eye bolts at the posts have become loose or are completely missing. The frayed cables should be replaced, loose cable rail segments should be tightened at the turnbuckles, and missing eye bolt and hooked connections and clamps should be replaced immediately – and thereafter replaced / tightened as needed during routine maintenance. Cables and connectors exhibiting surface rust should be cleaned of rust and a galvanizing repair coating should be applied. If the connectors appear to be failing or are losing functionality because of corrosion, they should be replaced in kind.

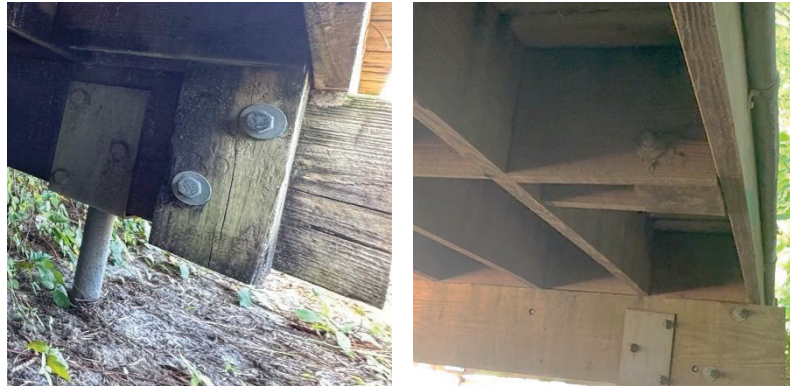
The guardrail posts serve the critical purpose of securing the railing against pedestrian live loads (horizontal loads, typically) and were very rigid when tested using a hand-applied load. The high rigidity of the guardrail is due to the guardrail posts being bolted to the primary support beams (above pile locations) or bolted to vertical blocking between the rim and first interior joist (at intermediate locations between piles) (photo 7).

**Photo 7:** Rigid guardrail construction, bolted to beam (left) or bolted to vertical blocking (right)

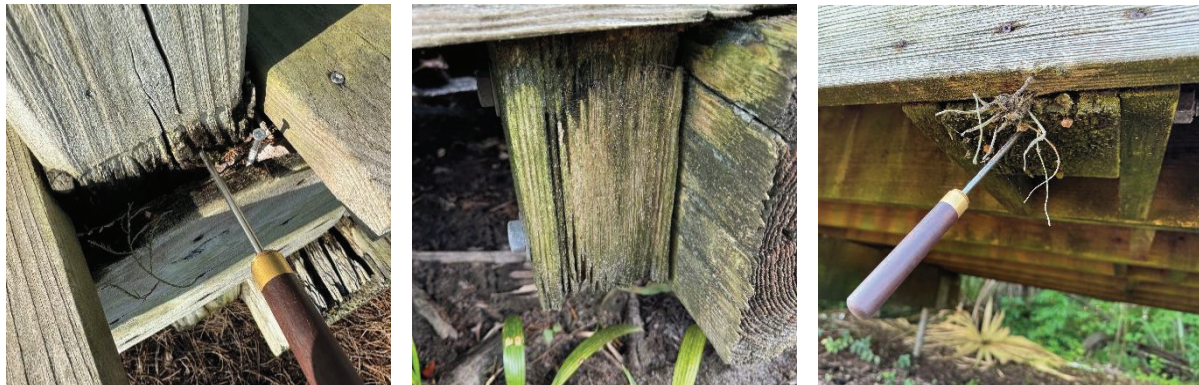
Many of these guardrail posts are in good condition, while some posts are rotting adjacent to the penetration through the deck at the top of the rim joist, with deterioration extending down to the post's

bottom end grain (photo 8). In some cases, the framing (typically the rim joist) in abutting the post is also rotting. The compromised posts are looser to the touch compared to those in good condition. The tops of the guardrail posts are generally in good condition as the posts are protected by a light gage metal cap that appears to be fastened with two screws. This cap protects the top end grain of the wood from direct moisture exposure.

**Photo 8:** Guardrail post rot at rim joist (left) and at the end grain (center, right)

The guardrail posts that have rot along their base adjacent to the penetration through the deck and joists (which occasionally extends completely down to the bottom of the post) need to be replaced. The tight construction of the deck, post, and rim joist/beam provides a surface for moisture to accumulate upon and pond against the posts for prolonged periods of time. Additionally, the end grain at the bottom of the posts is exposed as is typical in this type of construction. Application of a water sealer treatment and

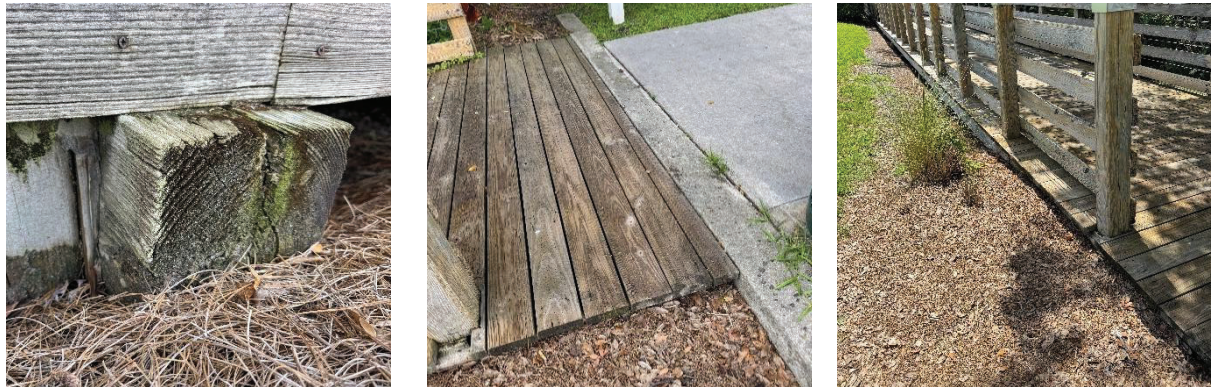
Referring to photo 9, the wood beams, joists, and decking that are in contact with the soil exhibited heavy rot and softness from prolonged exposure to moisture/saturation and insect activity. This condition most frequently occurred along the north side of the boardwalk where the grade rose steeply to meet US 192 and at the three boardwalk-to-abutment transitions.

**Photo 9:** Locations of rotted wood framing in contact with soil

The close proximity to or direct contact with earth leads to accelerated decay and deterioration of the treated wood framing due to greater exposure to aggressive environmental conditions. At the abutment areas, simply replacing the deck boards at these buried and grade-bearing boardwalk segments will be insufficient for the segments' long-term safety and serviceability. In these situations, the boardwalk framing – including beams, joists, and any supports for these elements as well as guardrail posts – will need more frequent review and replacement than at elevated boardwalk conditions. When the deck boards are replaced at these segments during routine maintenance, the framing that is in contact with soil should also be reviewed and replaced where significant deterioration is found. Regularly replacing the framing in these areas does not resolve the issue of wood framing in contact with soil but maintains its safety and integrity.

To reduce the cost and complexity of ongoing replacements at segments with soil contact, several alternatives exist: replace the wood framing and decking with a composite material, extend the concrete sidewalks or abutments until the grade is sufficiently low to avoid contact with the wood (providing a minimum 8-inch gap between wood and soil), or by re-grading. Re-grading will require the attention of a Civil Engineer to ensure that proper drainage away from the boardwalks and abutments is maintained to prevent undermining and erosion. Boardwalk 27 within the CCDD jurisdiction is an example of an abutment that rises up to meet the boardwalk so that the wood framing is not in contact with the soil at the boardwalk-to-abutment transition (photo 16).

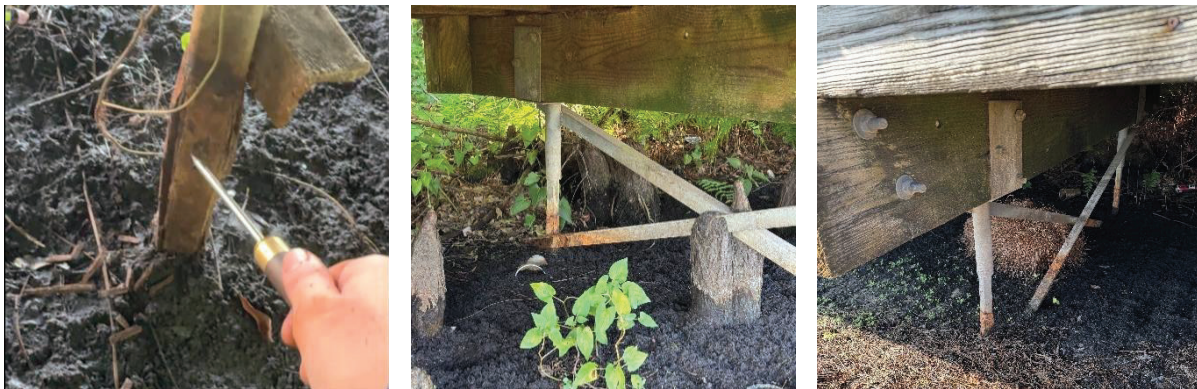
There are many instances of steel helical piles and angle braces with light surface corrosion. However, there are several notable instances where there is more moderate corrosion and some expected minor section loss of the steel elements that are in contact with soil and experience frequent wet-dry cycles (photo 11). This corrosion and potential section loss did not appear to be greater than 10% of the steel angles or piles where we cleared off corrosion product to observe the base steel. Where we excavated below grade, the corrosion did not appear to extend significantly below the surface on the helical piles.

Some of the braces were noted as having a slight “bow” or curvature to them, and a few of the steel piles have a visible “lean” (out-of-plumbness). In each of these instances, the conditions did not appear to yet affect structural integrity and in the case of the leaning piles, appears to be an original condition from the construction of the boardwalk. The pile-to-beam connectors at these conditions were shimmed with shims that appeared to be of an equivalent age to the beams.

**Photo 11:** Steel angle brace and helical pile with corrosion

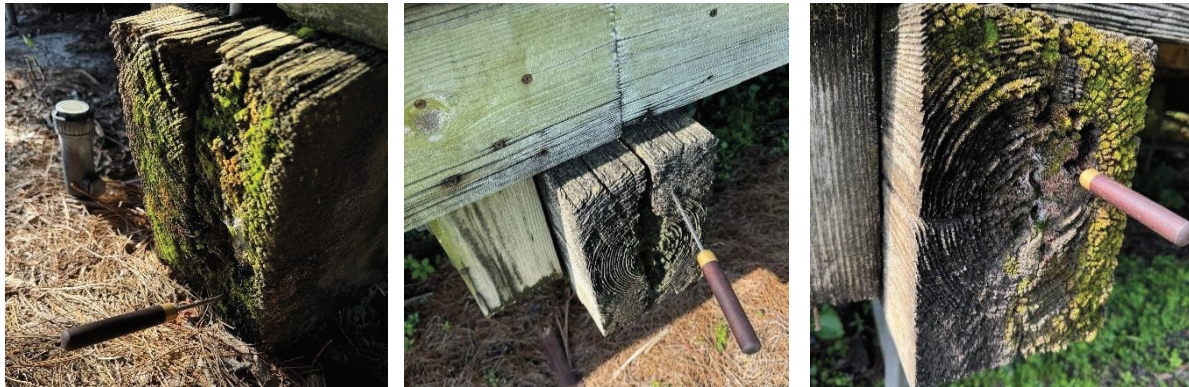
Overall, the beams are generally in good condition, especially the center span of the beam that is sheltered by the deck. The ends of the beams along the north side of the boardwalk, especially those buried or in contact with soil, exhibited the most frequent and severe rot and deterioration (refer to photo 12 for examples). While this side of the boardwalk should receive the most sunlight and dry most readily after rainfall, it is possible that nearby irrigation systems / sprinklers are spraying the framing along the north perimeter. This would potentially explain the high levels of rot we observed.

Most of the soft or rotting beam ends we observed do not yet present a structural issue since the rot has not extended to the guardrail post's connections or further inward to the helical pile bearing. However, there are some cases where the rot *has* extended to the guardrail or beam's connection at the pile – this becomes a structural concern as it will impact these connections and these conditions need to be addressed. This is noted in the database.

**Photo 12:** Rotted beam ends

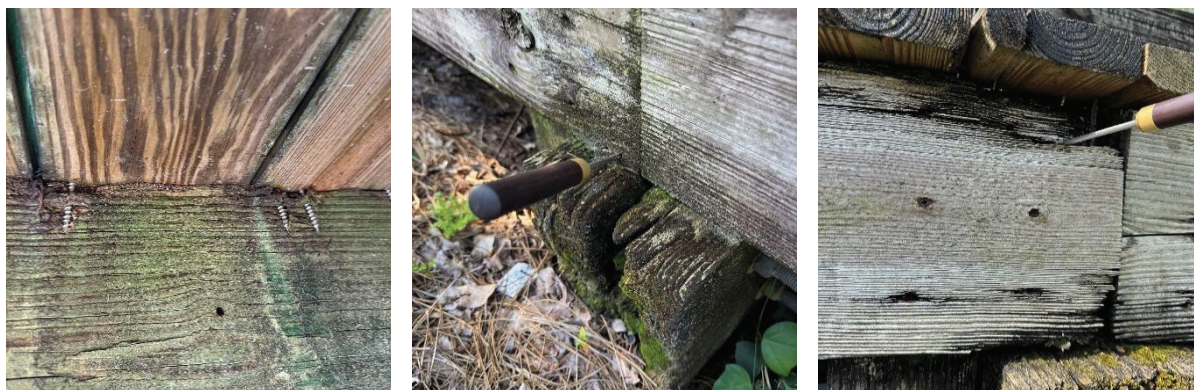
There are several instances where the rim/exterior joists are rotted along their top edge and/or at their bearing ends atop the beams. In some cases, the joists were observed to be split or cracked – sometimes due to fasteners that did not penetrate at the center of the narrow face of the joist and in other cases due to what may have been original splits or checks that have propagated. These defects range from poor to severe condition.

Additionally, while we did not directly observe deterioration at the top edge of most of the joists, these top surfaces are frequently exposed to rain between the deck boards, and this exposure promotes rot and decay. Fastener replacement during replacement of deck boards will also deteriorate the top surface over time as previous screw penetrations are abandoned. Refer to photo 13 for observed joist defects.

**Photo 13:** Joists with deck fasteners improperly installed along edge, rot at bearing, rot at top edge (from left to right)

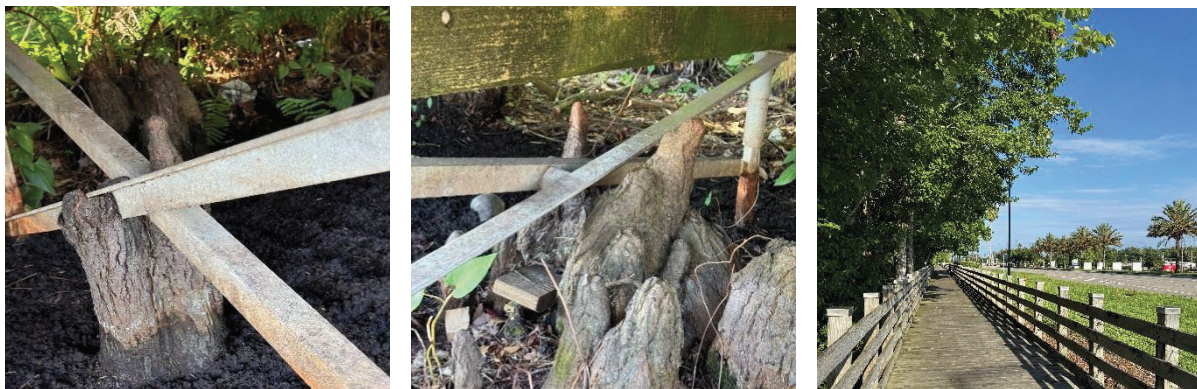
Some of the foundation elements are affected by tree roots that appear to be growing around and are potentially beginning to impact the steel members (photo 15). Upward pressure from growth will eventually compromise the steel cross-bracing as shown in the left and center photographs. The growing roots in contact with the steel will trap moisture and provide a mechanism for corrosion.

Moreover, along the south side of the boardwalk, heavy undergrowth is at times in contact with the framing and foundations and overhangs the walking path (also photo 15). Some of the vines that were wrapped around the railing had sharp thorns that present a hazard to pedestrians. The proximity of and contact with vegetation increases the deleterious effects of moisture exposure and insect activity with respect to the wood framing. The undergrowth also will impede the ability of maintenance teams to reach the underside and south side of the boardwalk and may obscure deteriorating framing from view.

**Photo 15:** Tree roots impacting steel braces (left, center) and overgrown vegetation along boardwalk.

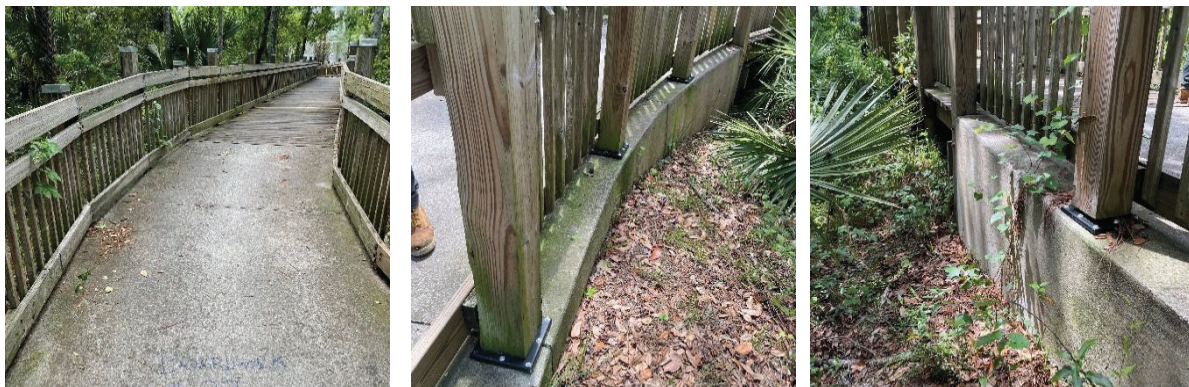
**Photo 16:** Concrete ramp at Boardwalk 27 in CCDD jurisdiction

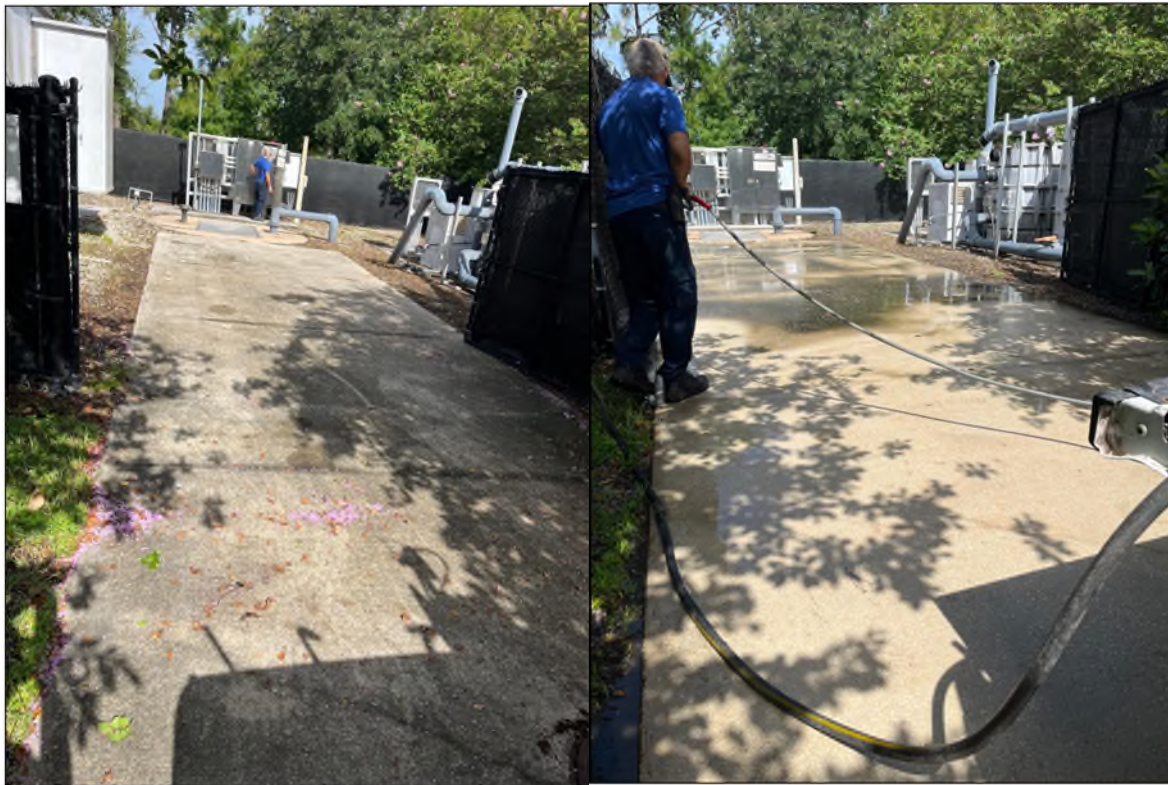
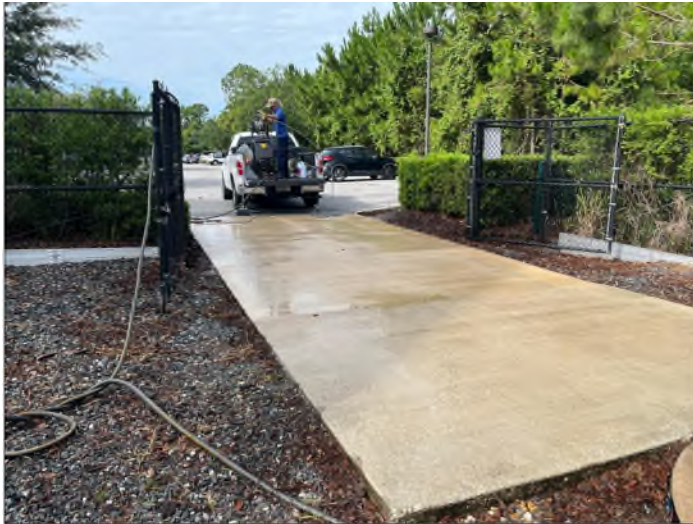
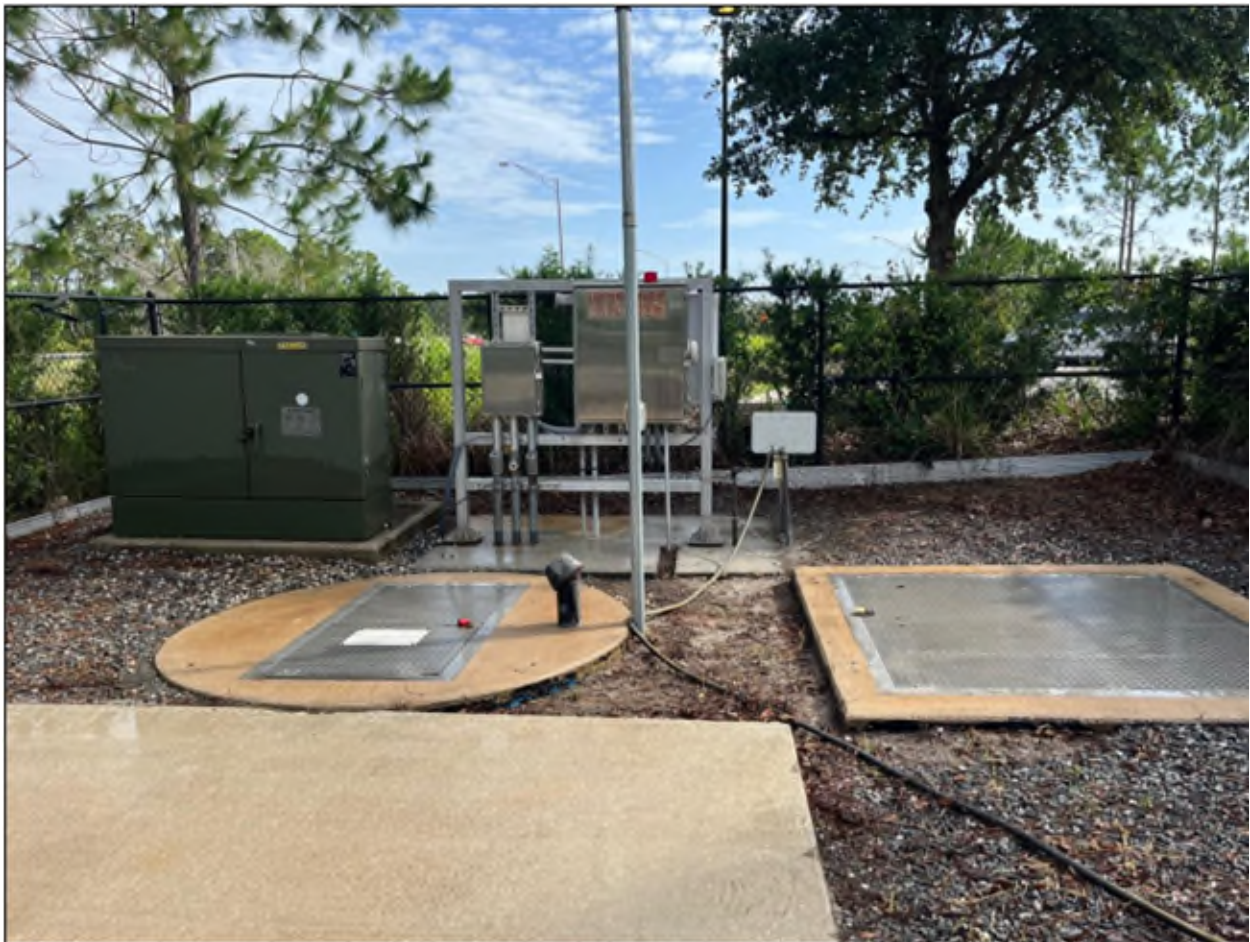
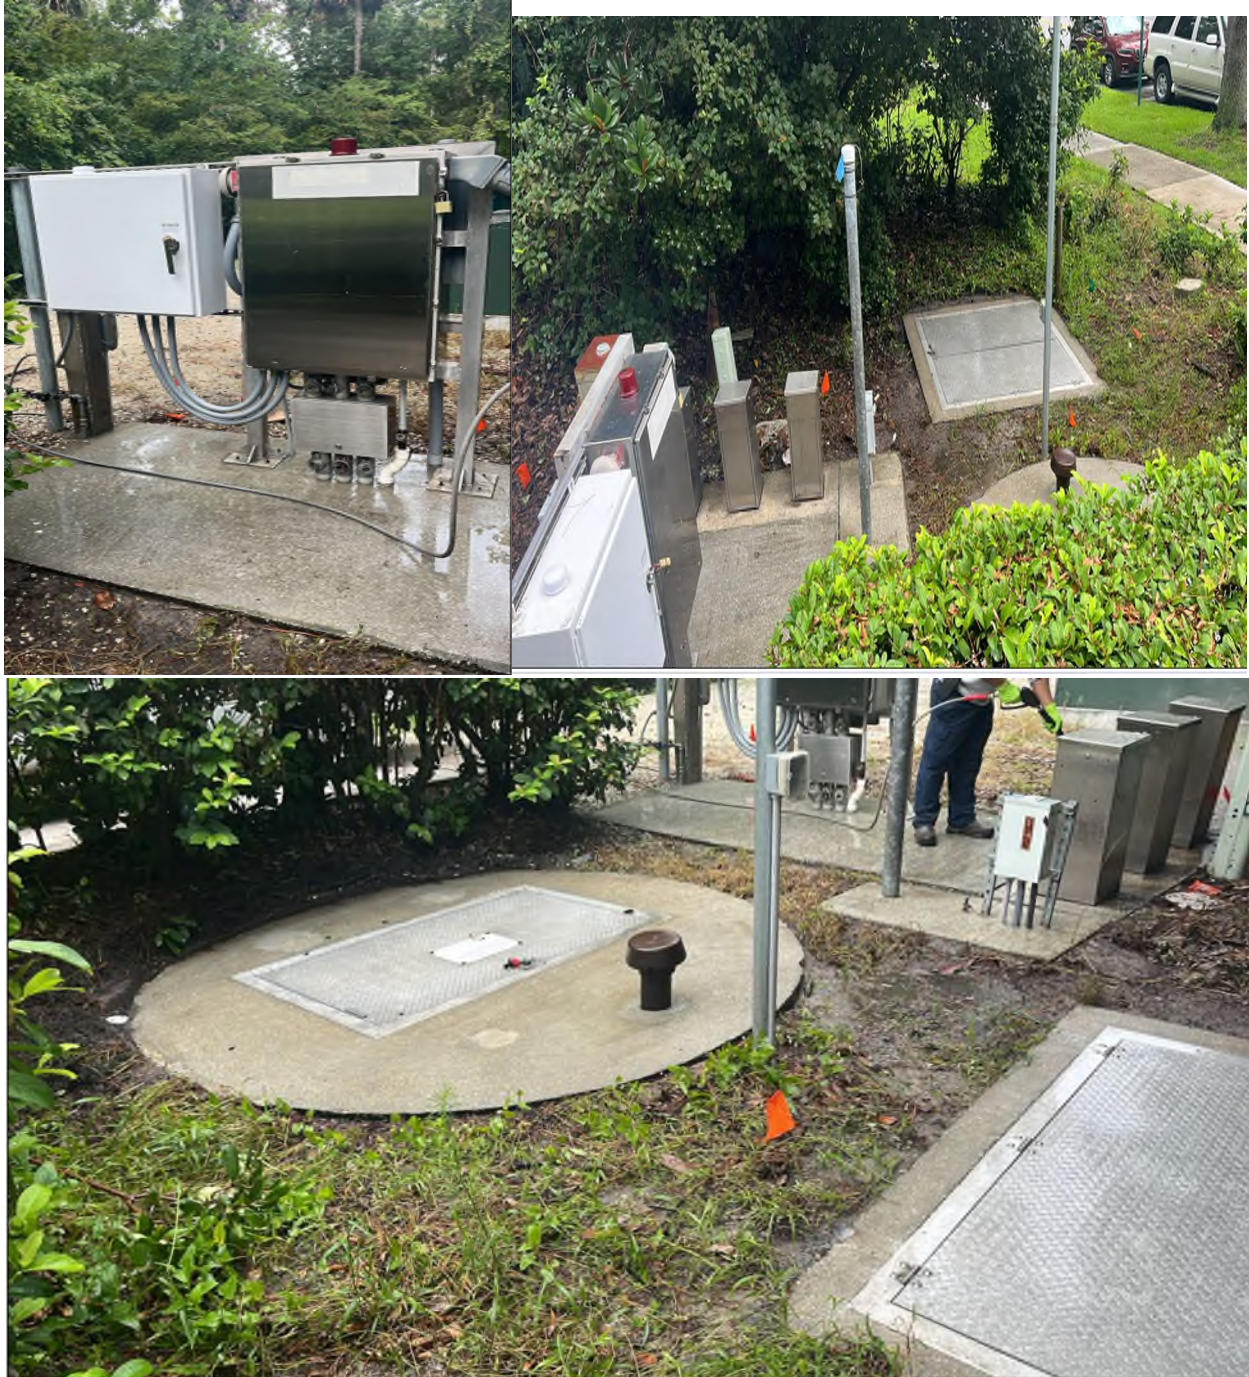
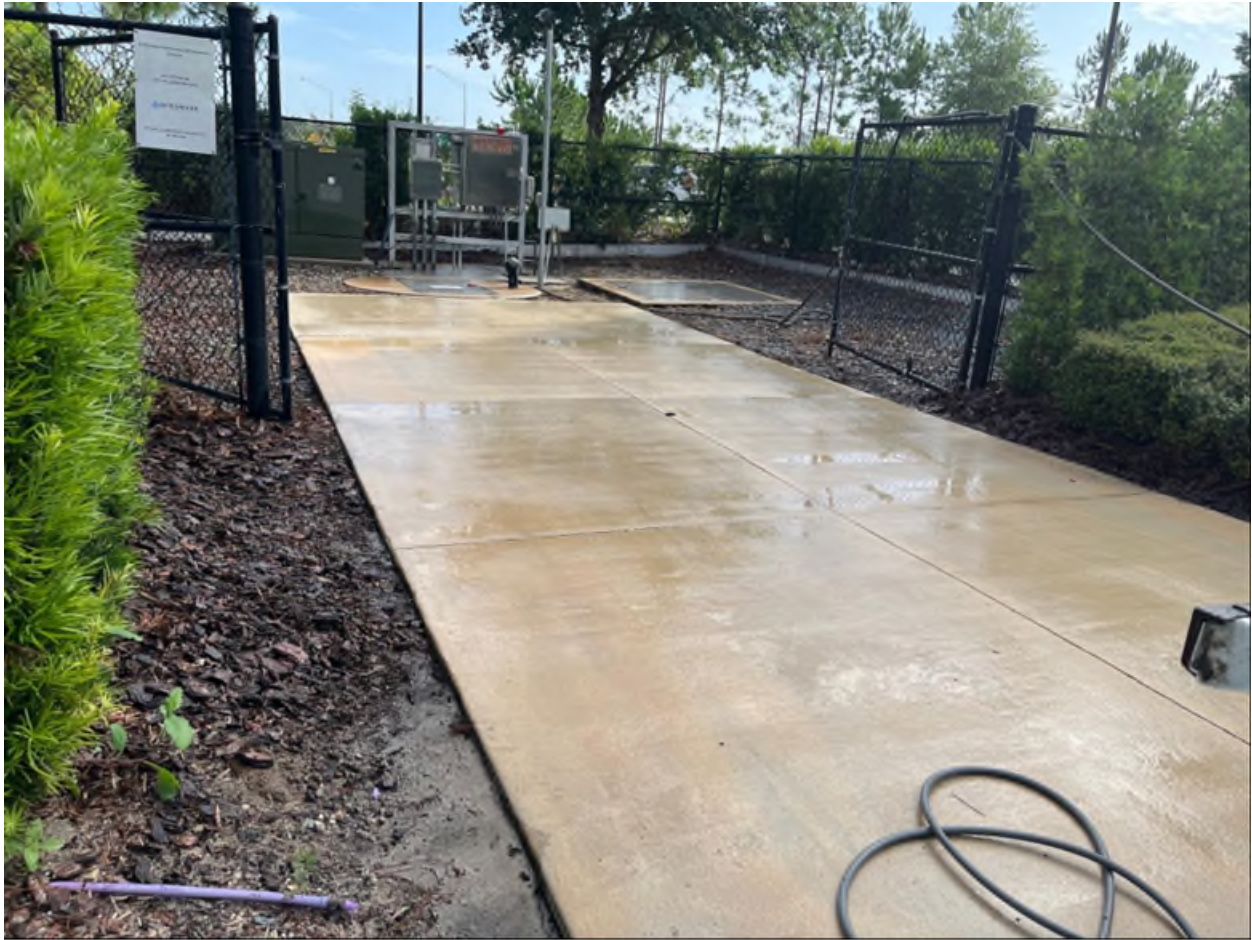
BELOW ARE PICTURES OF LIFTSTATION THAT WERE RECENTLY PRESSURE WASHED AND CLEANED.
