Our School Buildings' Strengths, Challenges, and Needs

Lock Pampel-Montague – FGM Architects

Draft Building Needs Presentation

- District Overview
- Existing Conditions – Aging Schools
- Facilities Assessment – Estimated Life Spans

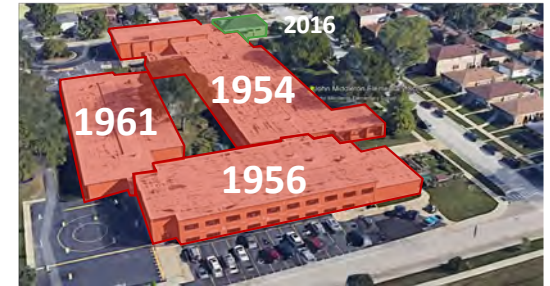
- Roof systems beyond their useful life
- Cracking noted at interior and exterior masonry walls
- Failing window systems
- Mechanical, electrical, and plumbing equipment and systems beyond their useful life

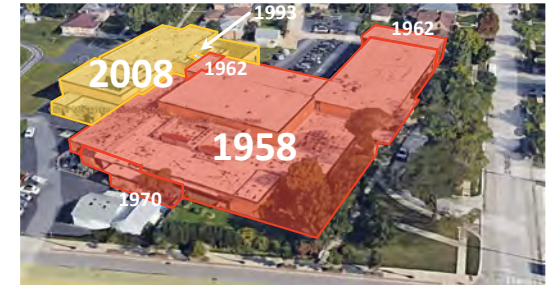
- Roof systems beyond their useful life
- Cracking noted at interior and exterior masonry walls
- Failing window systems
- Mechanical, electrical, and plumbing equipment and systems beyond their useful life

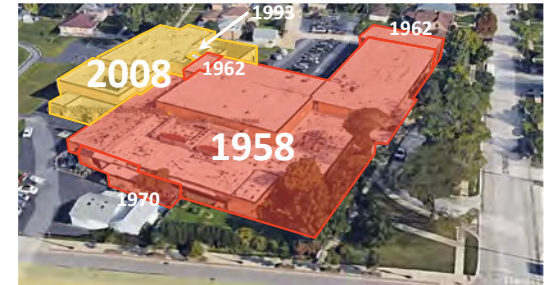
- Heating and cooling systems do not operate properly, causing temperature issues
- Evidence of roof or pipe leaks above ceiling
- Significant leaks and clogs at single-user restrooms, locker rooms, and library
- Lack of outlets

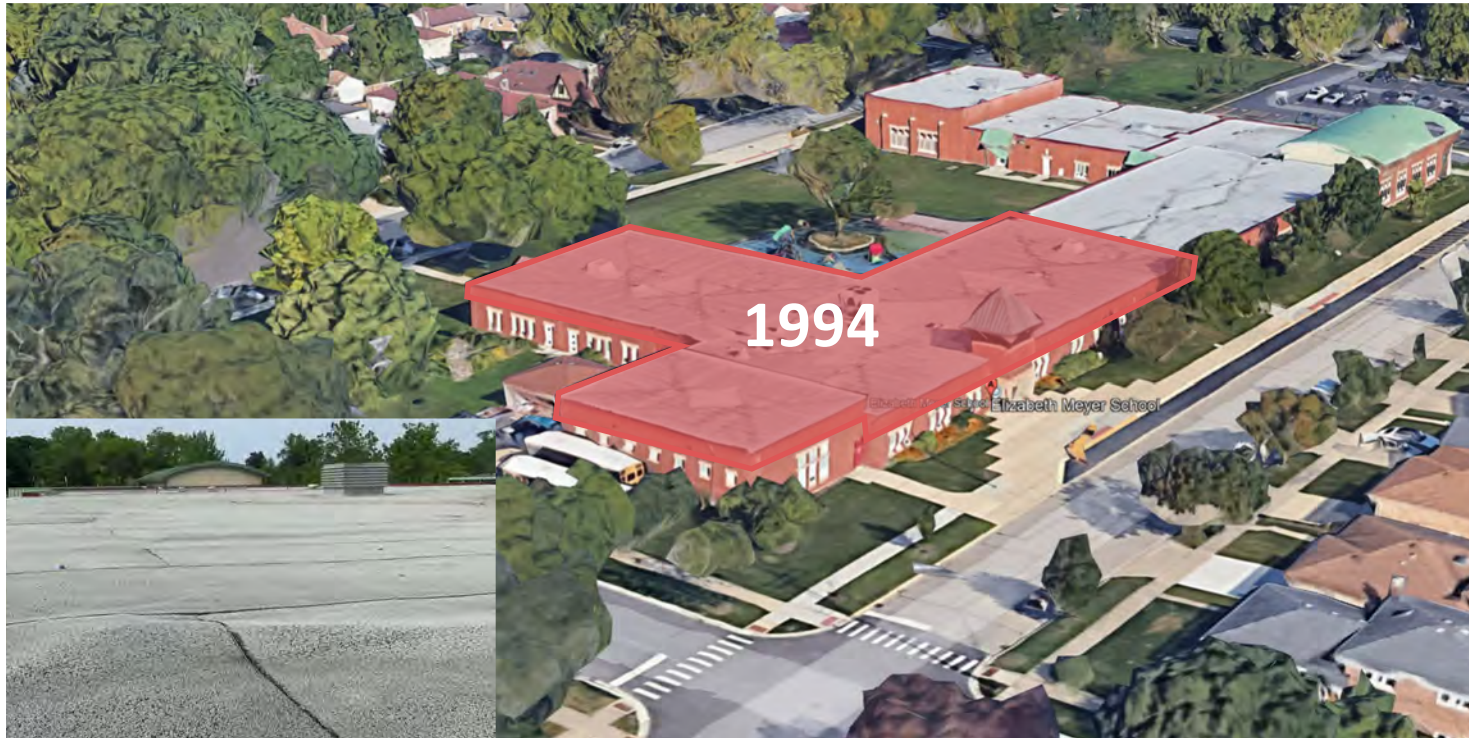
Roof Replacement

Roof is cracking and buckling, causing leaks

- Remove roof covering to structure
- Relocate ceiling tiles as needed at exterior walls
- Increase roof thickness to meet energy code
- Replace and repair ceilings

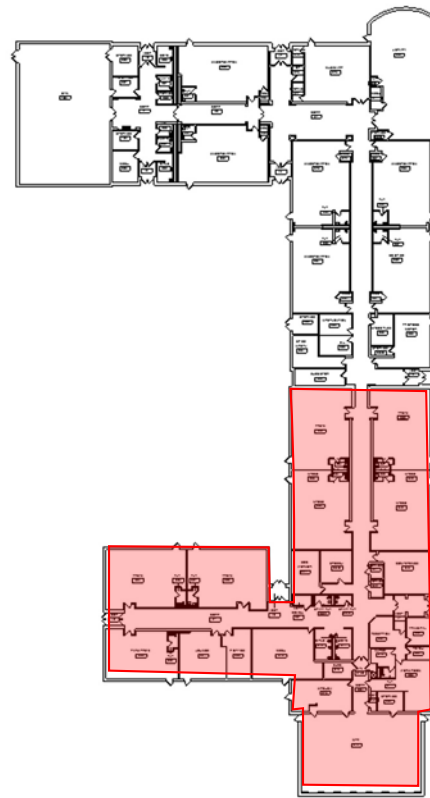
Heating and Cooling System Replacement

Existing Ceiling and Heating and Cooling System

Existing Roof and Heating and Cooling System

- Remove existing units in ceilings and on roof
- Relocate ceiling tile throughout corridors and rooms
- Replace units and controls
- Replace and repair ceilings

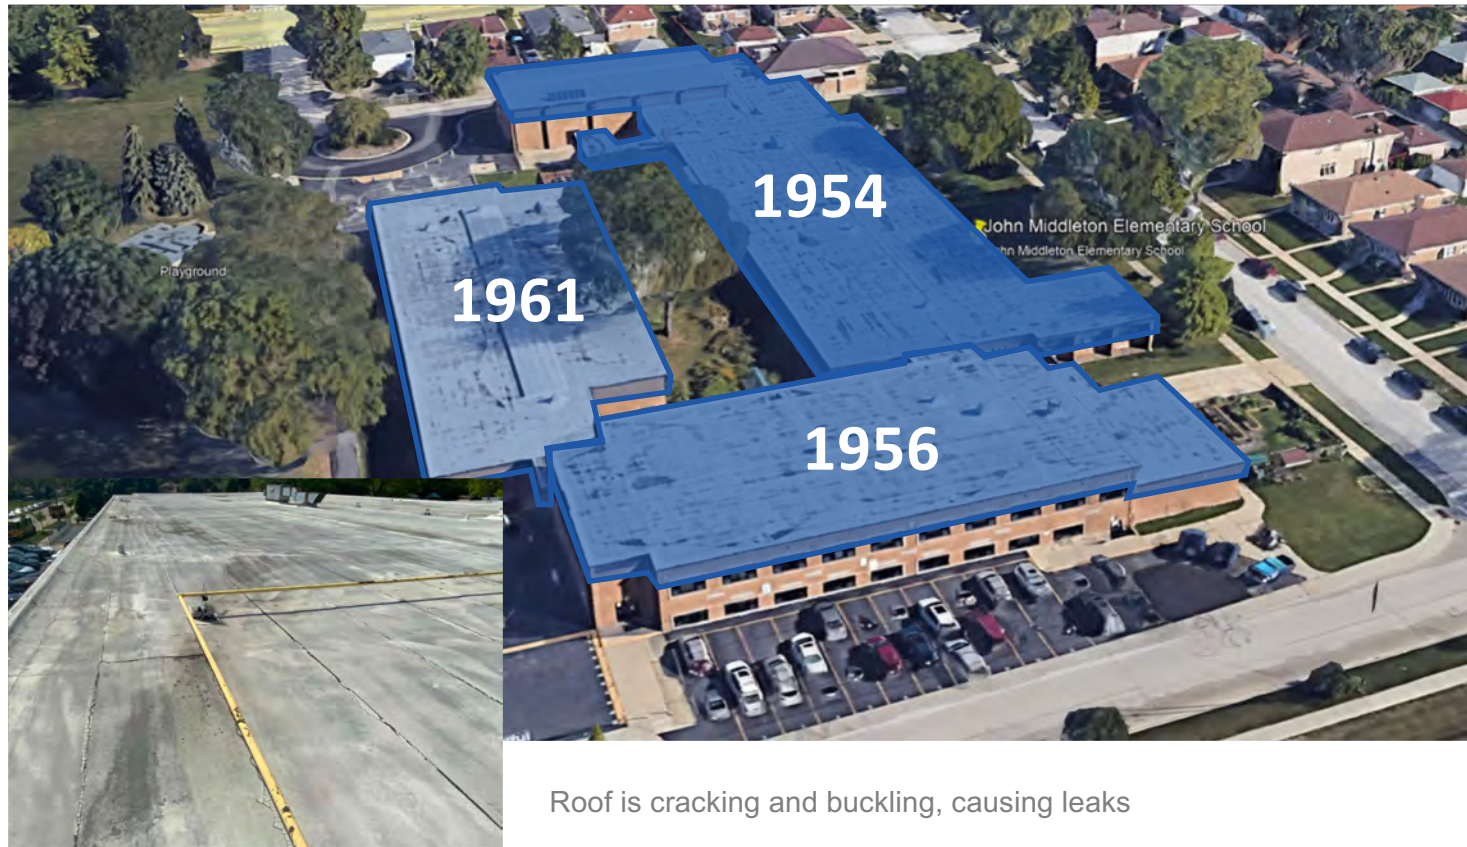
Roof Replacement

Roof is cracking and buckling, causing leaks

- Remove roof covering to structure
- Relocate ceiling tiles as needed at exterior walls
- Increase roof thickness to meet energy code
- Replace and repair ceilings

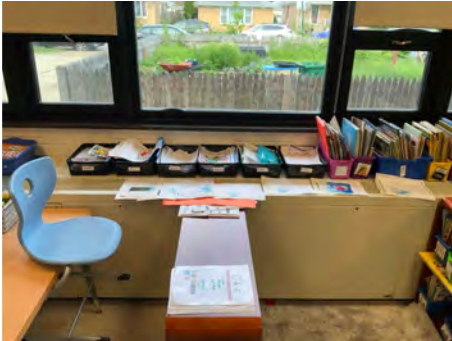
Heating and Cooling System Replacement

Existing Window and Heating and Cooling System

- Remove existing units and cabinetry at windows
- Relocate ceiling tile throughout corridors and rooms
- Replace units and controls
- Replace and repair ceilings

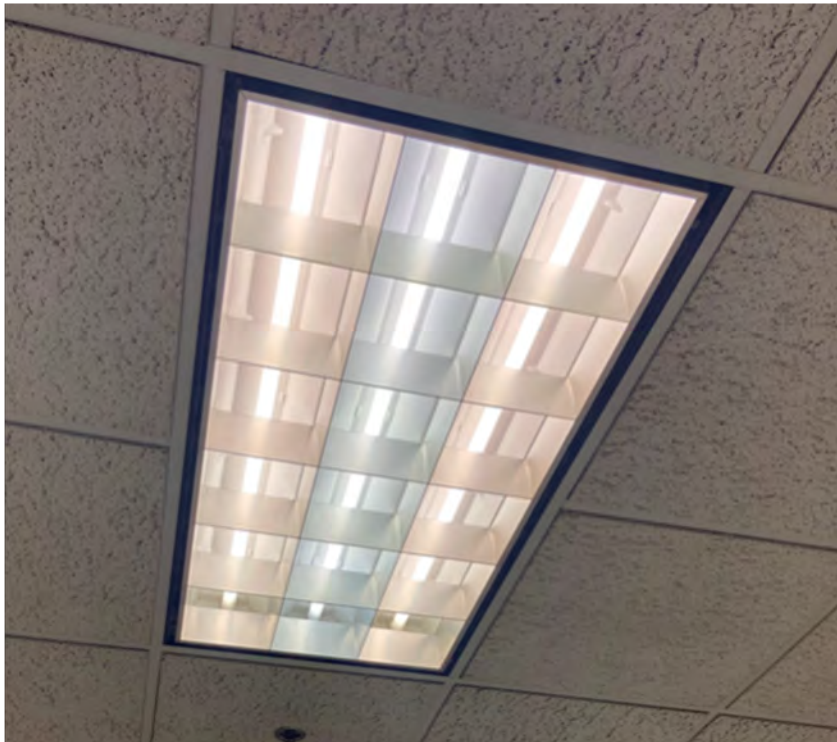
Existing Fluorescent Light

- Relocate ceiling tile throughout corridors and rooms
- Remove existing lights, piping, and IT cables
- Replace lights, piping, and IT cables
- Provide additional outlets in all teaching spaces
- Replace and repair ceilings

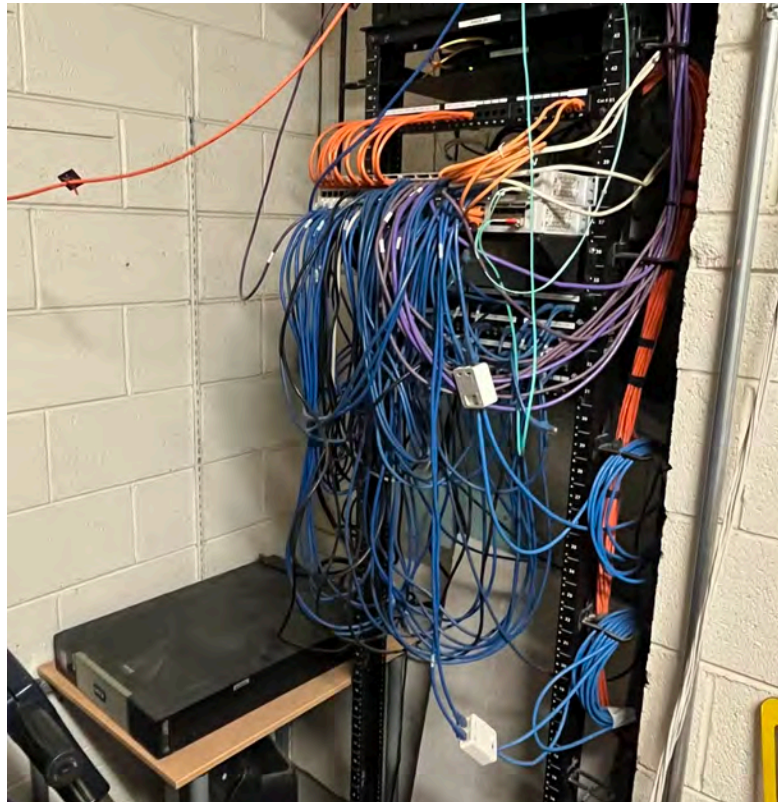
Existing Undersized IT Closet

- Relocate ceiling tile throughout corridors and rooms
- Remove existing lights, piping, and IT cables
- Replace lights, piping, and IT cables
- Provide additional outlets in all teaching spaces
- Replace and repair ceilings

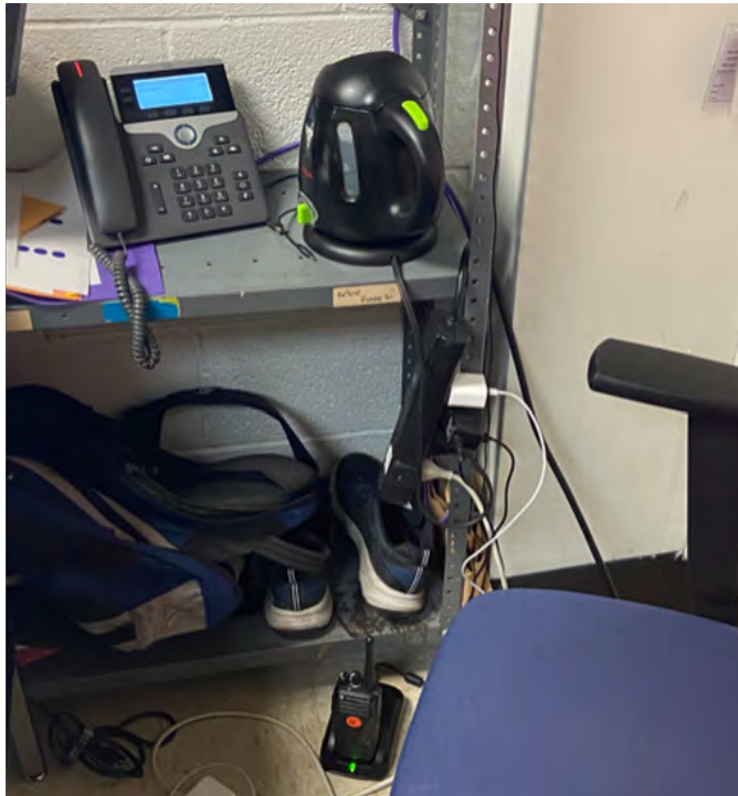
Existing Lack of Power Outlets

- Relocate ceiling tile throughout corridors and rooms
- Remove existing lights, piping, and IT cables
- Replace lights, piping, and IT cables
- Provide additional outlets in all teaching spaces
- Replace and repair ceilings

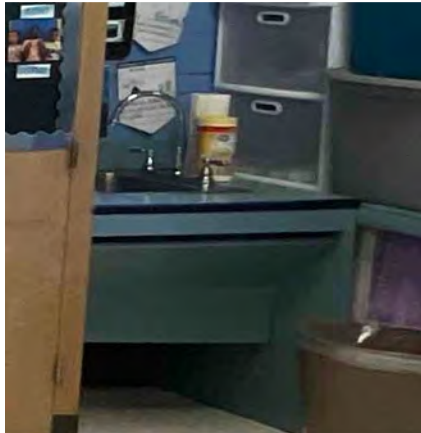
Example of Aged Galvanized Pipe

Existing Sinks Leaking and Lacking Temperature Controls

- Relocate ceiling tile throughout corridors and rooms
- Remove existing lights, piping, and IT cables
- Replace lights, piping, and IT cables
- Provide additional outlets in all teaching spaces
- Replace and repair ceilings

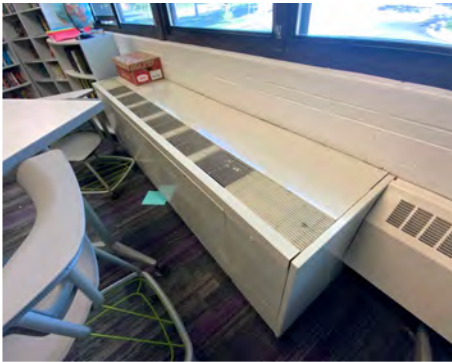
Heating and Cooling System Replacement

Existing Window and Heating and Cooling System

- Remove existing units and cabinetry at windows
- Relocate ceiling tile throughout corridors and rooms
- Replace units and controls
- Replace and repair ceilings

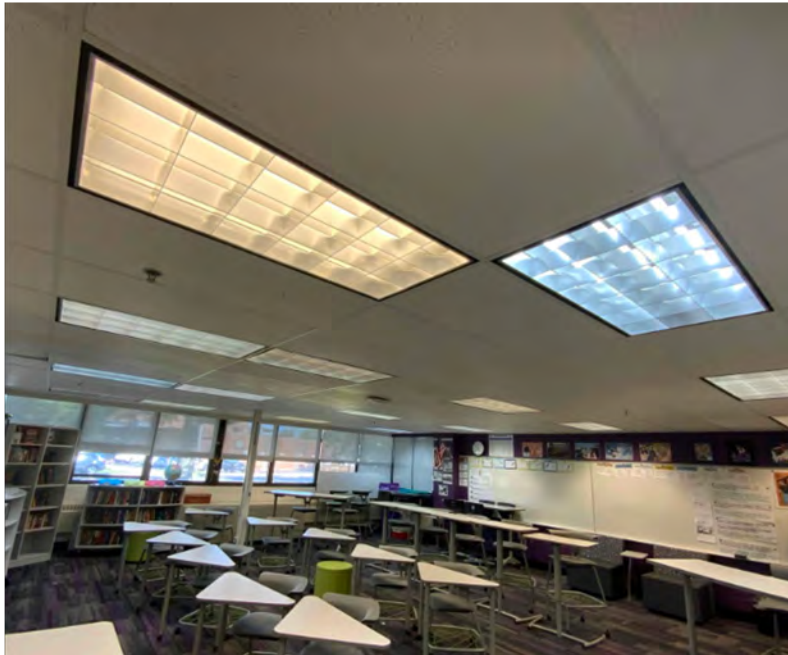
Existing Fluorescent Light

- Relocate ceiling tile throughout corridors and rooms
- Remove existing lights, piping, and IT cables
- Replace lights, piping, and IT cables
- Provide additional outlets in all teaching spaces
- Replace and repair ceilings

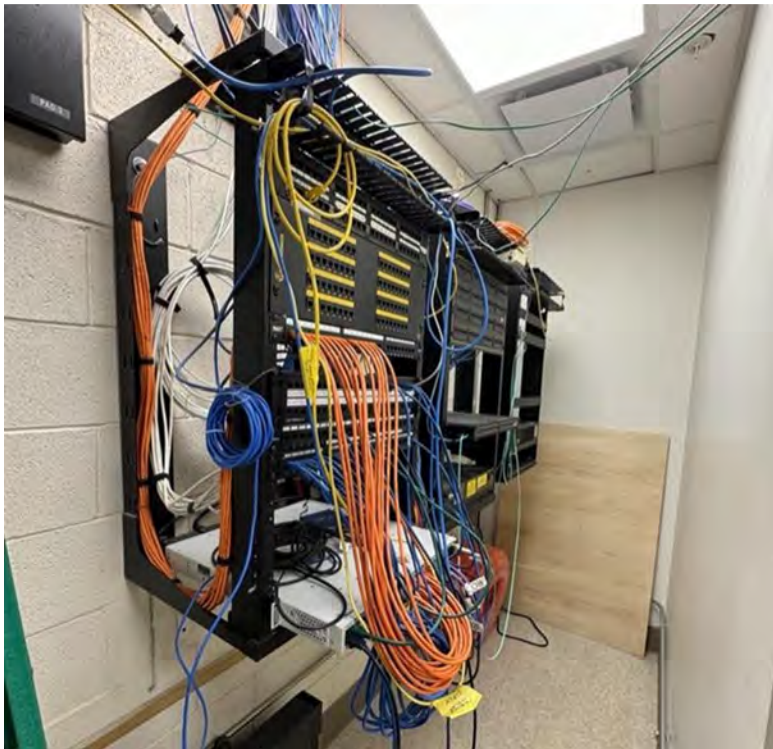
Existing Undersized IT Closet

- Relocate ceiling tile throughout corridors and rooms
- Remove existing lights, piping, and IT cables
- Replace lights, piping, and IT cables
- Provide additional outlets in all teaching spaces
- Replace and repair ceilings

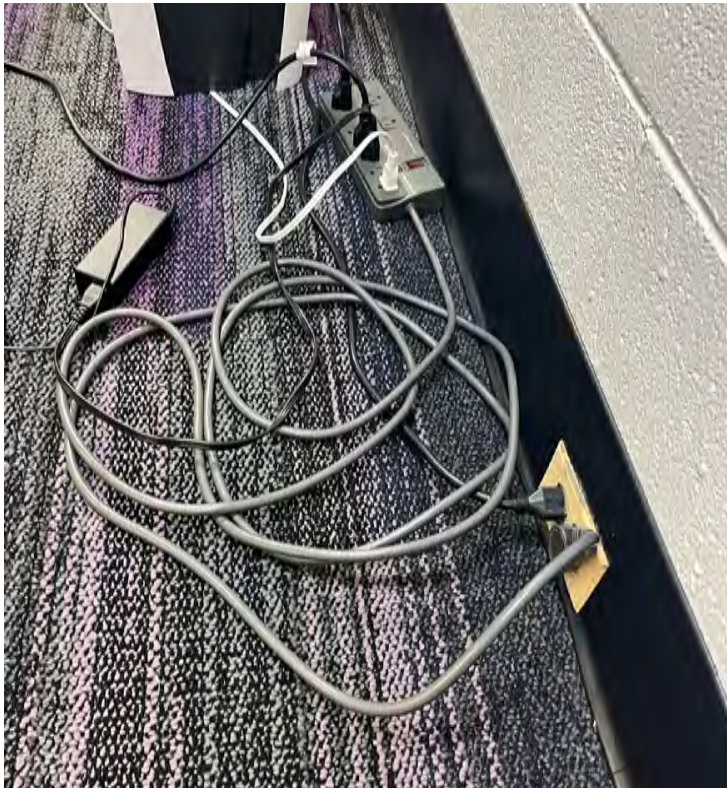
Existing Lack of Power Outlets

- Relocate ceiling tile throughout corridors and rooms
- Remove existing lights, piping, and IT cables
- Replace lights, piping, and IT cables
- Provide additional outlets in all teaching spaces
- Replace and repair ceilings
