Easton Park Community Development District

May 21, 2026

Agenda Package

Easton Park CDD Waterway Inspection Report

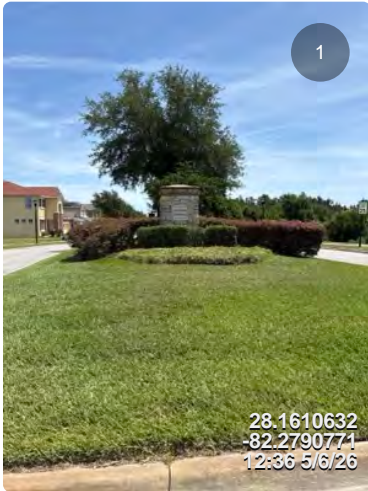
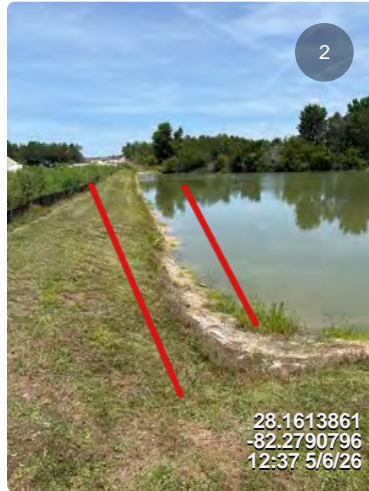
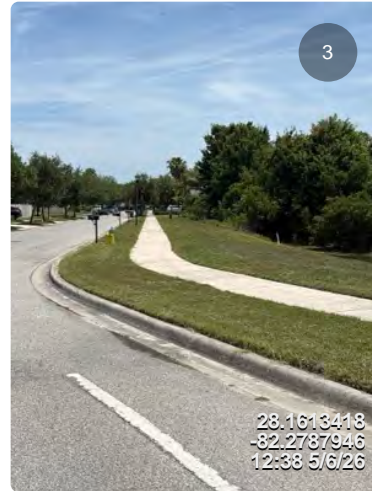
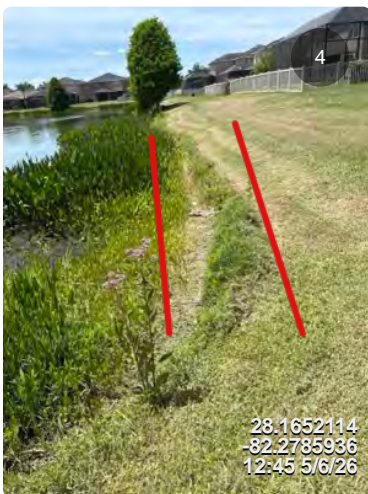
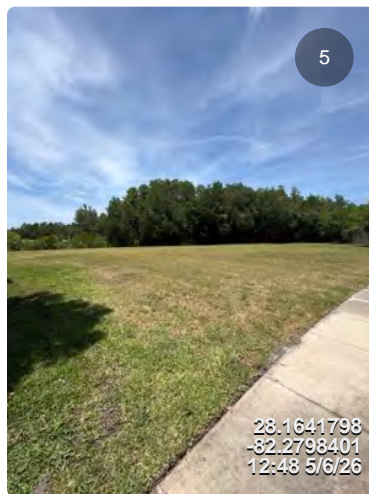
Hidden Terrace is generally well maintained. Proper mowing around the pond banks and pocket parks are being performed. It appears the pond banks are being missed by line trimming.

- Please line trim the pond banks at next service.

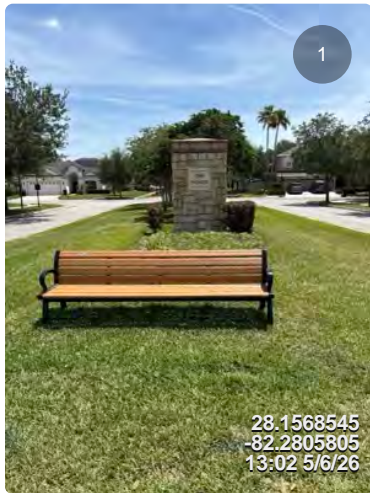
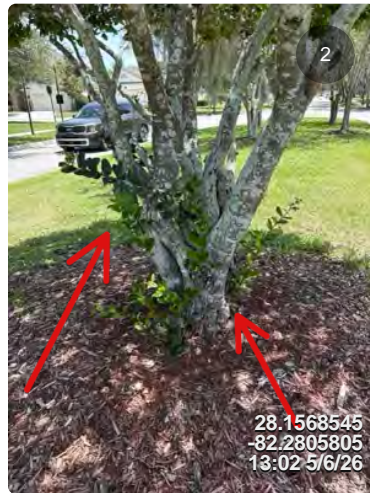
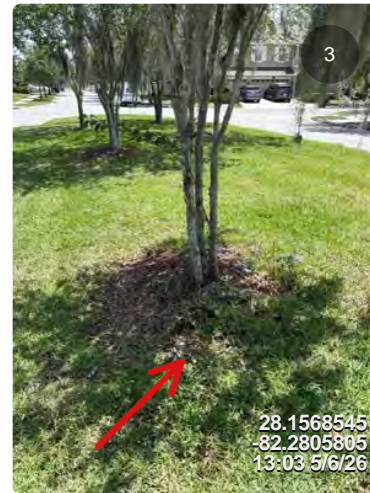
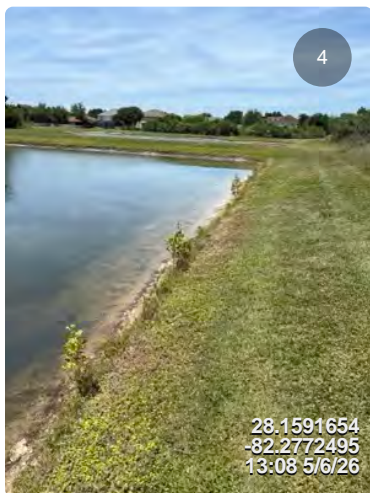
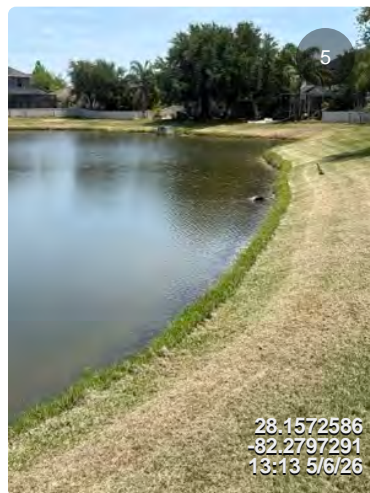
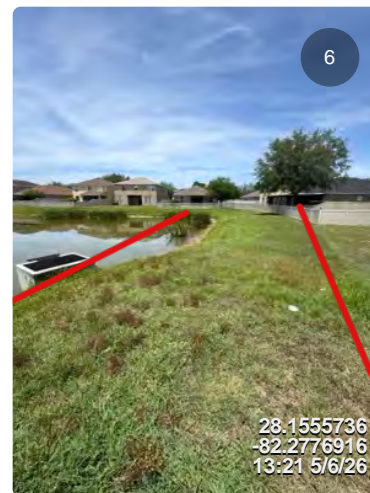
Items 2 - The Winds

The Winds is generally well maintained. The middle pond in this sub-neighborhood appears to have been missed at service. Remaining pond that has been mowed still needs to be line trimmed.

- Please be sure to service all pond banks during routine maintenance.
- Please line trim all pond banks at next service.
- Please clean up all the sucker growth from the Crape Myrtles.
- Please provide better edge definition to the tree rings that have encroachment.

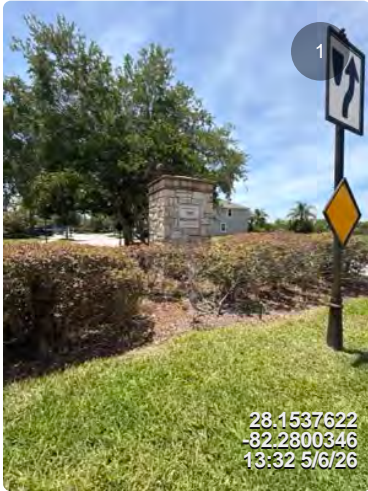
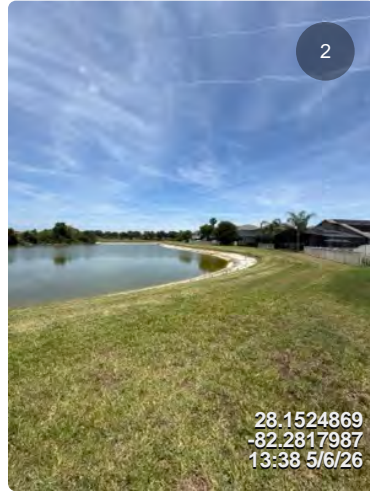
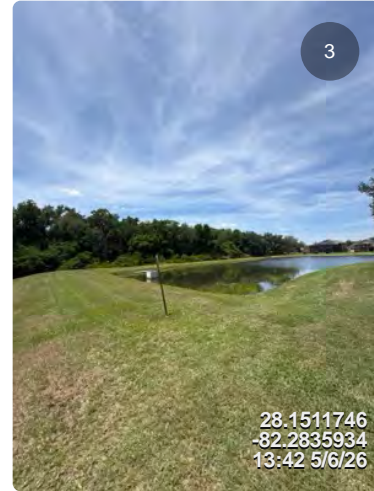
Items 3 - The Breakers

The Breakers is generally well maintained.

- Please be sure to police for trash in the garden beds during routine service.

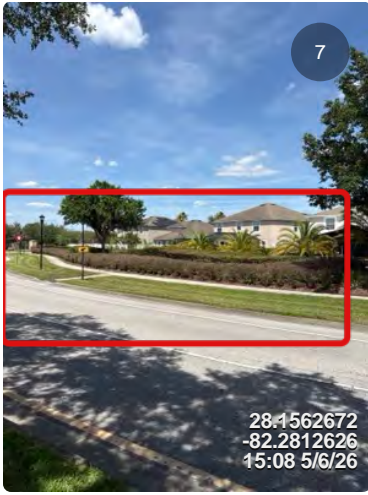
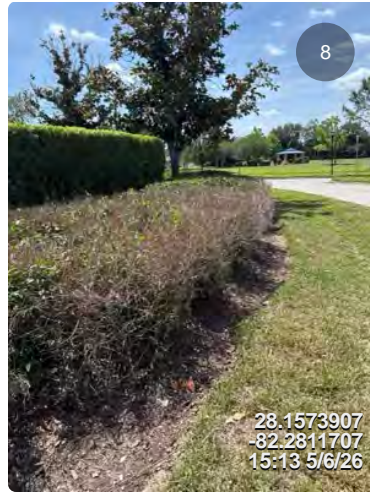
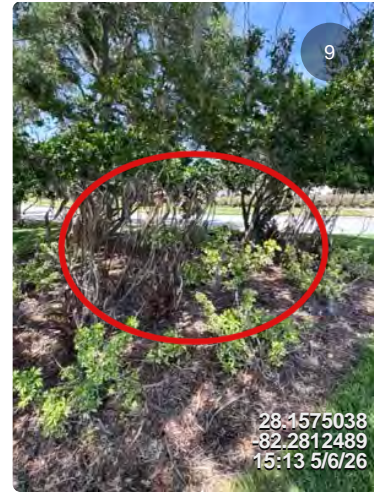
Items 6 - Pictorial Park Dr.

Landscape throughout the main boulevard appears well maintained but in struggling condition. It is evident that landscape is still recovering from previous cold snap. Suggesting a rejuvenation cut-back to encourage healthy growth in the struggling plants. Some garden beds in the median appear to have overgrown weeds and sucker growth on the Crape Myrtles.

- Please service the median garden beds and treat for weeds.
- Please cut the sucker growth from Crape Myrtles at next service.
- Please trim the Cordyline Red Sister of dead plant material.

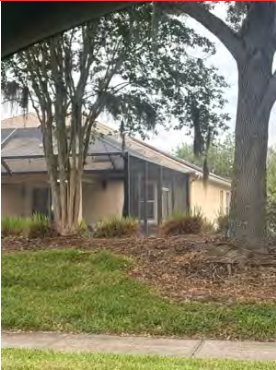
OBSERVATION 2

Grasses have been cut back

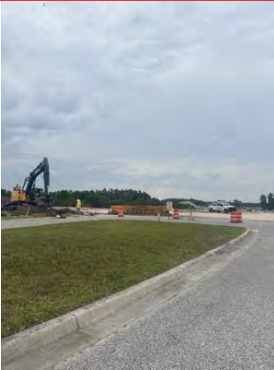
OBSERVATION 6

Common areas being maintained

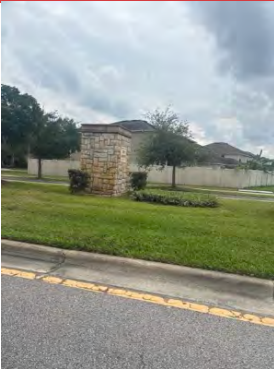
OBSERVATION 7

The wind's monument has been cleaned up

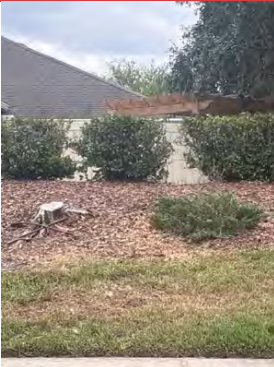
OBSERVATION 9

Weeds have been treated

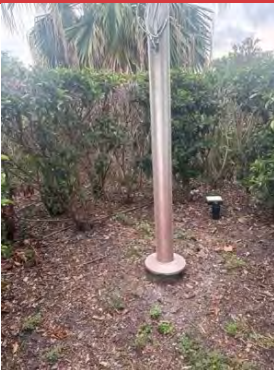
OBSERVATION 16

Needs to be treated again and maintain but flagpole area in traffic circle shows improvement

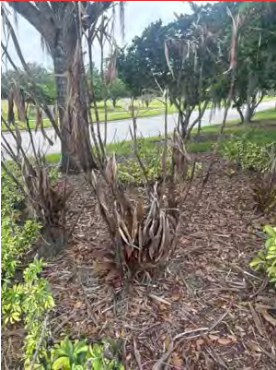
Upon next treatment please evaluate turf in traffic circle
