# ***Cedar Hammock Community Development District***

### LAKE BANK EROSION AND STABILIZATION ANALYSIS

August 2026

**Cedar Hammock CDD  
Lake Bank Erosion Report  
August 2026**

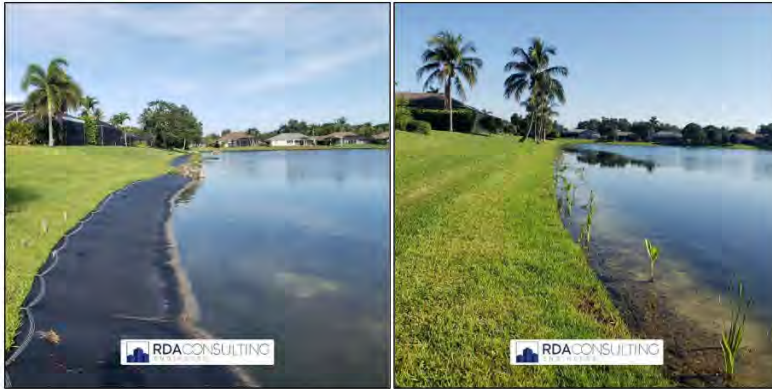
Figure 7. Erosion Control Wraps During and After. (RDA Consulting Engineers, 2026).

Erosion Control Wraps are a common stabilization method for wet detention lake bank erosion in Southwest Florida. The polyethylene mesh fabric is anchored near the top of the bank and extended past the water line, and then folded over to be anchored again at the top of the bank. Sediment is filled within the mesh made "pockets." After installation, the Erosion Control Wrap is seeded, sodded, or planted with vegetation to mimic a natural shoreline. The sediment can be dredged from eroded soil within the lake to reduce the import of fill. This option provides a higher level of erosion protection than non-reinforced reestablished lake banks and similar protection as Erosion Control Mats and Geocell Systems. This method requires regular irrigation and is not intended for lake bank slopes greater than 4-ft horizontal to 1-ft vertical. A segment of Lake 5 was inspected in August 2026 to consist of a Erosion Control Wrap exposed due to erosion.

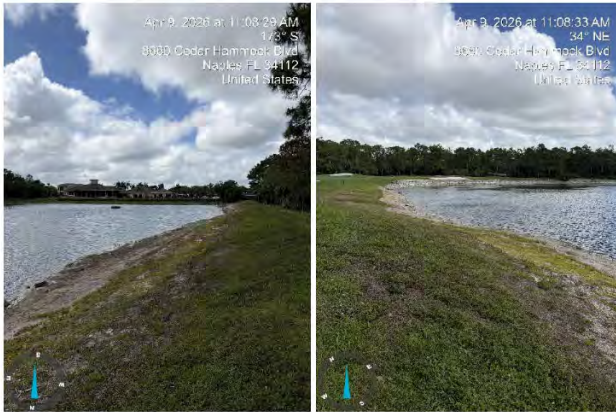
Images 80 & 81

Lake 1 is reported as having minimal erosion. However, please note a portion of the western lake bank is permitted to be a 6:1 slope and appeared during the site inspection to be greater than designed. It is recommended to reestablish this slope with imported or dredge fill per a geotechnical engineer's specifications.

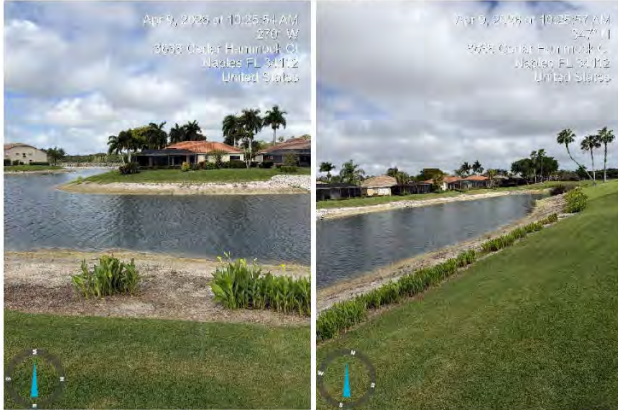
Images 26 & 27

| Cedar Hammock CDD | | INSPECTION DATE: April 9, 2026 | |
|---|---|---|---|
| Lake 3 | Lake L-13 | MODERATE EROSION | Photos: 22-50<br>27: Rip-rap appears to be installed without filter fabric and slope degradation and drop-off from vegetation along the bank.<br>34: Erosion and slope degradation.<br>36: Large drop-off from vegetation to bank on the southwest side. Limestone rock exposure. PVC pipe exposure along the northeastern lake bank.<br>41: Limestone rock exposure.<br>44: Vegetation removal appears to have caused some erosion.<br>48: Minor drop-off from vegetation.<br>49: Lake bank appears to have a severe washout with PVC pipe exposure. Rip Rap appears to be installed without filter-fabric material.<br>53: Major slope degradation and drop-off from vegetation.<br>59: Major slope degradation. Limestone exposure.<br>60: Rip-rap appears to be installed without filter fabric, some erosion has occurred.<br>61: Major slope degradation.<br>65: Moderate drop-off between vegetation and rip-rap.<br>68: Major slope degradation.<br>70: Multiple pipes installed at High Water Line creating erosion and washouts. One outfall pipe appears to be obstructed. Rip-Rap does not appear to be placed with filter-fabric. |

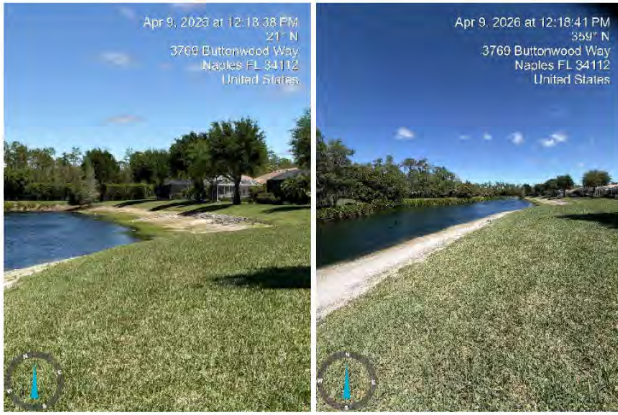
Images 166 & 167

| Cedar Hammock CDD | | INSPECTION DATE: April 9, 2026 | |
|---|---|---|---|
| Lake 6 | Lake L-12 | MODERATE EROSION | Photos: 166-173<br>166: Minor rills and drop-offs along vegetation near rip-rap.<br>168: Rip-rap appears to be installed without filter fabric, minor slope degradation. |

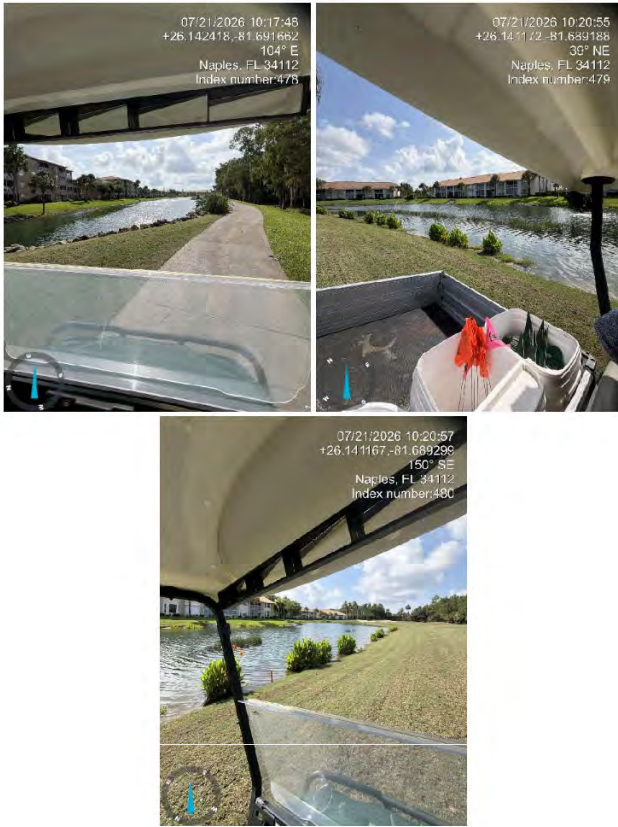
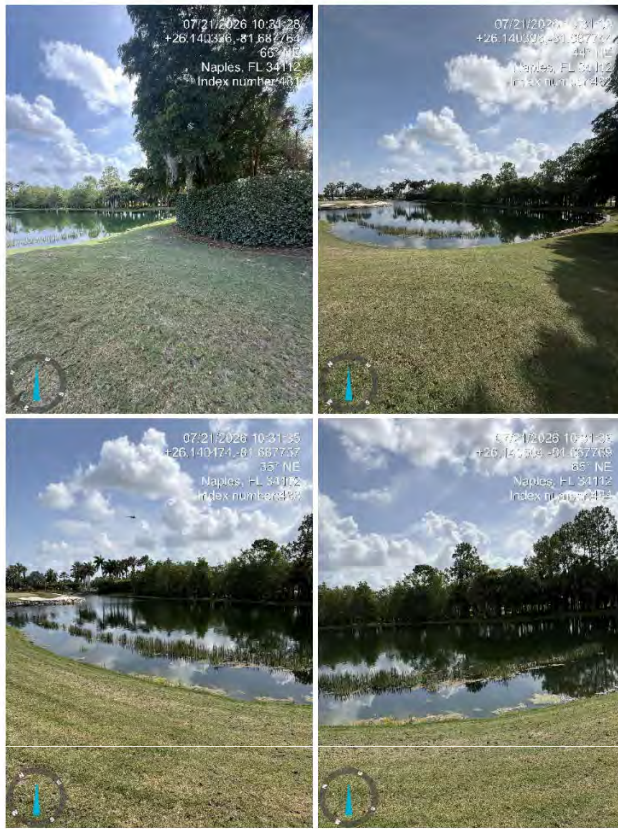
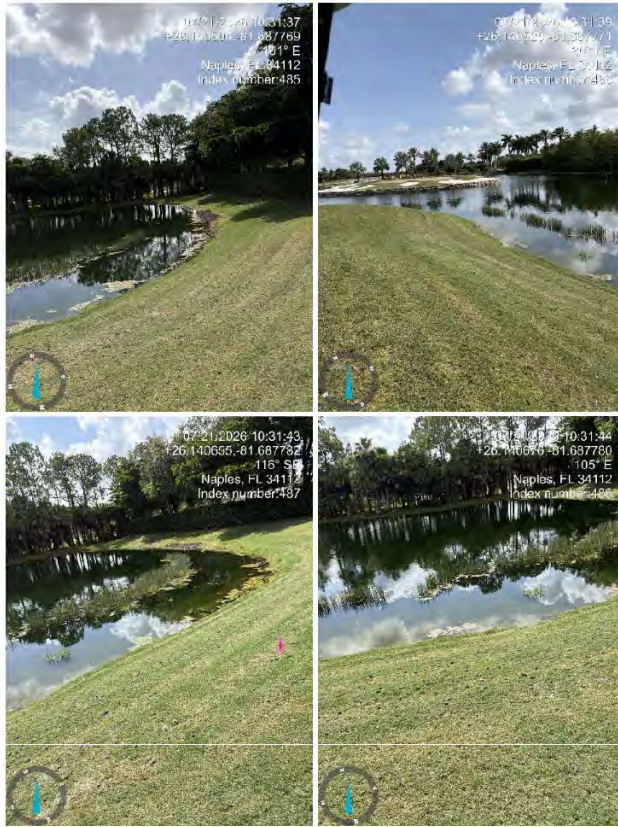
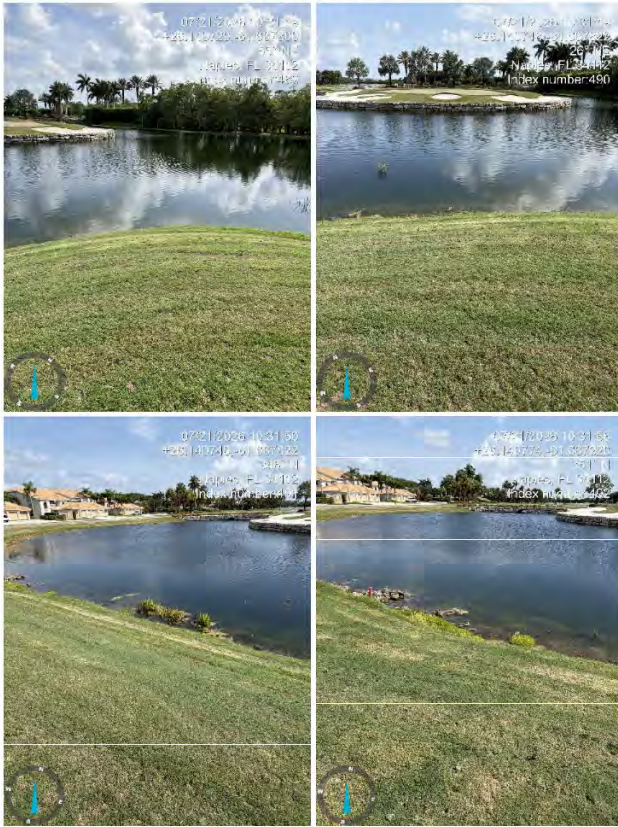
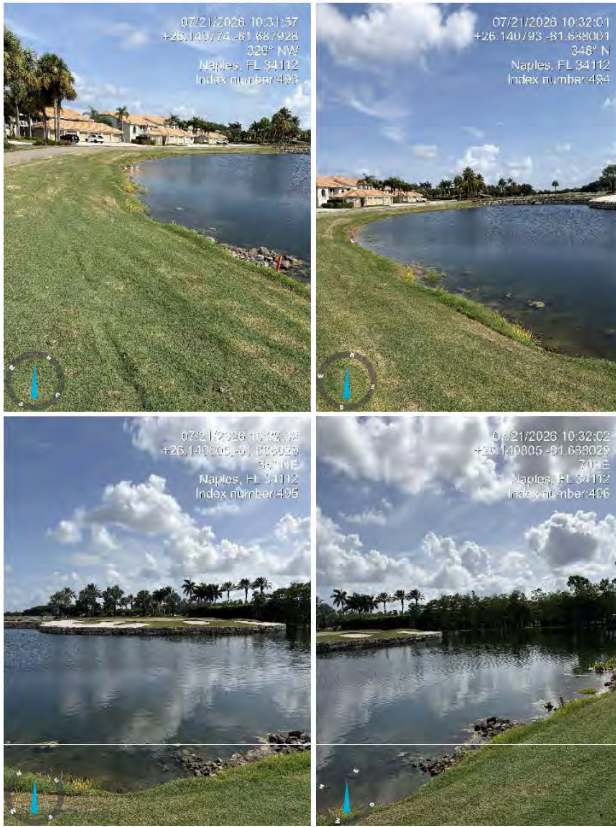
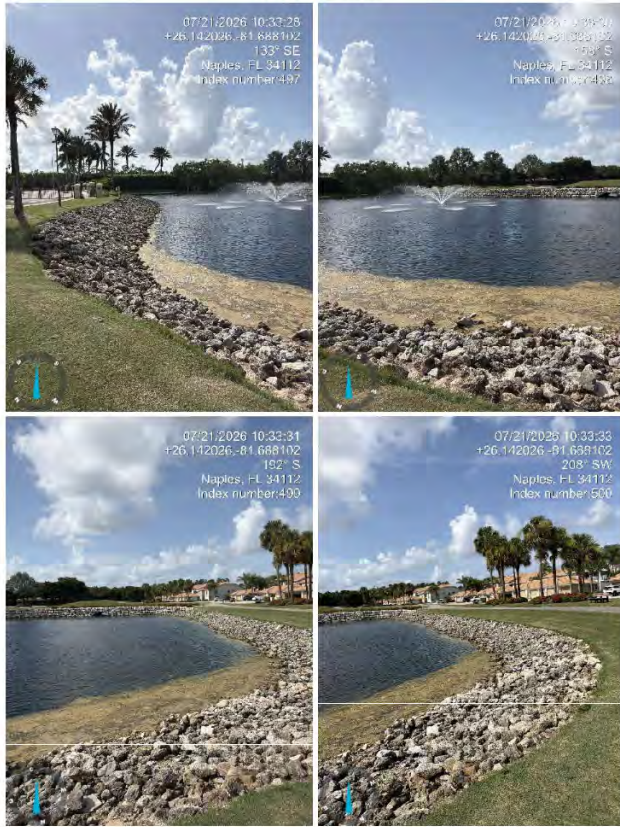
| Cedar Hammock CDD | | | INSPECTION DATE: August 7, 2026 | |
|---|---|---|---|---|
| Lake 15 | 3 | Lake L-5 | MAJOR EROSION | Photos: 478-489<br>479: rip-rap present. Slope degradation along villa side. |
