Chapter 1: Wenatchee High School Site Plan

Chapter 1: Wenatchee High School Floor Plan

Chapter 1: Wenatchee High School Systems Narrative: Architectural Report - ALSC Architects

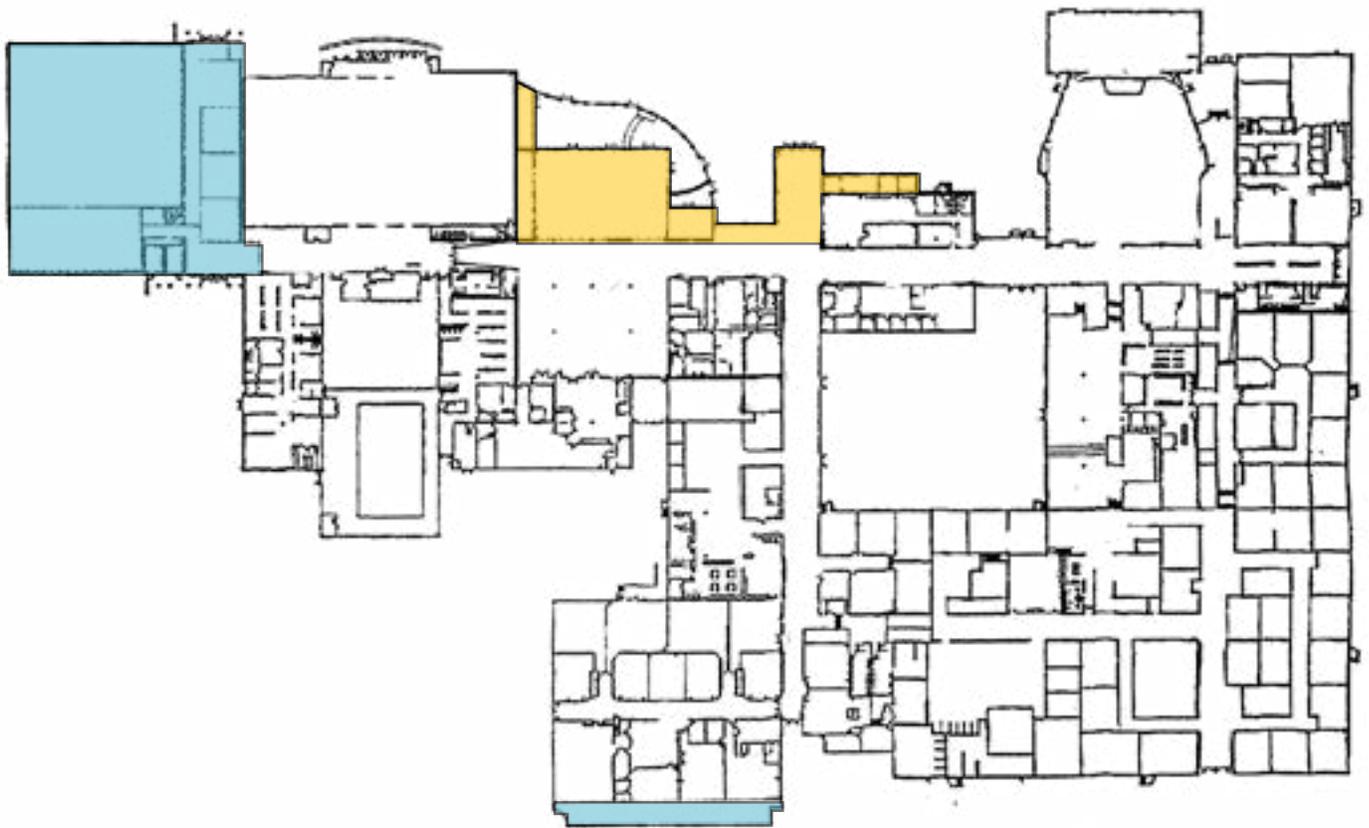
- 1972 original
- 1994 addition
- 2004 addition
- not to scale

Year	Sq. Ft.
1972	243,133
1994	26,135
2004	9,060
Grand Total	278,238
