AVALON GROVES COMMUNITY DEVELOPMENT DISTRICT

Advanced Meeting Package

Regular Meeting

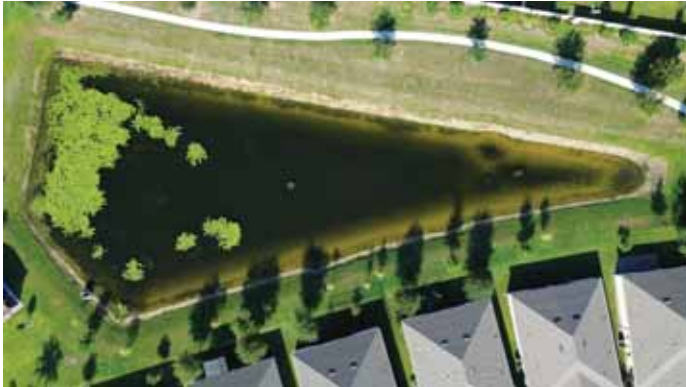
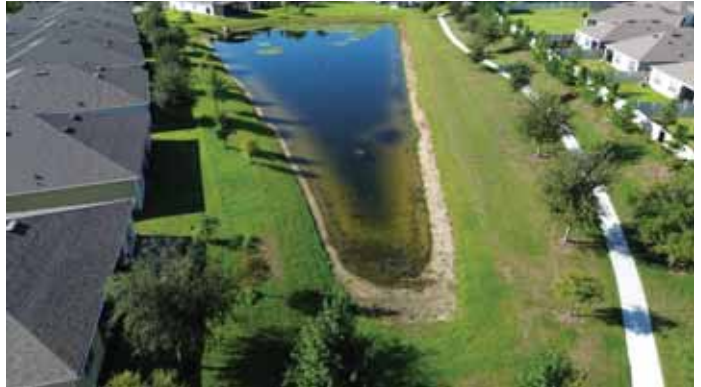
SITE: 2

Condition: Excellent Great ✓Good Poor Mixed Condition Improving

Mild submerged algae near the edge of the pond. The water in this section is shallow and much warmer, which feeds algal growth. Technicians will apply algaecide treatments during the next maintenance event. No nuisance grass growth aside from lilies.

<u>WATER:</u>	✗ Clear	Turbid	Tannic	
<u>ALGAE:</u>	N/A	✗ Subsurface Filamentous	Surface Filamentous	
		Planktonic	Cyanobacteria	
<u>GRASSES:</u>	✗ N/A	Minimal	Moderate	Substantial
<u>NUISANCE SPECIES OBSERVED:</u>				
	Torpedo Grass	Pennywort	Babytears	Chara
	Hydrilla	Slender Spikerush	Other: Water lilies

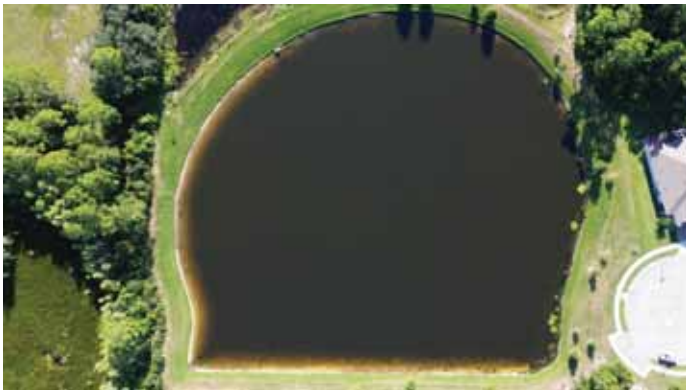
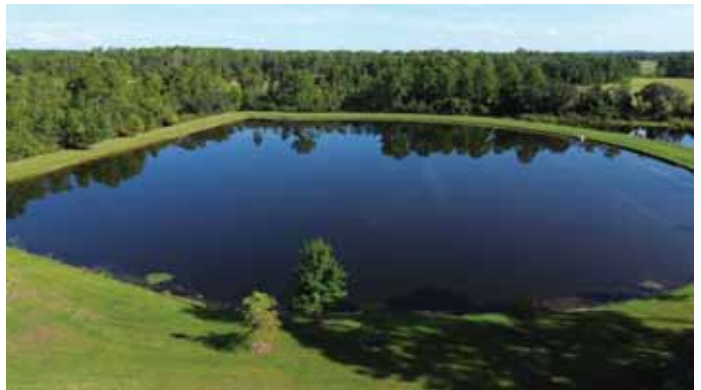
SITE: 3

Condition: Excellent ✓Great Good Poor Mixed Condition Improving

Mild patches of filamentous algae present on the perimeter. A quick treatment by a technician will begin to clear these areas. No nuisance grass growth observed.

<u>WATER:</u>	✗ Clear	Turbid	Tannic	
<u>ALGAE:</u>	N/A	✗ Subsurface Filamentous	✗ Surface Filamentous	
		Planktonic	Cyanobacteria	
<u>GRASSES:</u>	✗ N/A	Minimal	Moderate	Substantial
<u>NUISANCE SPECIES OBSERVED:</u>				
	Torpedo Grass	Pennywort	Babytears	Chara
	Hydrilla	Slender Spikerush	Other:

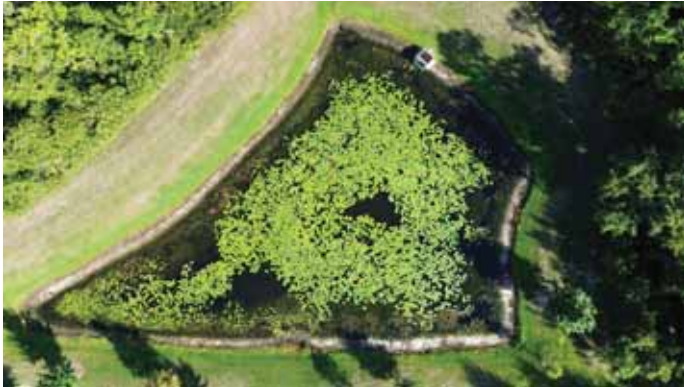
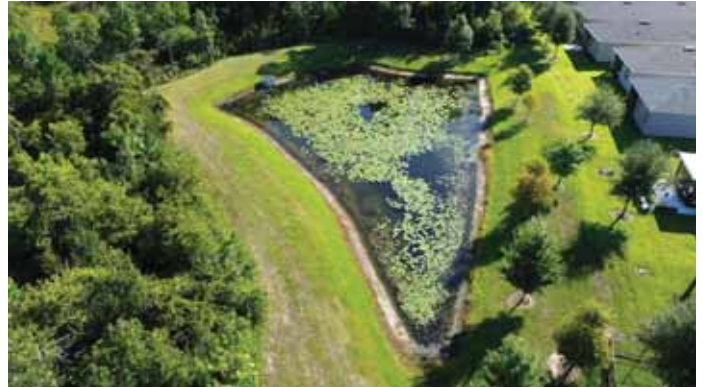
SITE: 4

Condition: Excellent Great Good ✓Poor Mixed Condition Improving

Filamentous algae, dense lily growth, and submerged vegetation are all present. Technicians have been regularly applying treatments for all of these during service visits. We are testing a new mix for growth like this and if its good results continue, a technician will employ it here.

<u>WATER:</u>	✗ Clear	Turbid	Tannic
<u>ALGAE:</u>	N/A	✗ Subsurface Filamentous	✗ Surface Filamentous
		Planktonic	Cyanobacteria
<u>GRASSES:</u>	N/A	✗ Minimal	Moderate
			Substantial
<u>NUISANCE SPECIES OBSERVED:</u>			
	Torpedo Grass	Pennywort	Babytears
✗ Hydrilla	Slender Spikerush	Other: Water lilies	Chara

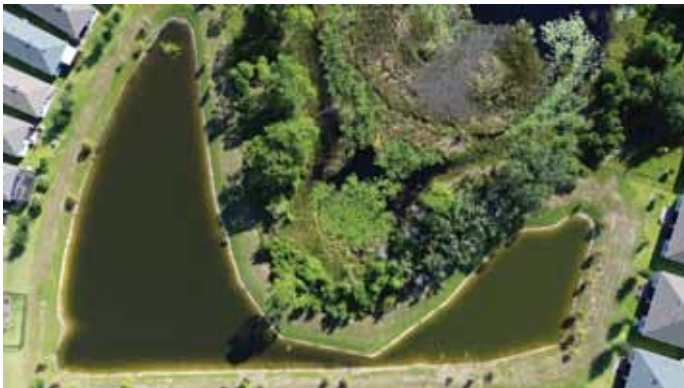
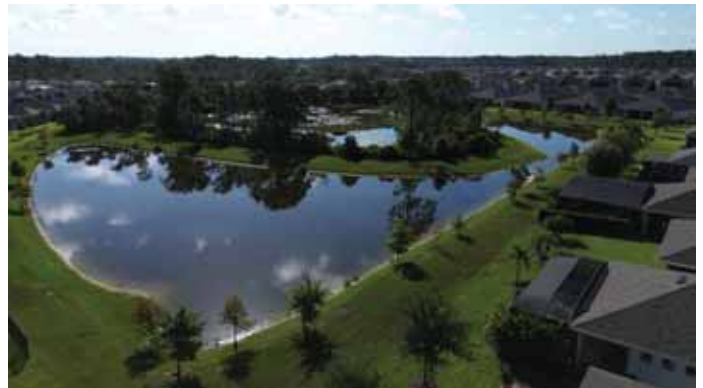
SITE: 5

Condition: ✓Excellent Great Good Poor Mixed Condition Improving

No algae or nuisance grass growth observed. Routine monitoring and treatments as needed will continue. It appears the two larger sections of this pond have recently re-joined together due to increased rain.

<u>WATER:</u>	✗ Clear	Turbid	Tannic
<u>ALGAE:</u>	✗ N/A	Subsurface Filamentous	Surface Filamentous
		Planktonic	Cyanobacteria
<u>GRASSES:</u>	✗ N/A	Minimal	Moderate
			Substantial
<u>NUISANCE SPECIES OBSERVED:</u>			
	Torpedo Grass	Pennywort	Babytears
	Hydrilla	Slender Spikerush	Other:
			Chara

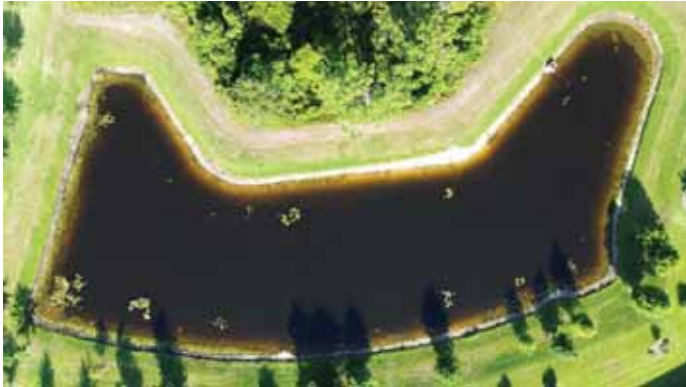
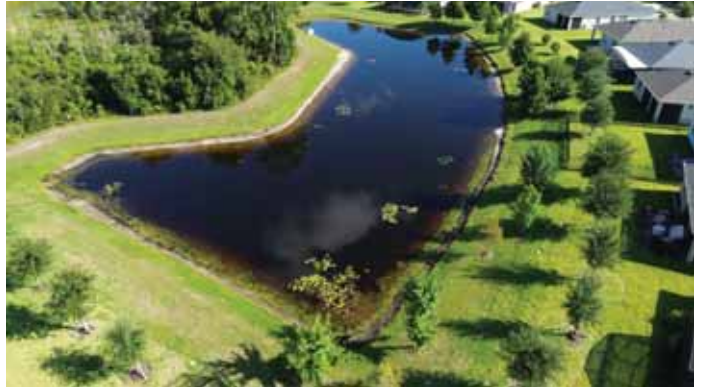
SITE: 6

Condition: Excellent Great ✓Good Poor Mixed Condition Improving

Sections of submerged vegetation and filamentous algae are present. Ongoing treatments for both have been occurring. The new mix can be used here as well.

<u>WATER:</u>	<input checked="" type="checkbox"/> Clear	Turbid	Tannic
<u>ALGAE:</u>	N/A	Subsurface Filamentous	<input checked="" type="checkbox"/> Surface Filamentous
		Planktonic	Cyanobacteria
<u>GRASSES:</u>	N/A	<input checked="" type="checkbox"/> Minimal	Moderate
			Substantial
<u>NUISANCE SPECIES OBSERVED:</u>			
Torpedo Grass	Pennywort	Babytears	Chara
Hydrilla	<input checked="" type="checkbox"/> Slender Spikerush	Other:

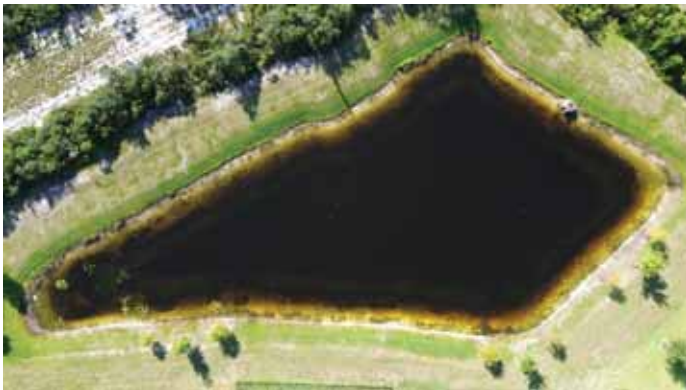
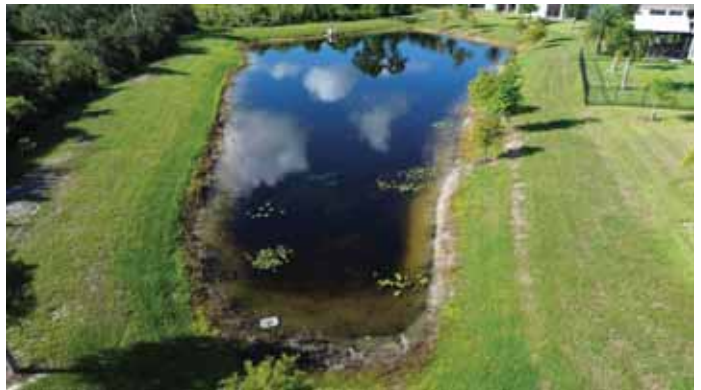
SITE: 7

Condition: Excellent ✓Great Good Poor Mixed Condition Improving

Submerged filamentous algae is present. It appears to be contained to a deeper, colder section of the pond. Some species of algae behave this way and will likely not creep toward the shore or surface. Technicians have access to algaecides that will combat this type of growth.
No nuisance grass growth observed.

<u>WATER:</u>	<input checked="" type="checkbox"/> Clear	Turbid	Tannic
<u>ALGAE:</u>	N/A	<input checked="" type="checkbox"/> Subsurface Filamentous	Surface Filamentous
		Planktonic	Cyanobacteria
<u>GRASSES:</u>	<input checked="" type="checkbox"/> N/A	Minimal	Moderate
			Substantial
<u>NUISANCE SPECIES OBSERVED:</u>			
Torpedo Grass	Pennywort	Babytears	Chara
Hydrilla	Slender Spikerush	Other:

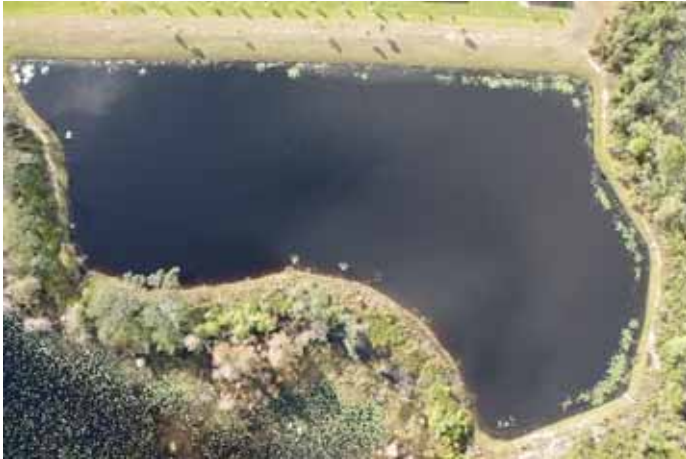
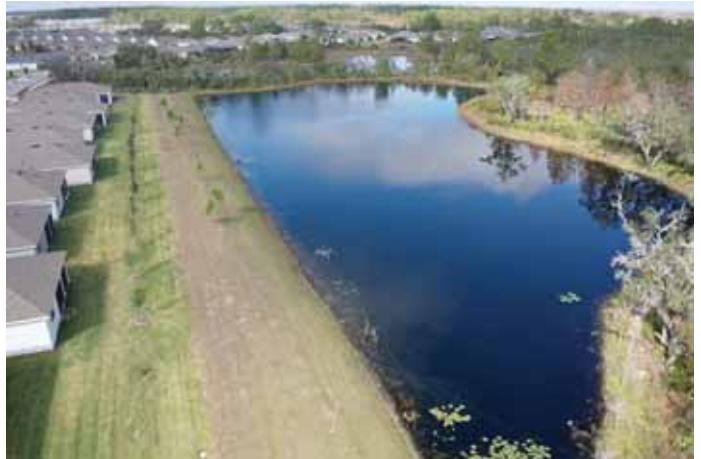
SITE: 8

Condition: Excellent Great ✓Good Poor Mixed Condition Improving

One small section of planktonic algae. This will be addressed next visit to prevent further growth.

No nuisance grass growth observed besides lilies.

<u>WATER:</u>	<input checked="" type="checkbox"/> Clear	<input type="checkbox"/> Turbid	<input type="checkbox"/> Tannic
<u>ALGAE:</u>	<input type="checkbox"/> N/A	<input type="checkbox"/> Subsurface Filamentous	<input type="checkbox"/> Surface Filamentous
		<input checked="" type="checkbox"/> Planktonic	<input type="checkbox"/> Cyanobacteria
<u>GRASSES:</u>	<input checked="" type="checkbox"/> N/A	<input type="checkbox"/> Minimal	<input type="checkbox"/> Moderate
			<input type="checkbox"/> Substantial
<u>NUISANCE SPECIES OBSERVED:</u>			
	Torpedo Grass	Pennywort	Babytears
	Hydrilla	Slender Spikerush	Other: Water lilies

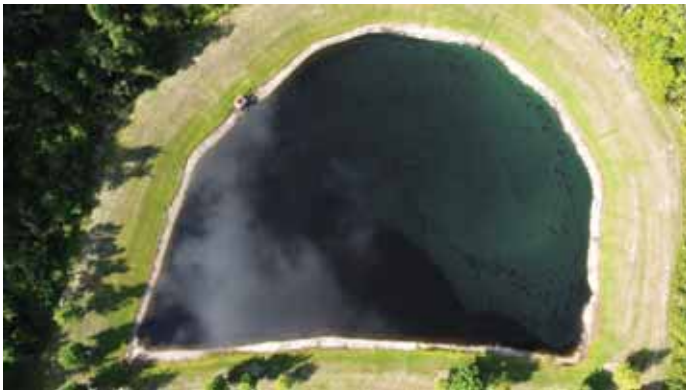
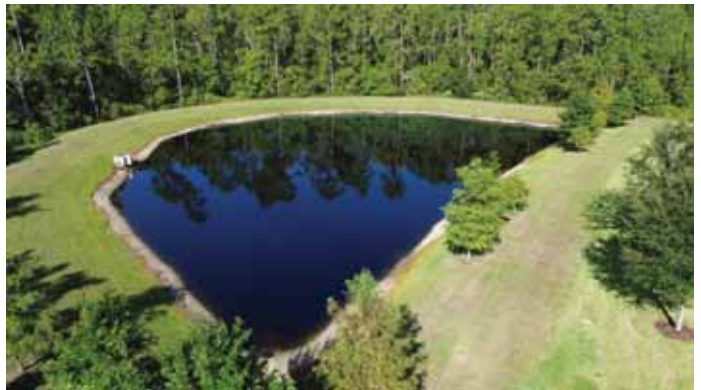
SITE: 9

Condition: Excellent Great Good Poor ✓Mixed Condition Improving

The only nuisance growth present is a planktonic algae bloom. A nearby pond is set for treatment for the same issue, so this one will be included as well.

<u>WATER:</u>	<input checked="" type="checkbox"/> Clear	<input type="checkbox"/> Turbid	<input type="checkbox"/> Tannic
<u>ALGAE:</u>	<input type="checkbox"/> N/A	<input type="checkbox"/> Subsurface Filamentous	<input type="checkbox"/> Surface Filamentous
		<input checked="" type="checkbox"/> Planktonic	<input checked="" type="checkbox"/> Cyanobacteria
<u>GRASSES:</u>	<input checked="" type="checkbox"/> N/A	<input type="checkbox"/> Minimal	<input type="checkbox"/> Moderate
			<input type="checkbox"/> Substantial
<u>NUISANCE SPECIES OBSERVED:</u>			
	Torpedo Grass	Pennywort	Babytears
	Hydrilla	Slender Spikerush	Other:

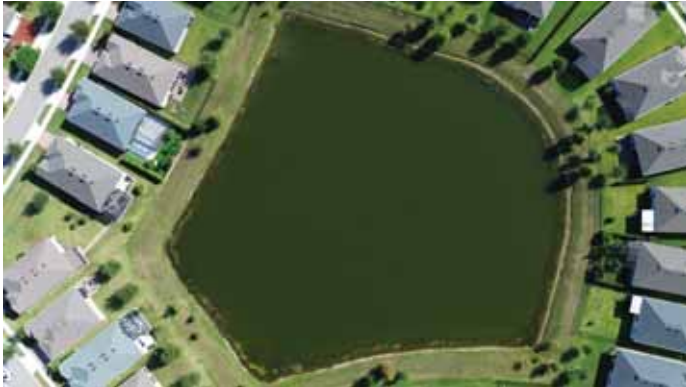
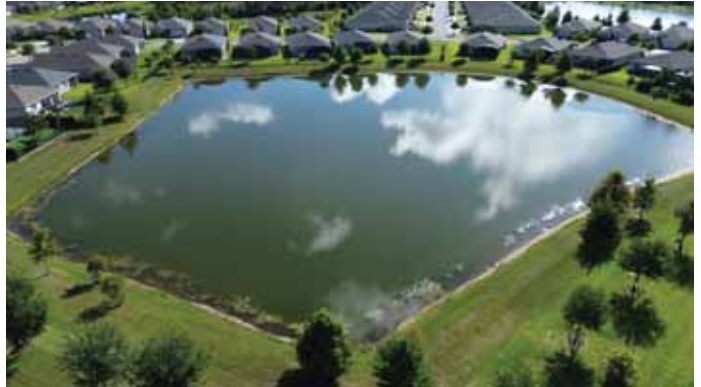
SITE: 10

Condition: Excellent Great ✓Good Poor ✓Mixed Condition Improving

Early signs of a planktonic algae bloom present. As with other ponds listed above, this one will be treated.

<u>WATER:</u>	<input checked="" type="checkbox"/> Clear	Turbid	Tannic
<u>ALGAE:</u>	N/A	Subsurface Filamentous	Surface Filamentous
		<input checked="" type="checkbox"/> Planktonic	Cyanobacteria
<u>GRASSES:</u>	N/A	<input checked="" type="checkbox"/> Minimal	Moderate
			Substantial
<u>NUISANCE SPECIES OBSERVED:</u>			
	Torpedo Grass	Pennywort	Babytears
<input checked="" type="checkbox"/> Hydrilla	Slender Spikerush	Other:	Chara

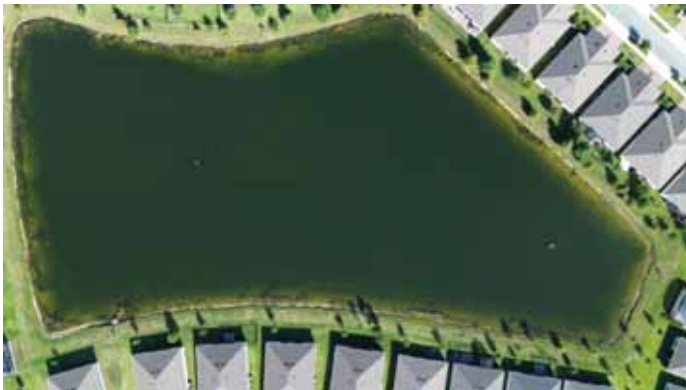
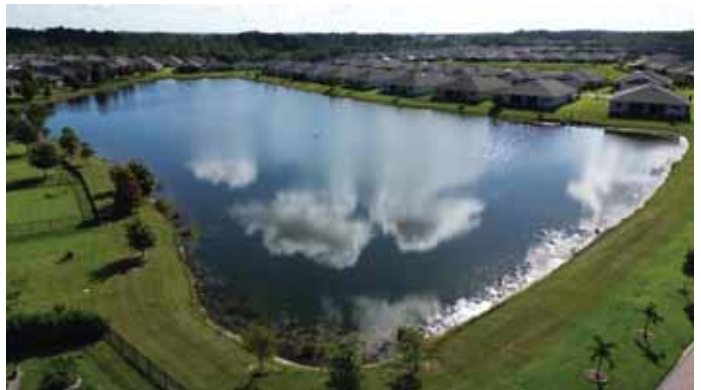
SITE: 11

Condition: Excellent Great ✓Good Poor Mixed Condition Improving

Algae is clinging to shoreline grasses. This will actually make it easier to treat both simultaneously and begin clearing growth. A technician will do this treatment next visit.

<u>WATER:</u>	<input checked="" type="checkbox"/> Clear	Turbid	Tannic
<u>ALGAE:</u>	N/A	<input checked="" type="checkbox"/> Subsurface Filamentous	Surface Filamentous
		Planktonic	Cyanobacteria
<u>GRASSES:</u>	N/A	<input checked="" type="checkbox"/> Minimal	Moderate
			Substantial
<u>NUISANCE SPECIES OBSERVED:</u>			
	Torpedo Grass	Pennywort	Babytears
Hydrilla	Slender Spikerush	Other:	Chara

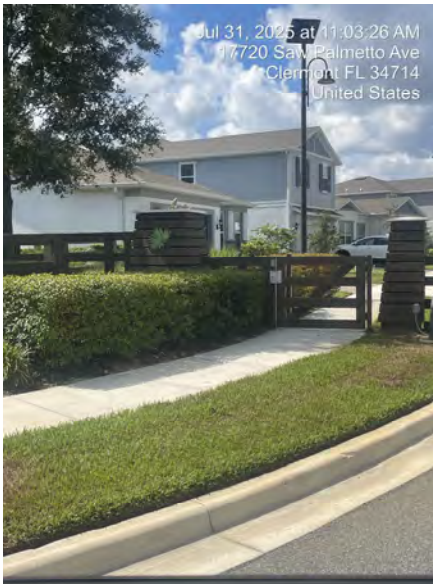
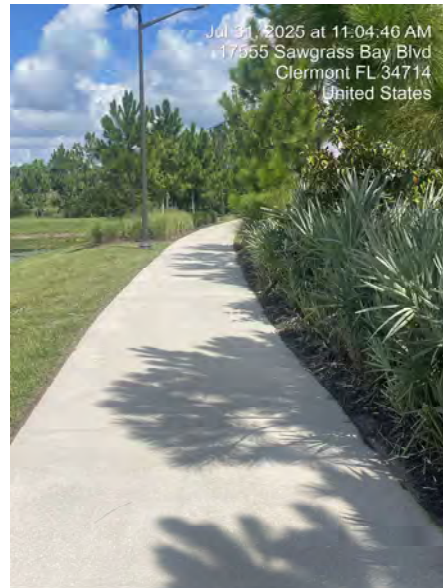
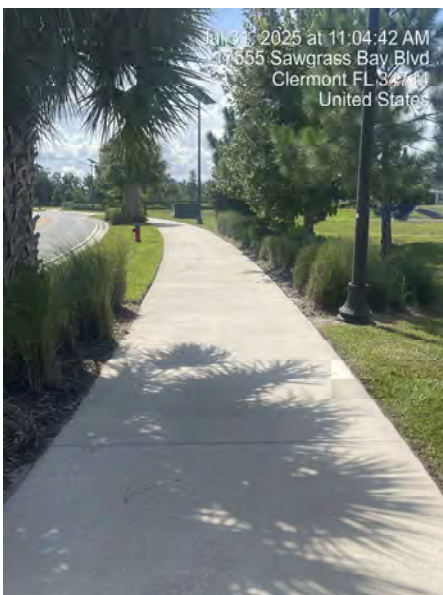
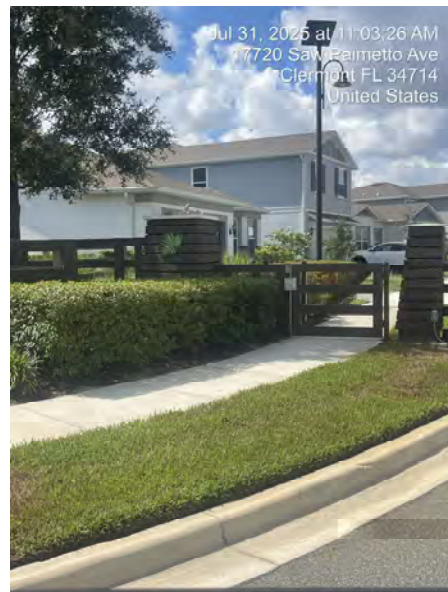
- 7/21 Mow, string trimmed, hard edged all areas. Began cut back to all sidewalk and curblines along Sawgrass blvd beginning at Village 3. Daily litter patrol along Sawgrass Blvd to include advertising signage removal. Irrigation proposal #124316 completed 7/31 replacing the decoders in median near Sanctuary Dr.

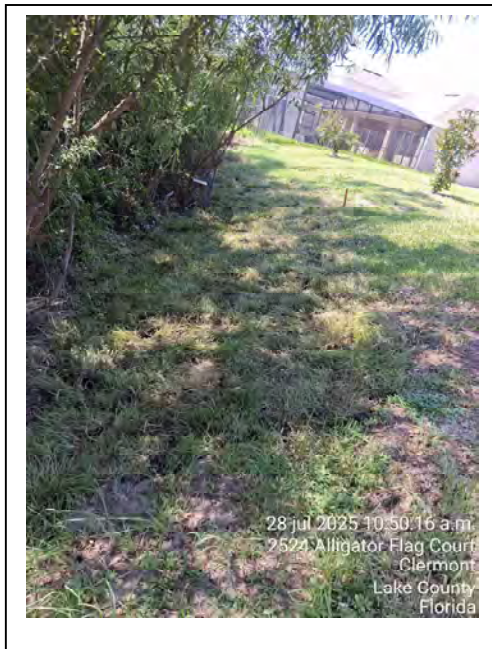
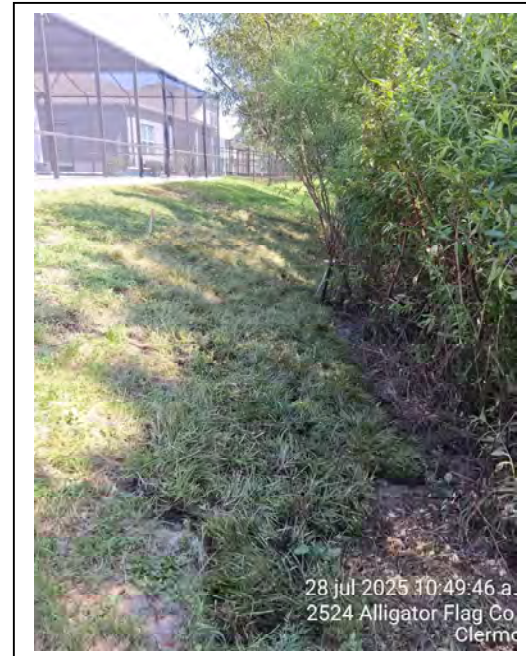
- 7/28 Mow, string trimmed, hard edged all areas. Continued cut back to all sidewalk and curblines along Sawgrass blvd beginning at Village 3. Daily litter patrol along Sawgrass Blvd to include advertising signage removal. Alligator sod repair complete with cut backs done caused by pool installation.

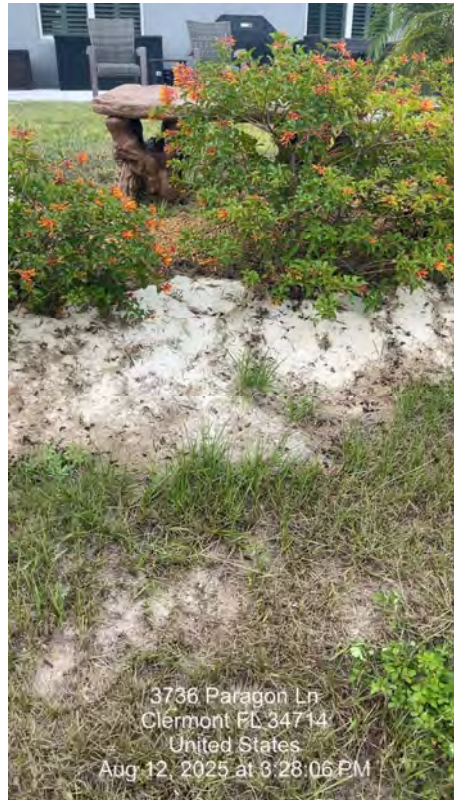
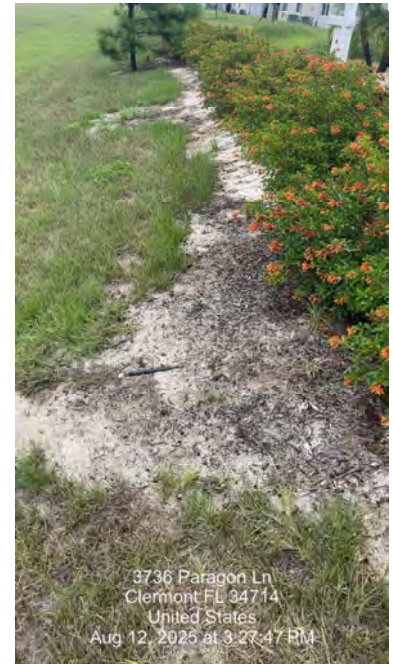
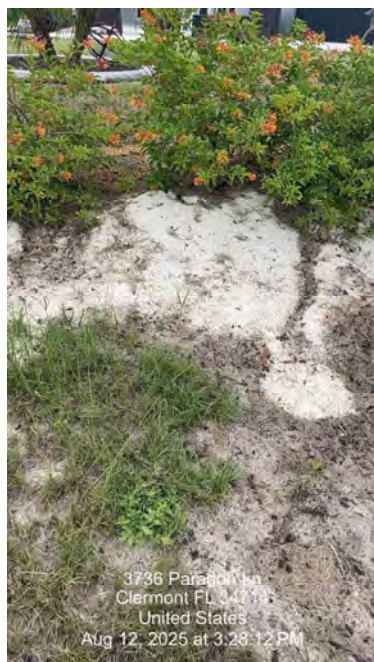
Trees were removed along the Edgemont bed line and rock installed on to CDD beds.

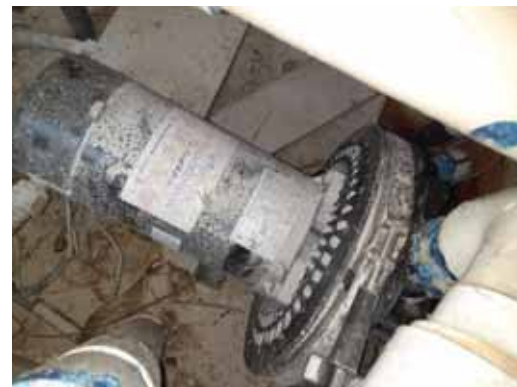
ID: 011

Item Description:
Pool pump

Notes:
Good condition

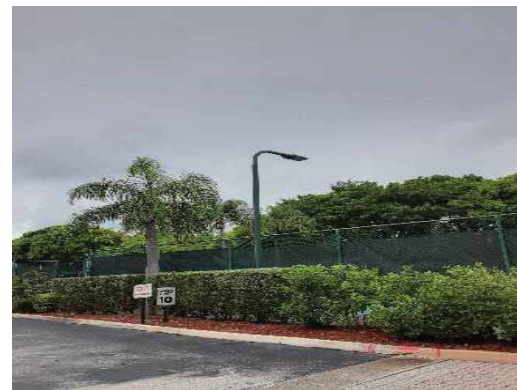
ID: 038

Item Description:
Tennis court lights

Note:
Rust has begun to set in on this lighting system and reaching the end of its useful life.

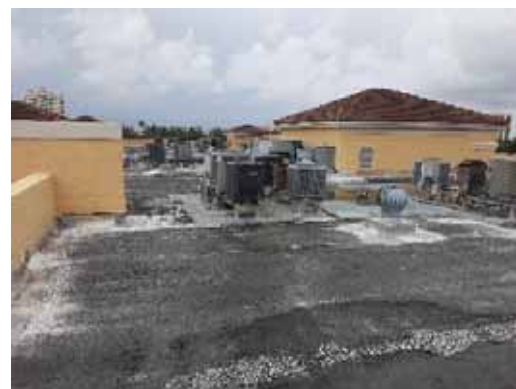
ID: 039

Item Description:
Flat roof on each building

Note:
Flat roofs tend to hold water and require more attention than sloped roofs

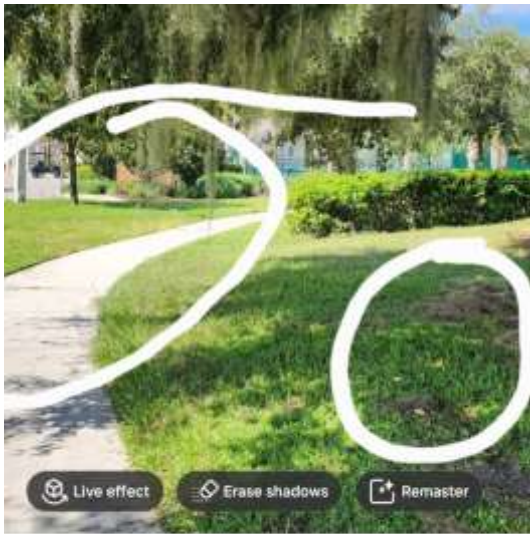
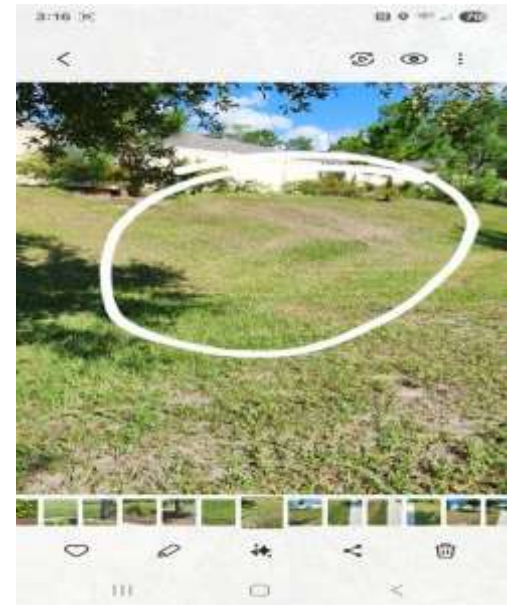
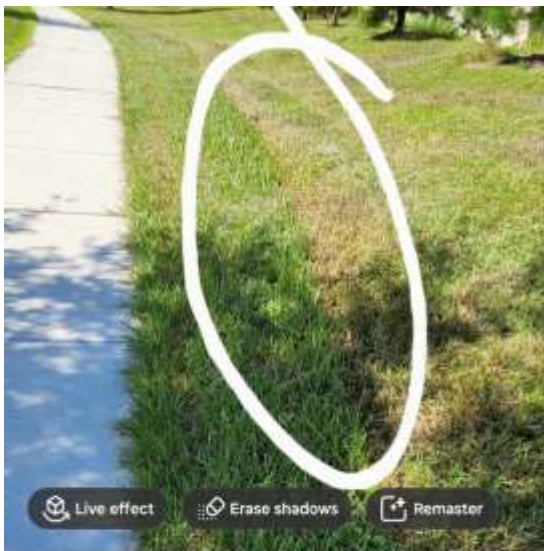
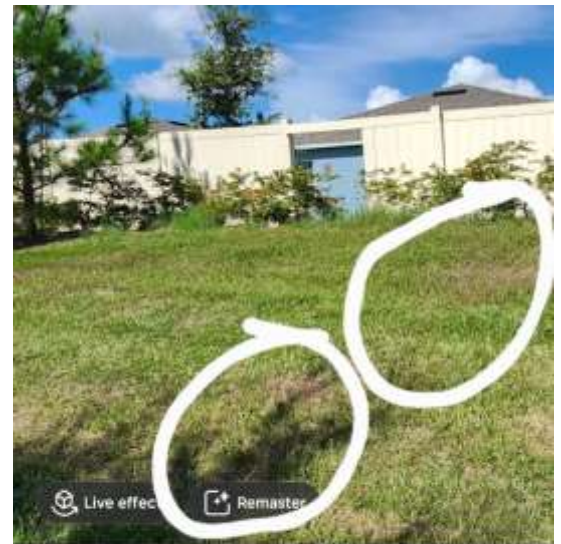
1. Mowing job is getting sloppy in and around PAS Clubhouse. Missed mowed spots, several grass clumps and low cutting. See pics.
2. Mowing is not being done on a weekly basis around the back area of residential homes (PAS), including other villages.
