# **Heritage Isle at Viera Community Development District**

**Board of Supervisors  
Meeting  
January 27, 2026**

## SIDEWALK TRIP HAZARD REMOVAL

Price Proposal

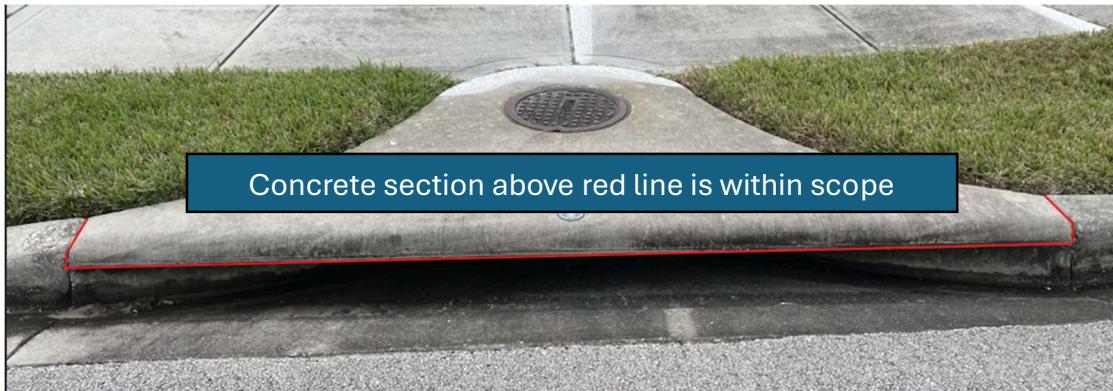
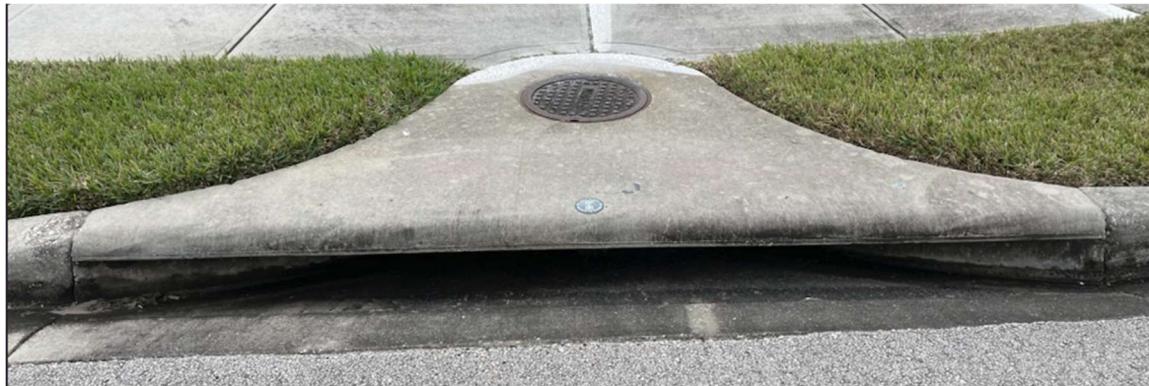
**Scope:** Rolling Suds will pressure wash the manhole covers and surrounding concrete pads of all storm drains identified within the attached *Heritage Isle at Viera CDD – Landscape, Sidewalk and Hardscape Facilities Map*. “Surrounding concrete surface” is defined as the concrete area outlined in red in the reference photo below.

Our survey identified approximately 280 storm drains within the project area. Each drain includes roughly 60 square feet of concrete surface, totaling 16,800 square feet of additional cleaning area ( $280 \times 60 = 16,800$ ).

During inspection, we noted significant black organic growth on the drain covers and adjacent concrete. This material requires chemical pre-treatment, a sufficient dwell period for the product to break down the organic buildup, and a full manual rinse using a pressure-washing wand. Because these drains discharge directly to stormwater systems and nearby waterways, the work must be performed using biodegradable, environmentally safe cleaning agents, which require a longer dwell time to achieve effective results.

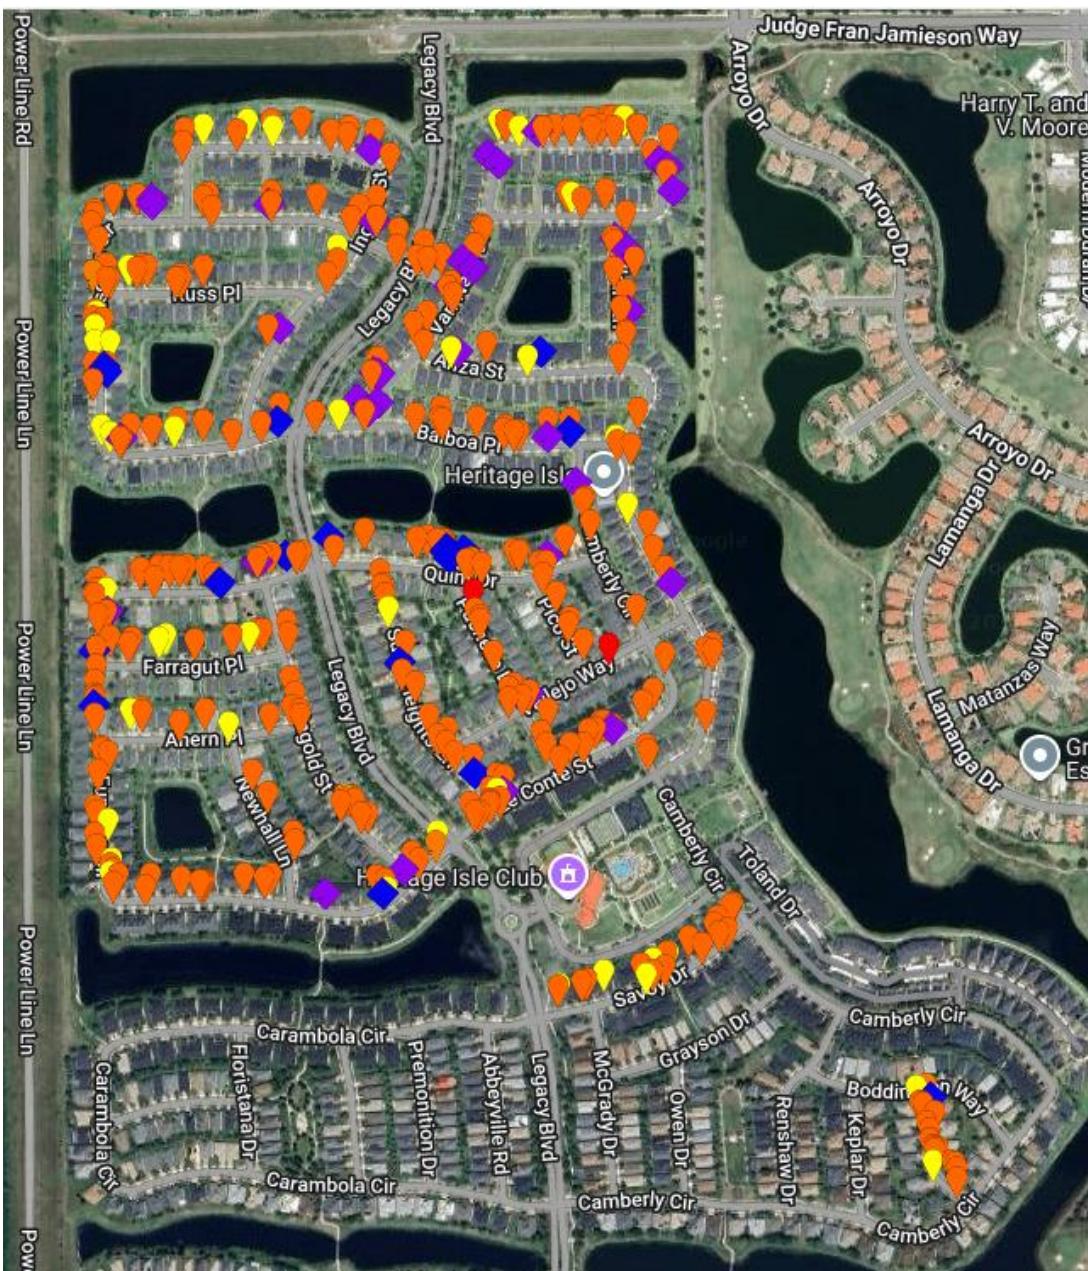
**Site Review Area – Hazards Identified on Reviewed Sidewalks at Heritage Isle CDD as Detailed in the "Site Review Summary"**

The map in this proposal shows the approximate locations of trip hazards included in the scope of this proposal. The accuracy of this map is dependent on the technology available on smart phones and should be relied upon as approximations only. The **Blue Diamond** designates hazards previously repaired utilizing a grinder that still have a change in level meeting the height specification; these locations must be repaired once again by PSSC in order to completely remove the hazard and provide the proper slope. The **Purple Diamond** designates hazards up to  $\frac{1}{2}$ " in height on concrete surrounding storm drains intruding into the sidewalk right of way.

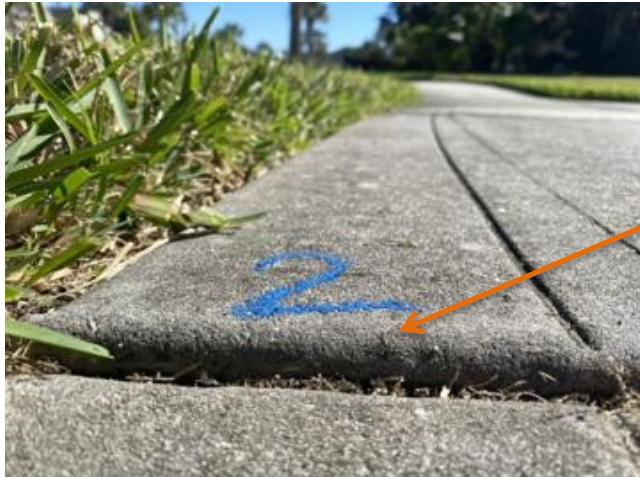
**Figure 1**

Example of a  $\frac{1}{8}$ " high "Least Severe" hazard on Ringold St. These are often the hazards that people catch their toe on, as they do not notice them. This hazard is in the sample area marked for the community; it is marked "2" representing the height of the hazard in eighths of an inch.

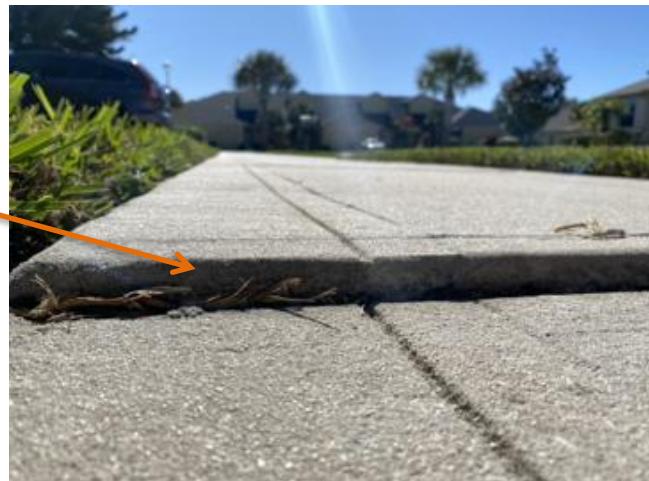
**Figure 2**

Example of a  $\frac{3}{4}$ " high "Severe" hazard in the reviewed areas on Pico St.

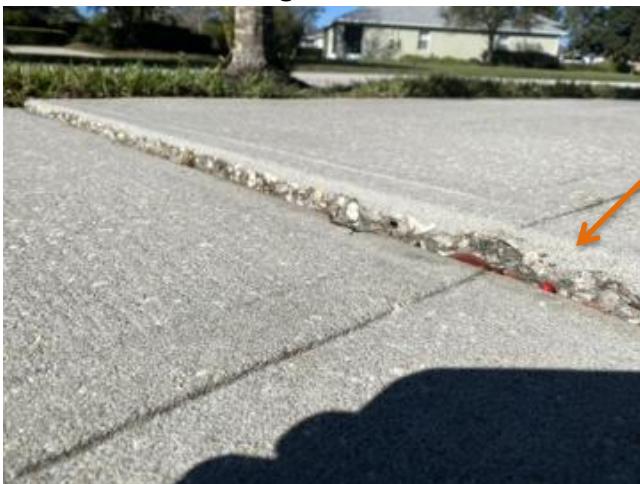
**Figure 3**

Example of a 1 ¼" high "Most Severe" hazard on Pacheco Lane.

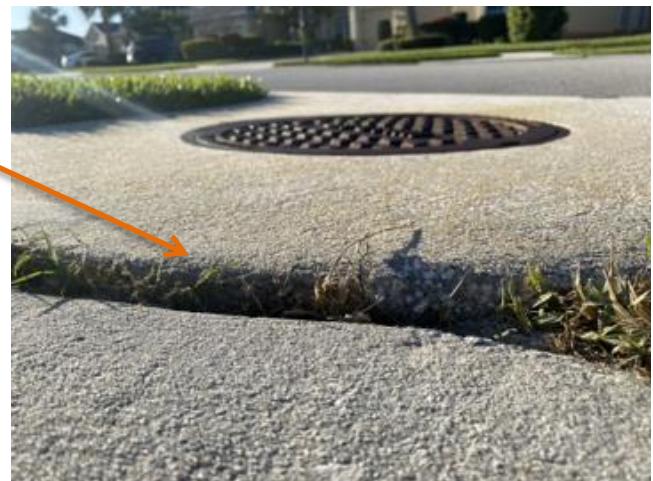
**Figure 4**

Example of a ½" high "Severe" hazard on Le Conte St created by the concrete surrounding a storm drain intruding into the sidewalk right of way. As directed by the community, hazards on concrete surrounding storm drains up to ½" in height are **included** in this proposal.

During the course of our review, PSSC identified hazards created by raised concrete surrounding storm drains directly intruding into the flow of pedestrian foot traffic on the sidewalks in the reviewed area. Concrete forms around storm drains have a compressive strength significantly higher than sidewalk concrete and are constructed with reinforcing bar (rebar) to provide added strength. Therefore, PSSC does not repair hazards above 1/2" in height on concrete surrounding storm drains, and any such locations are **excluded** from this proposal. The community requested that PSSC make repairs to hazards on concrete surrounding storm drains if possible, so repairs to these types of hazards up to 1/2" in height are **included** (see Figure 4 in Photo Examples below).

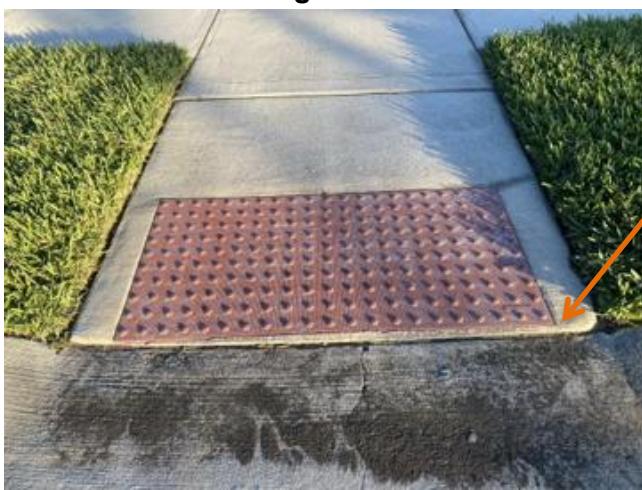
**Figure 5**

An example of a hazard on the concrete panels underneath the ADA-detectable warning mat. Hazards like this are **excluded** from this proposal.

There is at least one location where a hazard was observed on panels that have ADA detectable warning mats at crosswalks (see Figure 5). As discussed with Mr. Mendes, the removal of any hazards under the detectable warning mats themselves is **excluded** from this proposal. If there is a hazard on the panel that is not under the mat and therefore accessible, it is **included** for repair.

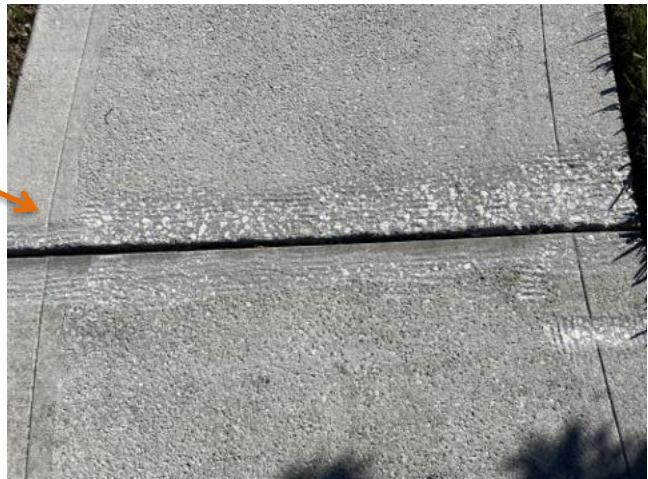
**Figure 6**

Example of a “Severe” hazard on Quint Dr previously ‘flattened’ a bit by a grinder. The grind method is not ideal for sidewalk repair since it does not result in an accurate slope or remove the hazard completely from end to end. The grinder also did significant, unnecessary damage to the adjacent panel. This location and others like it in the reviewed areas are **included** for repair by PSSC to remove remaining portions of the hazard and provide proper slope.

During our review, PSSC observed hazards where a grinder was used to attempt a repair at Heritage Isle CDD (see Figure 6). Locations that still have a change in level are **included** in this proposal since they will need to be repaired again by PSSC in order to remove the remaining portions of the hazard and provide the proper ADA-compliant slope. To meet slope requirements for each repair, PSSC must take into account both the past measurements of the concrete that has been removed and the new amount that must be removed in order to eliminate the hazard.

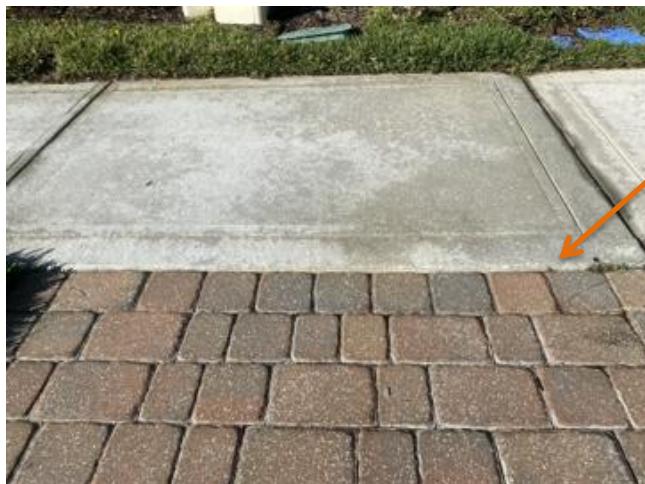
**Figure 7**

Example of a  $\frac{1}{2}$ ” high “Severe” hazard on Savoy Dr. This hazard is on the concrete adjacent to a brick paver walkway and is **included** in this proposal for consideration. If the community decides not to have PSSC make this type of repair, this location will be left as is and the community will not be charged for this repair.

Brick pavers laid in sand often sink or move over time, which can create a trip hazard on adjacent concrete. At Heritage Isle CDD, this situation exists where sidewalks abut a brick paver walkway (see Figure 7). PSSC recommends that the pavers be repositioned, which prevents a permanent repair being made to the concrete. In addition, even after the concrete repair is completed to remove the change in level, the pavers will likely continue to shift, sink, or move. However, in the case of Heritage Isle, the CDD is responsible for the sidewalks. One hazards adjacent to ungrouted bricks was observed at the time of the review, and Mr. Mendes directed PSSC to **include** this type of hazard in order to eliminate the change in level that exists at this time as an option for the Board to consider.

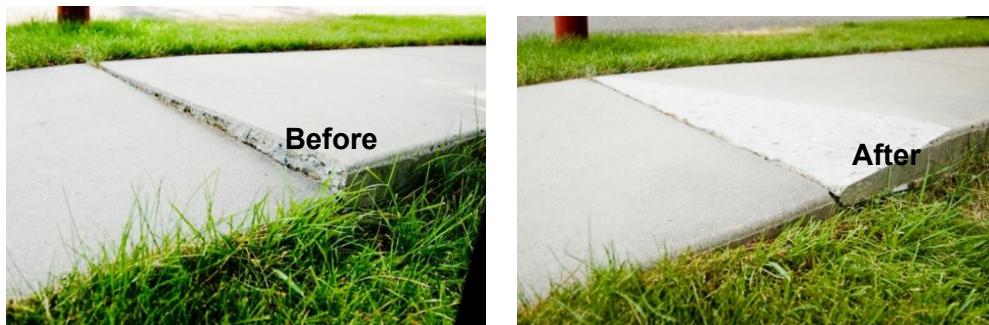
**Figure 8: Precision Sidewalk Safety Work Example**

Precision Sidewalk Safety estimates that the work can be completed in 3 - 5 days, with the note that wet weather will delay our operations. We will re-route pedestrian traffic on small sections of sidewalk (10'-15') for periods that range from 3 minutes to 20 minutes while those sections are being repaired. **No assistance will be required from the District; however, we do require that a representative of Heritage Isle CDD review and accept the work (or request adjustments) prior to the crew's estimated departure.** While the sidewalk restoration project is underway, we will:

- keep the sidewalks in service
- require no heavy equipment or traffic control
- remove all debris and recycle the concrete waste materials
- leave the proposed areas clean and trip hazard-free

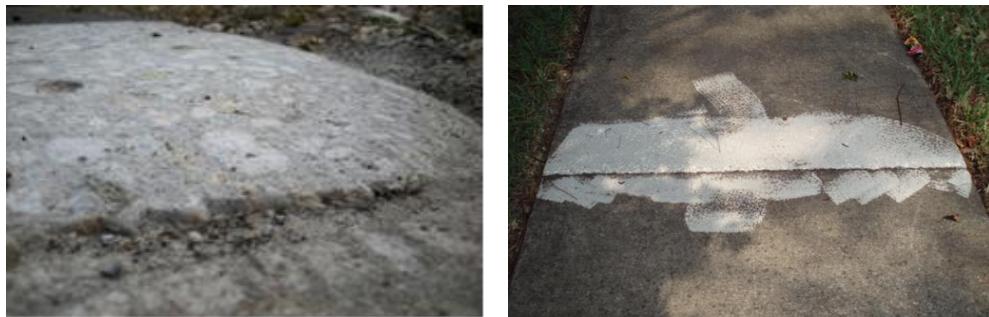
**Figure 9: Typical Results from a Grinder**

In addition, grinding causes considerable dust and mess. If the dust is managed with water, the property risks slurry and runoff into storm drains or local water. In most cases, grinding cannot be compared to the Precision method since grinding cannot achieve like results. Still, in a comparison of the same number and size hazards, Precision Sidewalk Safety is comparable in cost. Figure 9 shows results from a typical grind.
