Waterchase Community Development District

March 9, 2026

Agenda Package

Field Inspection Report - February 2026

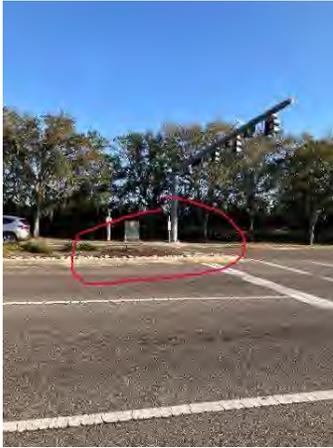
- Beds are empty. Replacement was approved with the POA schedule at the end of March.
- There are weeds here that need to be pulled or line trimmed and sprayed, please.

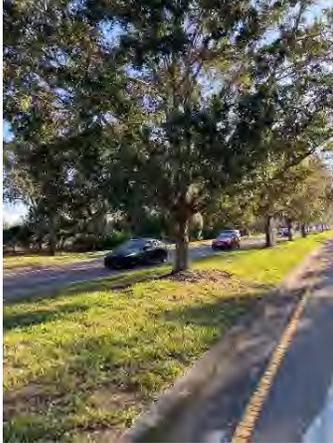
- Turf is unpleasant. Part due to drought, part due to weather conditions, and part due to the fact that it is much the part weeds. This has been mentioned many times. The only real solution would be to re-sod.

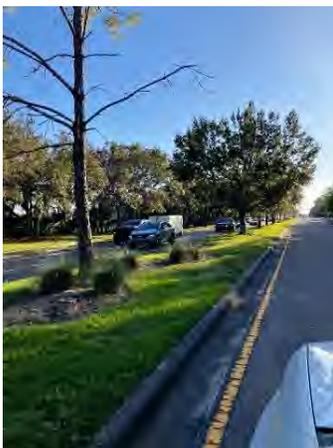
- Grass are starting to come back. Look good!!

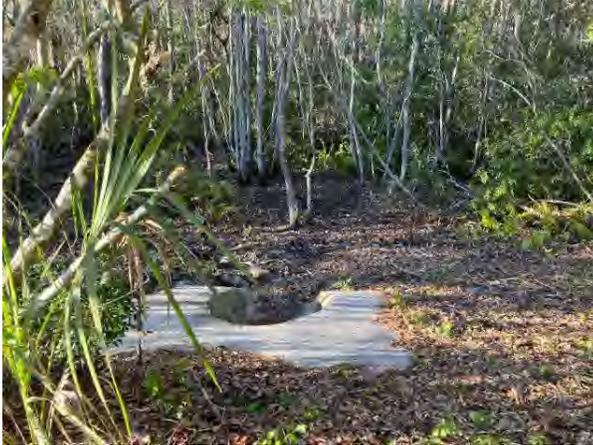
- Culverts are clean. Nice job.

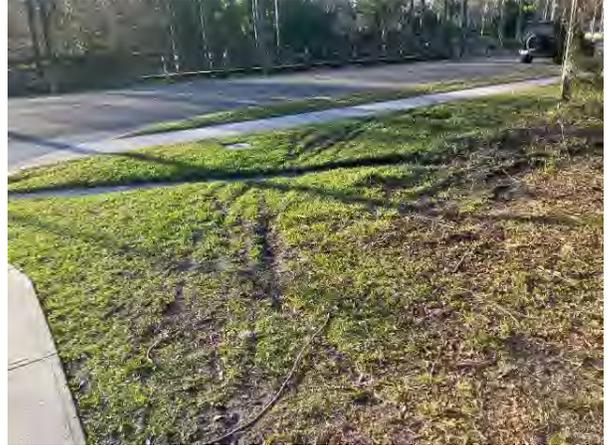
- Area still seems to be damp despite almost no rain.

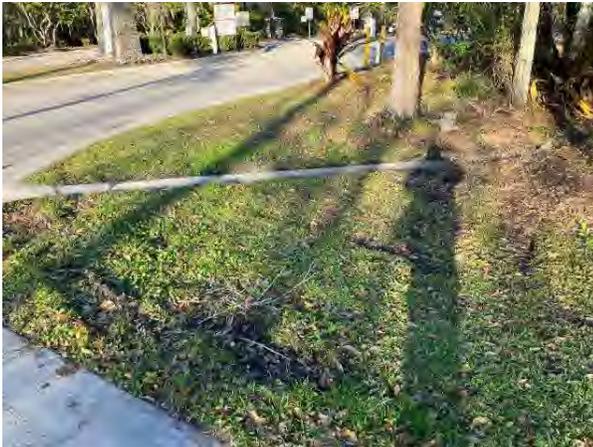
- Damp area

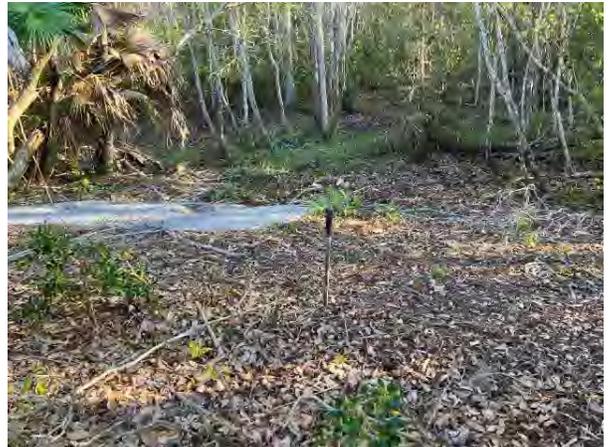
- East culvert also is clear.

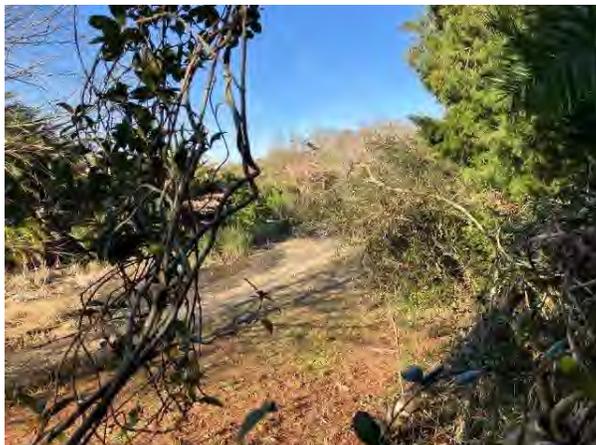
• Pond 7 - Please remember that we are only to cut the side of the retention pond on the East by the fence. The other side is now the homeowner's responsibility. If there are any questions please refer them to call John Weaver.

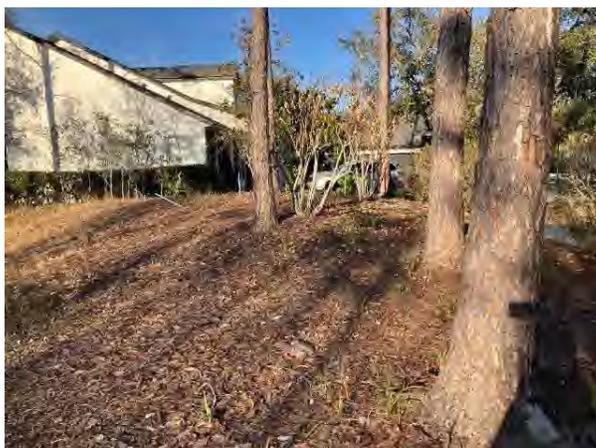
• End of San Chaliford street. Looks clean. The Jatropha and Azeleas are coming back nicely. Please remove anything that proves to not have survived in 2-3 weeks once the plants have had a chance to regenerate.
• PLEASE DO NOT ALLOW THE FAKAHATCHEE GRASSES to come back here. Brandon did a really good job of removing it, and I would hate to see all of that work go bad.

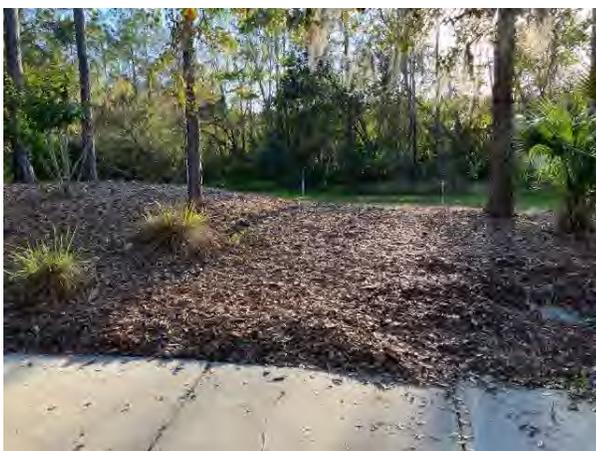
- Very few weeds on berm area. Please just keep up with herbicide applications.

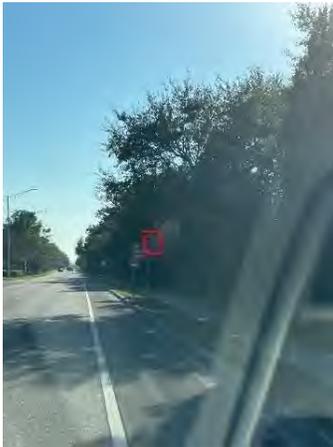
- The photo is difficult to see, but there is a tree branch that is partially blocking this sign on RTR.

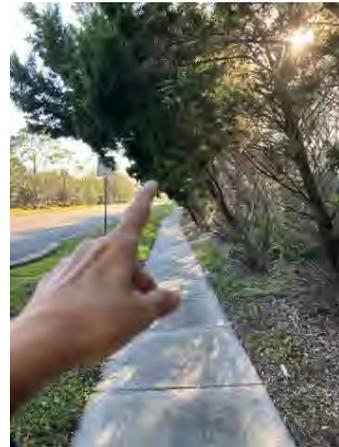
- Some of these Cedar trees are starting to encroach on the sidewalk at RTR. Could you please take the power polesaw and trim up to 10' so that someone doesn't get hit in the face. Thank you!

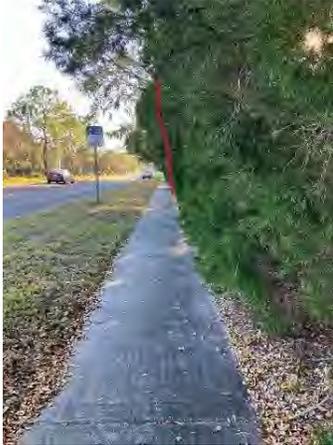
- This is on RTR and is just a different shot of the Cedars encroaching on the sidewalk. Please trim just as high as 10'.

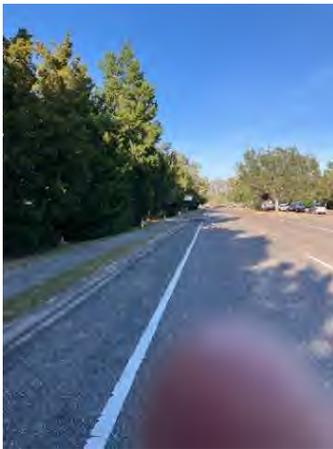
- Clearance for sidewalk on RTR is good.

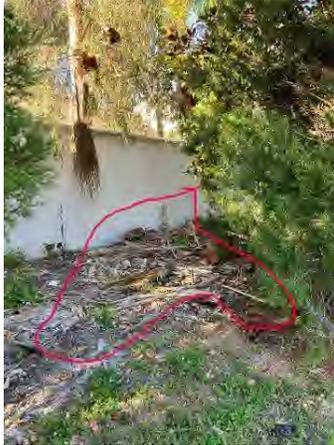
- Race Track Rd. has A LOT of debris that seems to A. be falling from the Palms behind the wall and B. Looks like the homeowners are possibly throwing it over instead of taking it to the street. I am sorry for this, but could you please pick it up?

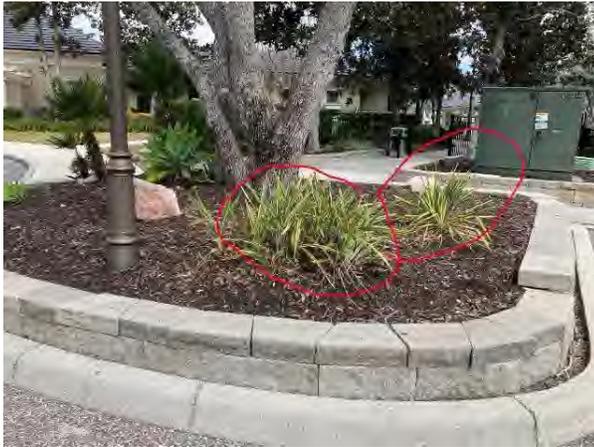
- These random Flax Lily will be removed as well as the same ornamental grass that is in the fountain area.

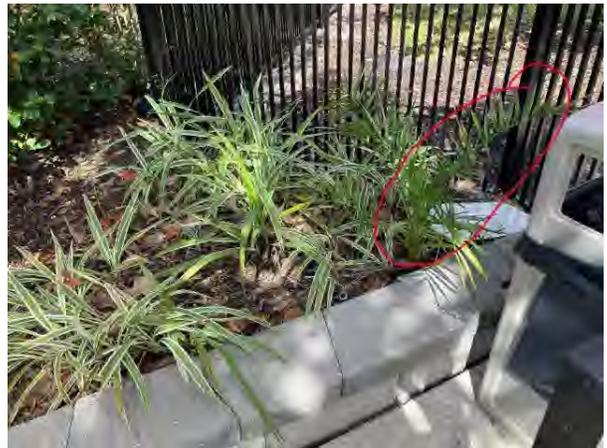
- There is a Palm volunteering it's services here in the Flax bed. Please remove it. It is over by the entry to the children's playground.

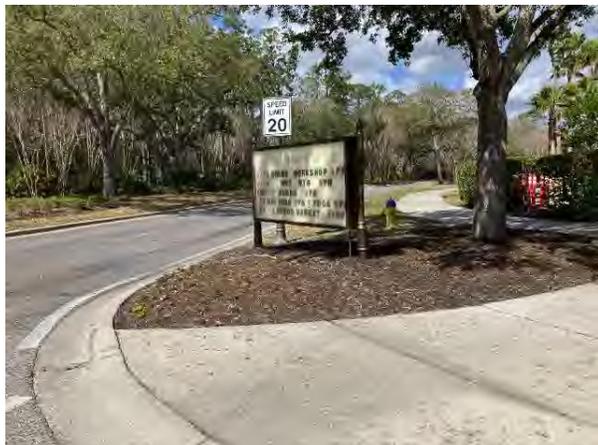
- I don't know exactly at this point what is going on with some beds of annuals. Some look good and some stink. This one stinks. This one I blame on irrigation. Herminia, please pull what is left that hasn't already degraded itself. I'd rather see nothing.

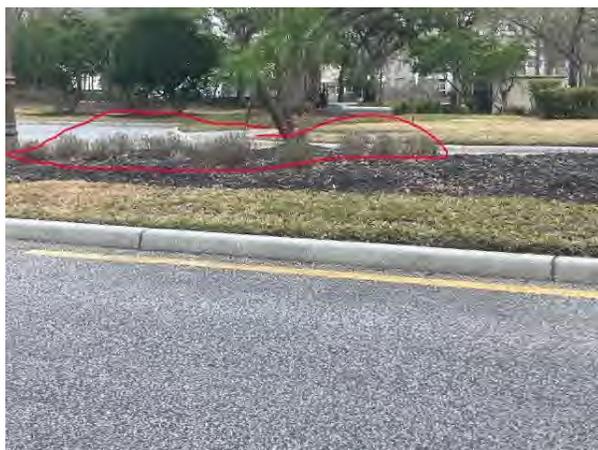
- These Blue Daze will be cut to 1" and allowed to flush back out on 2.25.26. For future reference, as much as I like Blue Daze and everyone went wildfire over it 3 years ago when it got planted EVERYWHERE and the price went up exponentially, it does not do amazing in most instances (in my experience.) I am not saying that it cannot do well. I have a property (MY PERSONAL HOUSE) that it does great with no attention. However, most of my experience is that every few months it becomes Grey Daze. It can generally rejuvenate with a hard cutback, but it is a difficult plant to upkeep.

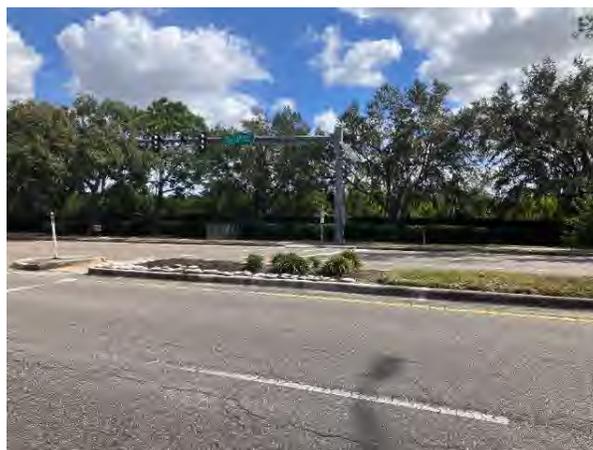
- I have pulled the Begonias from the front two tips on Race Track Rd. median. They melted in the cold. Tip.. Begonias are almost like a succulent and due to their high water content, they are highly effected by extreme cold, but they are also highly effected by the drought. They look GREAT when they are happy, but these were not happy. I spoke with David, and the decision was to leave them empty and fill them with the next flower rotation in March with the rest of the property.

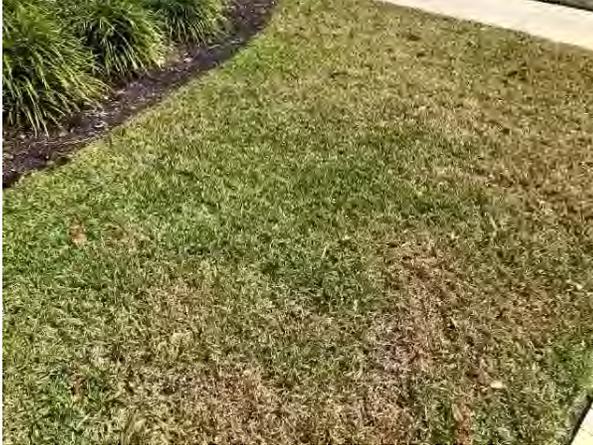
- Some areas are better than others. We have submitted an aeration proposal. Also, fertilization should start to take effect shortly as the rains return.
- Recovery will take a little time.

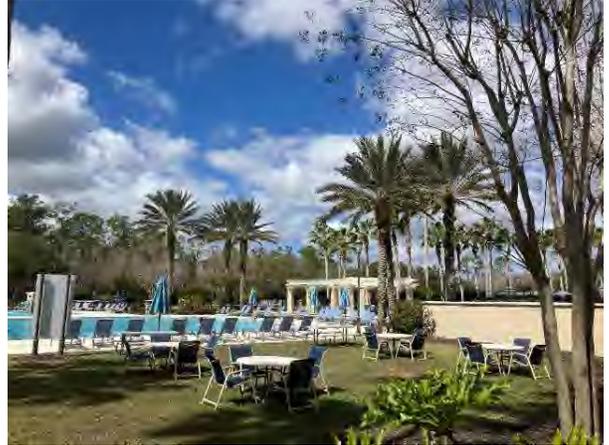
- Unhappy turf. I suggest artificial or re-sodding.

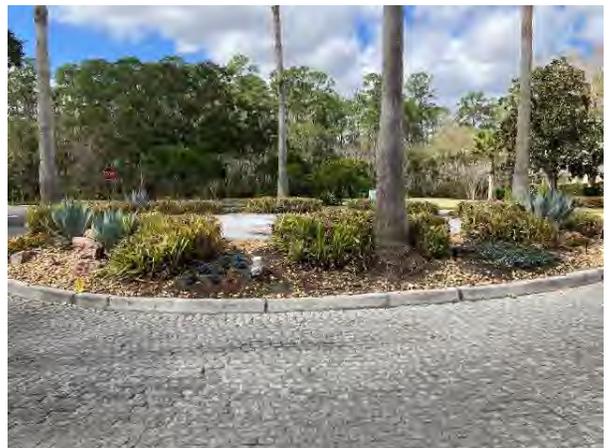
- After cutbacks - Suggested to David to remove ornamental grasses completely as they are the wrong plant for this location. They grow WAY too tall, and will never look good with constant cutbacks because the tips will always be brown.

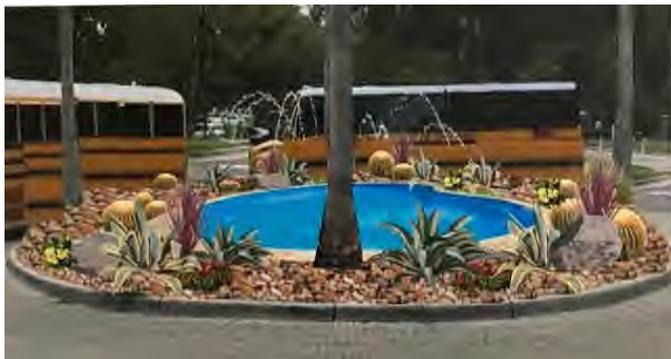
- This is the renovation rendering/estimate that I previously submitted. David has asked for a quote to remove the grasses, remove rock and lay weedblock, add rock back and spray with adhesive. Once we remove the grasses, we will need more plant material around the fountain. I'm open to whatever you would like, but as I mentioned in my previously delivered explanation, we need to have material that is sun and drought tolerant due to the conditions it will be living with ie. hot rocks, glare/heat off the roadway concrete, and direct, full sun all day.

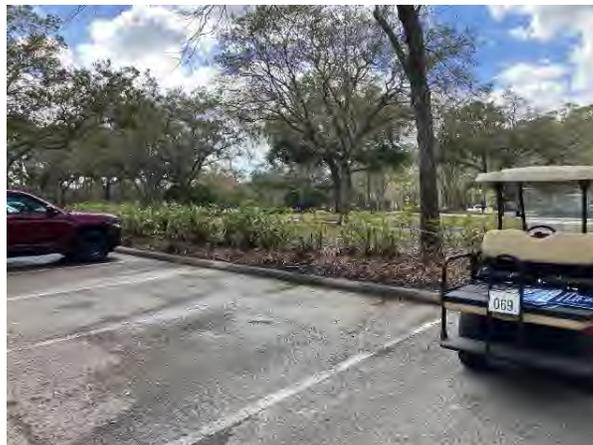
- After - I decided to cut back the shrub row in the parking lot. The Viburnum actually looked a bit better (believe it or not) when we went back to remove them. We will monitor and fingers crossed that they flush out at the bottom. That is A LOT of shrubs to replace so it is financially wise to try to fix this before we have to remove/replace. We will monitor. Even just hard cut back, it looks much better.

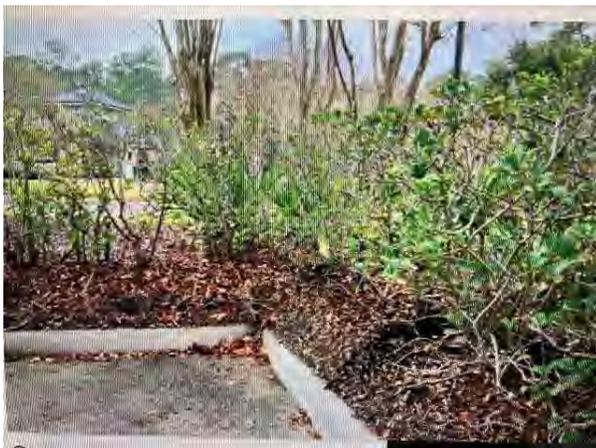
- Before - Parking lot Viburnum have been hard cutback to encourage basal growth.

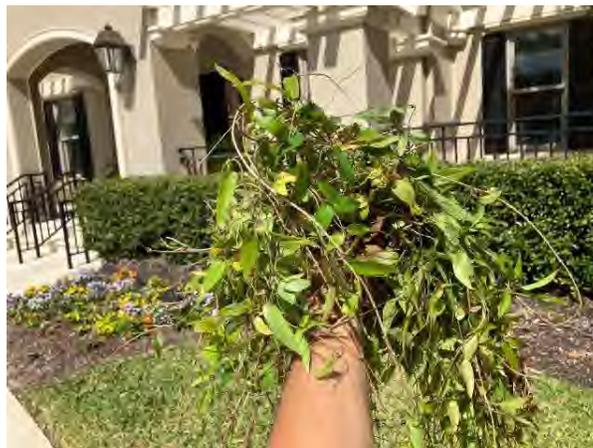
- After- Vines in shrub row at front of clubhouse. This will be an ongoing removal event, but currently we look much better. Keep up the good work, Herminia!

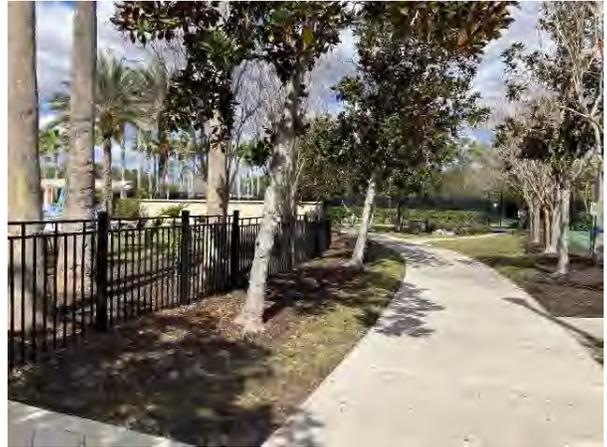
- After - Dead walkway shrubs removed. Gabriel, Amazing job!!! Your crew is made of awesome sauce!! Thank you.
- Mentioned under Enhancement opportunities... We could skip adding a privacy shrub back into this area along the fence by filling the inside empty bed with Philodendron. I think this would provide a much cleaner look unless you would like to hide the fencing. In which case, we could replace the shrub row.

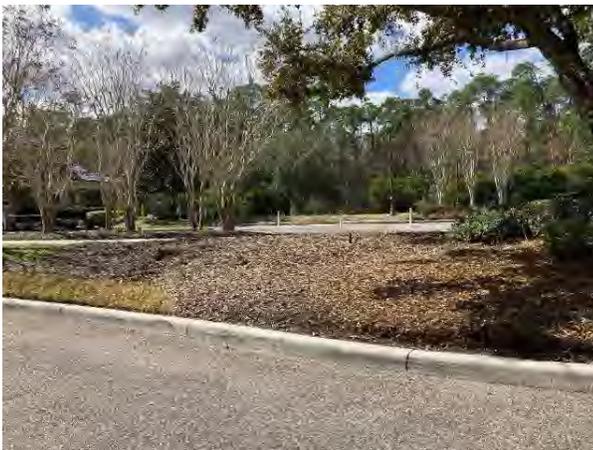
- After - Mayhem removed from this area. Sometimes nothing is better than dead or random "stuff".

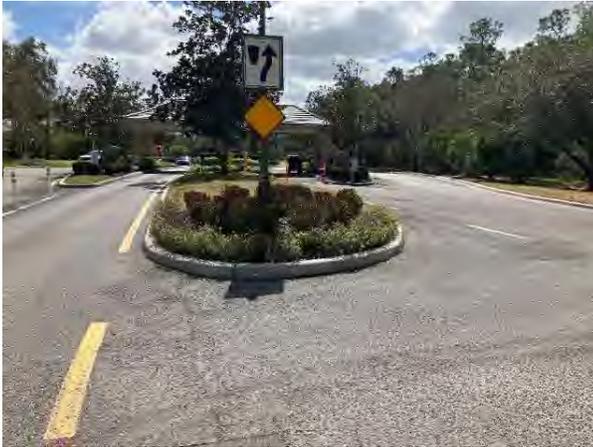
- This freeze damage to the top of the shrubs is difficult to see and not want to chop it off. Trust me. I feel the same. HOWEVER, as mentioned in the freeze information that I sent out, we need to wait just about 2 weeks more to give not only the plant a chance to rejuvenate before we stress it out, but also, to ensure that we don't get another spanking from Mother Nature. That darned groundhog did warn us that the season was not quite over.

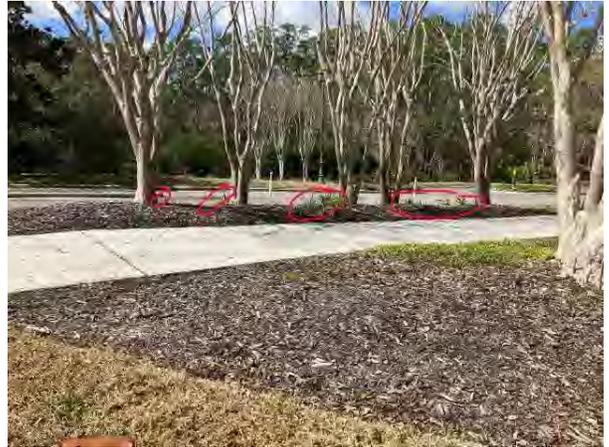
- Please remove the random.
- This will be removed by crew 2.25.26

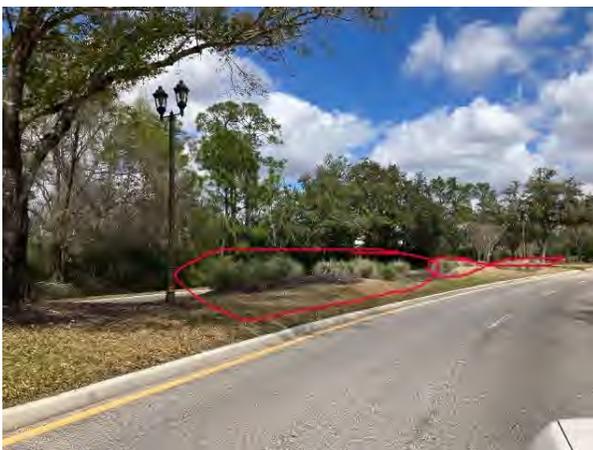
- BLUUJGGHH. Missed Ornamental grasses will be cut back during the course of each visit until completed. This particular one on the Waterchase roadway will be cut back on 2.25.26

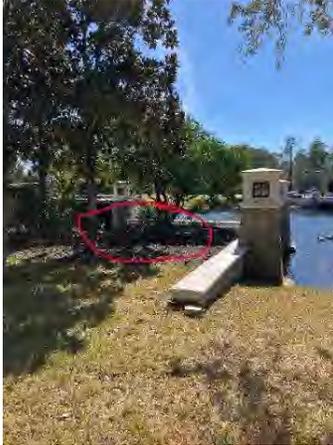
- Front monument dead plants will be removed starting 2.25.26. SOOO MANY

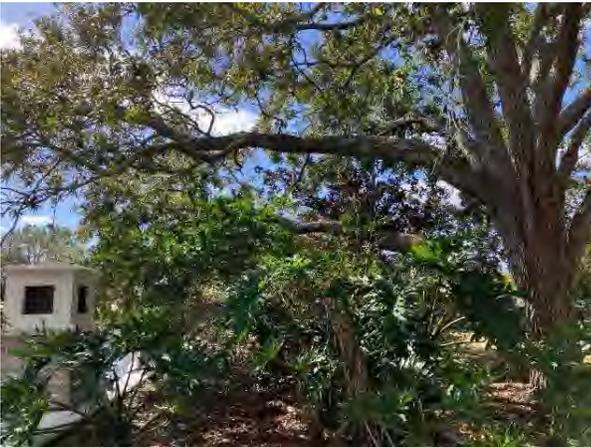
- Front Monument Oaks need major cutbacks off of sign. I will submit a proposal. The caliper is above scope.

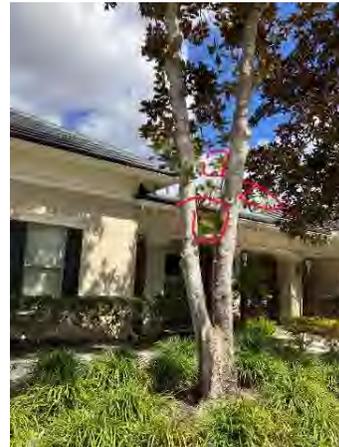
- Property wide ESPECIALLY BAD on the roadway between the entrance and guard shack. This is at the clubhouse. We need to get rid of suckers.

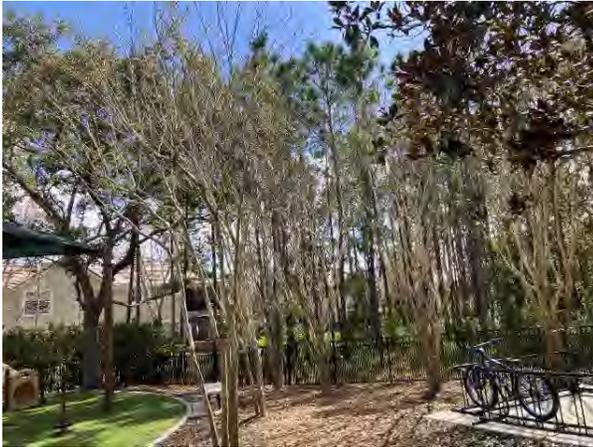
- I am not sure what your intention is with the Crape Myrtles throughout property. I can see from the "knuckles" that they have been overpruned them in the past. I am not a fan of pruning them at all or if pruned, only pencil pruning which is the proper way to do it. If you would like a proposal to prune them, I can certainly submit one, I would just like to know if you prefer the pencil or knuckle cut.

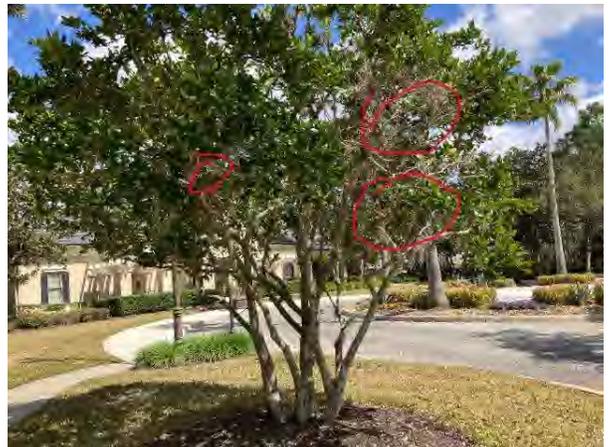
- Please remove Spanish Moss as high as you can reach it up to 10' property wide.

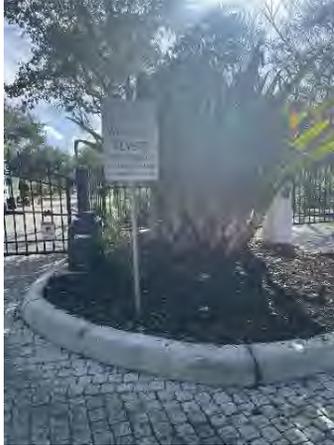
- After - Herminia's crew cleaned up the back entry Crinum Lily. Looks MUCH cleaner. I submitted a proposal to re-do this area. The Crinum Lily is just not the best plant for this location. It is a very high profile area, and in my opinion, Crinum Lily never really look polished. I do like them.. don't get me wrong, but I feel there are better options for a specimen plant here.

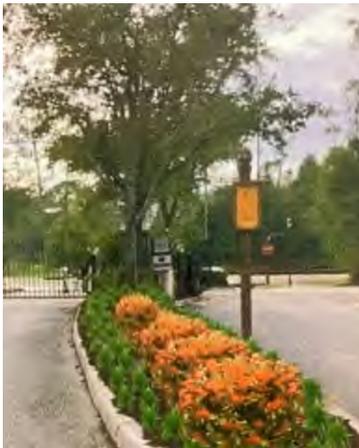
- Back entry island currently

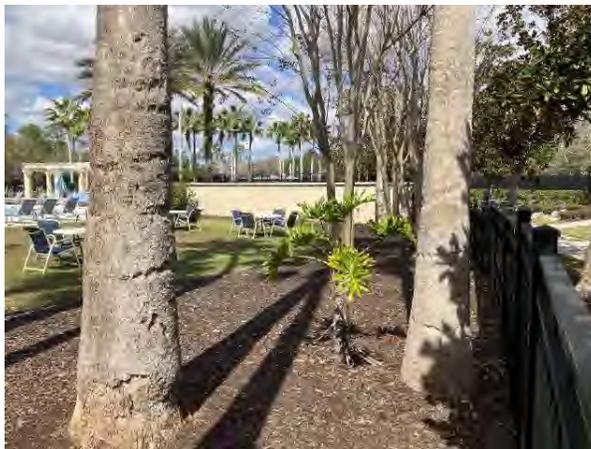
- I don't want to take this out without permission. Again, wrong plant/wrong place. These Palmettos will spread, which would be great for this space if they didn't have thorns and are directly at children's eye height. Request permission to eliminate.

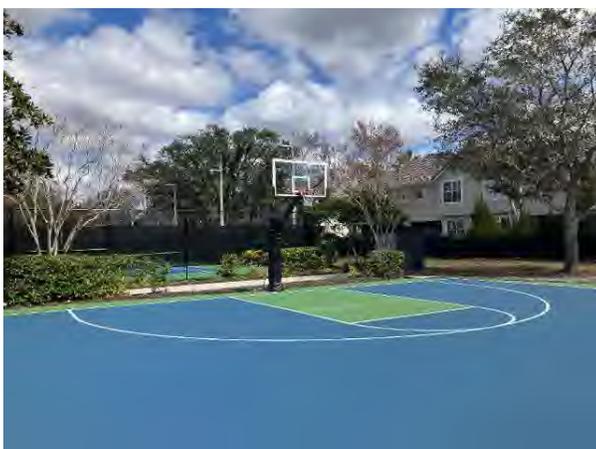
- I suggest to fill this area with Philodendrons after irrigation is fixed. I suspect that it once had them, and they died due to lack of water. They would look nice in this area and will fill in quickly. They would also eliminate the need to add a hedge row to the outside of the fence line by the walkway past the basketball courts.

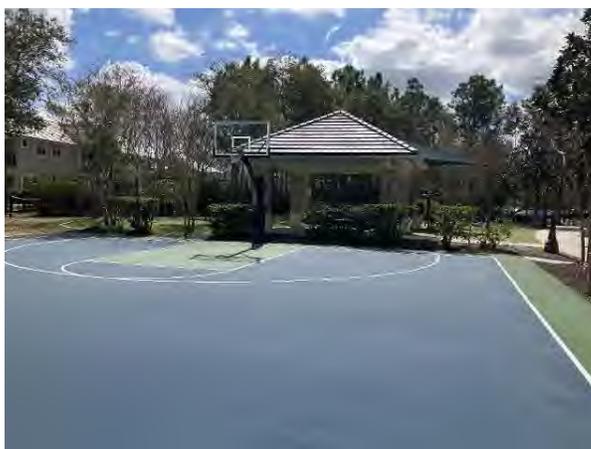
- Need to fill in this area with new. I can propose at the board's request.

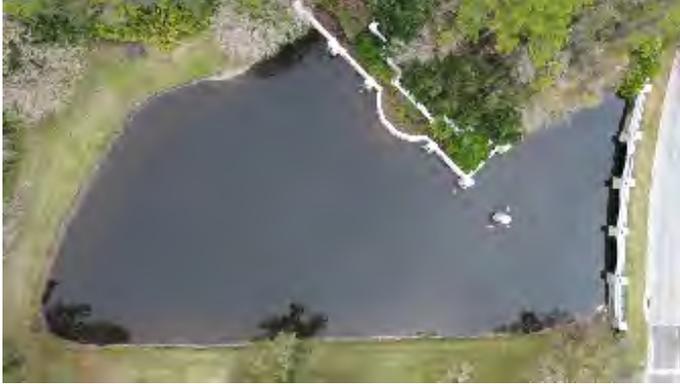
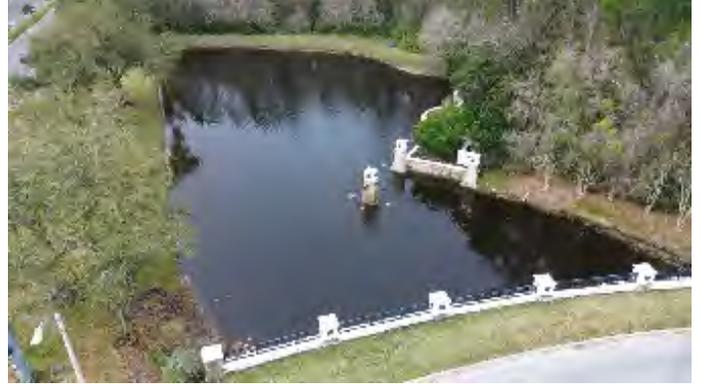
SITE: 1

No algae or nuisance grasses observed. Routine monitoring and treatment as needed will continue.

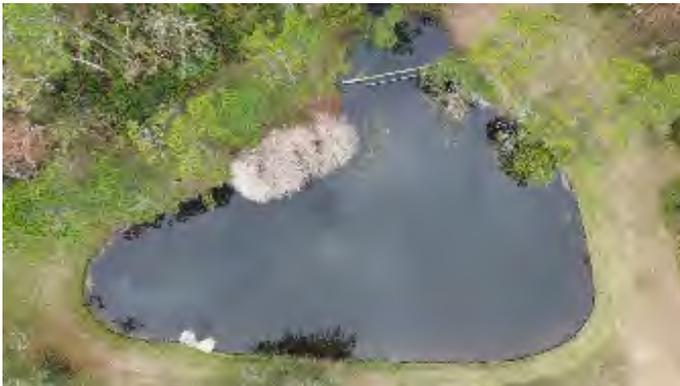
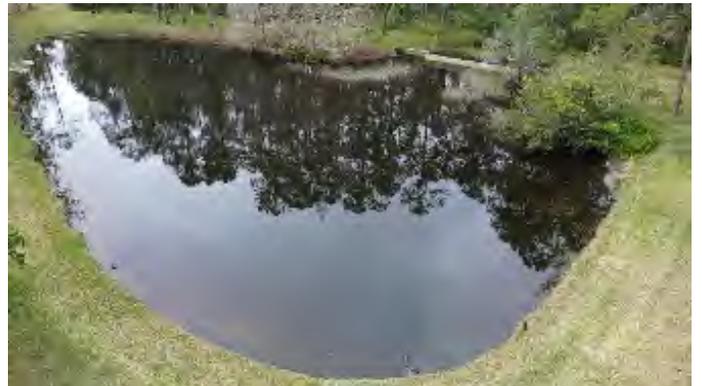
SITE: 2

No algae or nuisance grasses observed. Routine monitoring and treatment as needed will continue.

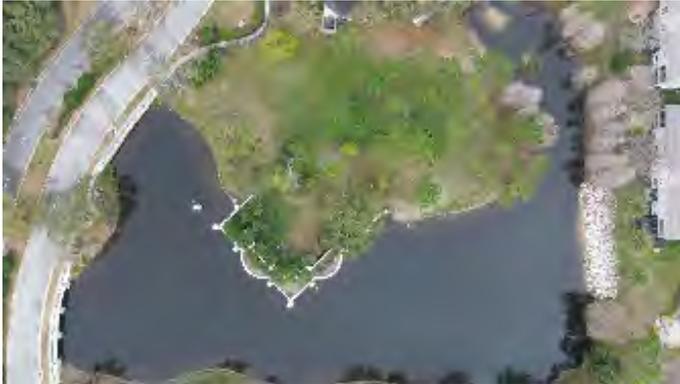
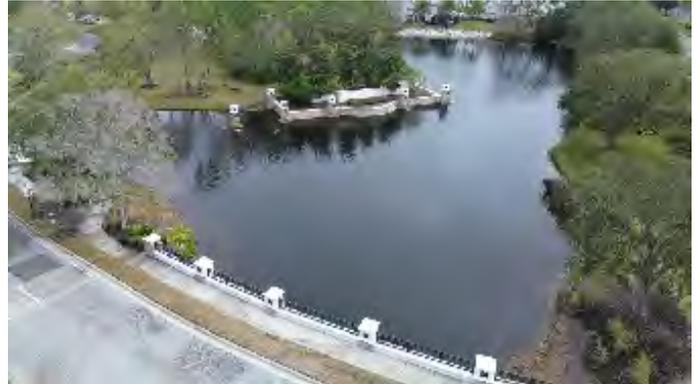
SITE: 3

No algae or nuisance grasses observed. Routine monitoring and treatment as needed will continue.

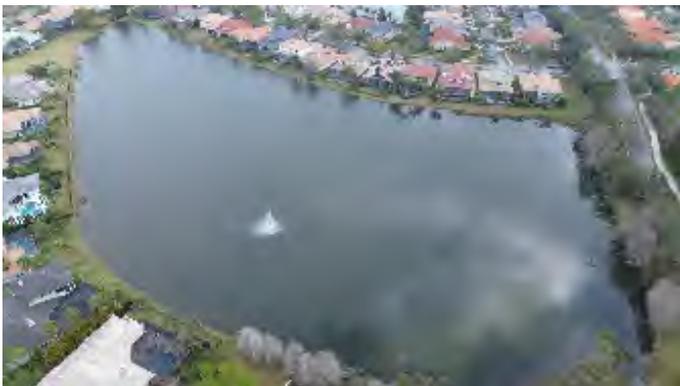
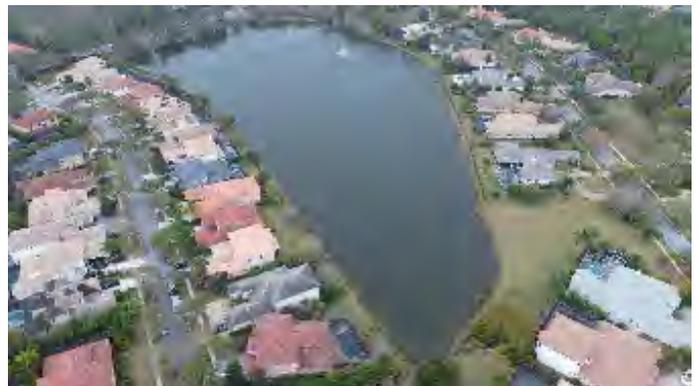
Ongoing treatments via boat have made progress in clearing submerged growth. Regular shoreline treatments will continue to further this progress. No other nuisance growth observed.

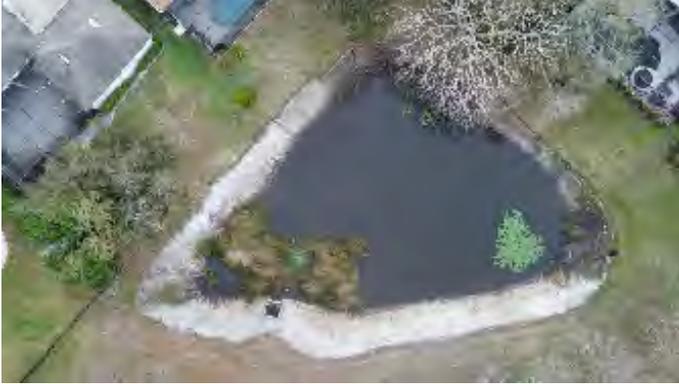
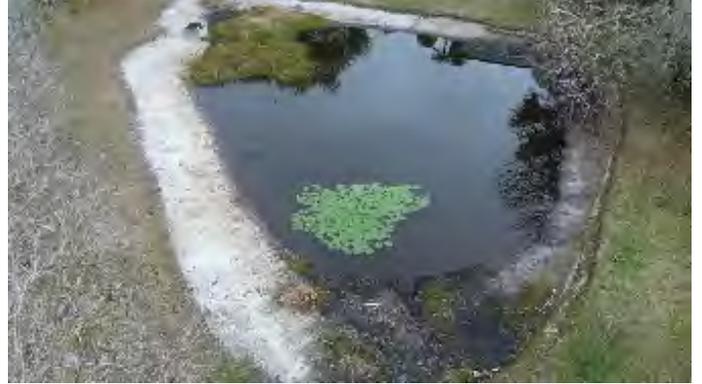
SITE: 15

No algae or nuisance grasses observed. Routine monitoring and treatment as needed will continue.
Any shoreline growth is terrestrial and will drown once water levels rise.

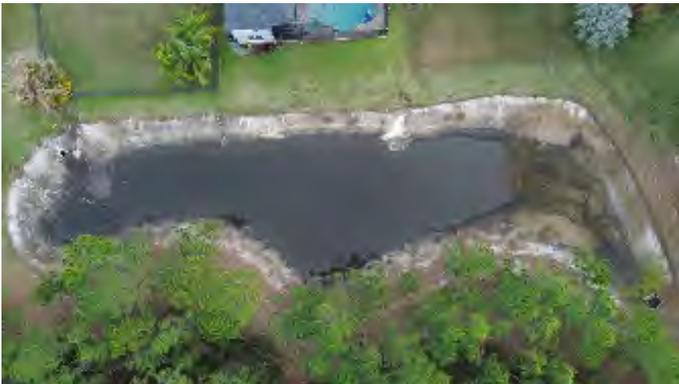
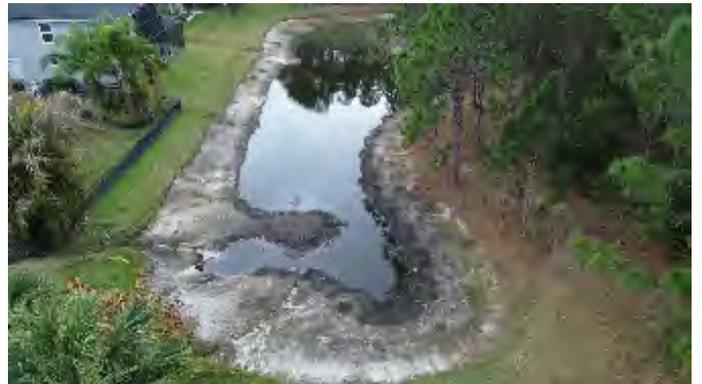
No algae or nuisance grasses observed. Routine monitoring and treatment as needed will continue.
One washout is starting to form. I will continue to monitor and recommend repairs if needed.

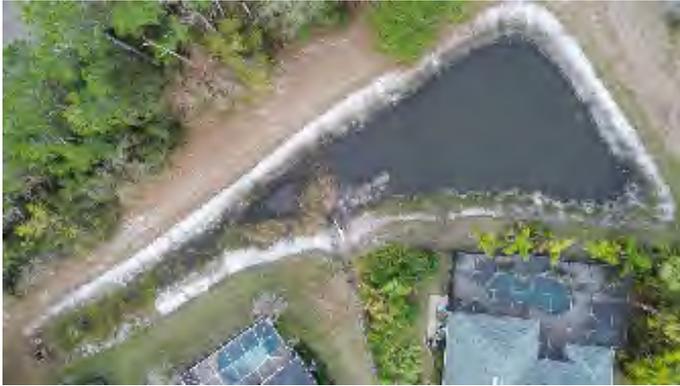
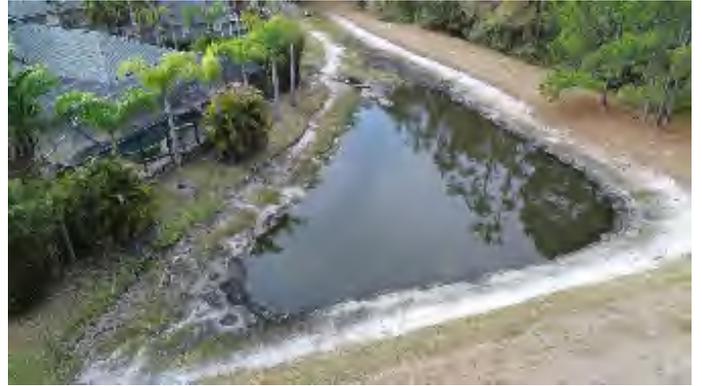
One small section of submerged algae present. An algaecide treatment by a technician will make quick work of clearing this.
No nuisance grass observed.

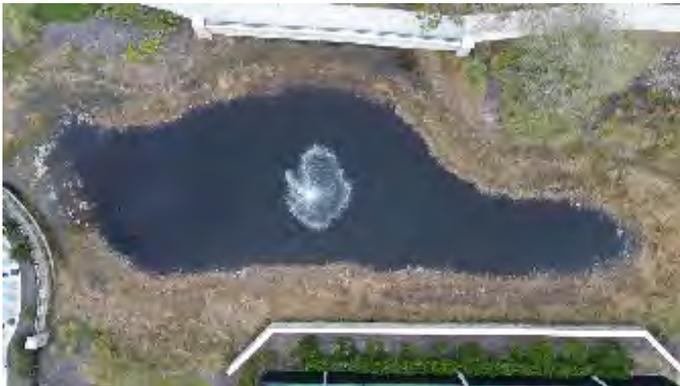
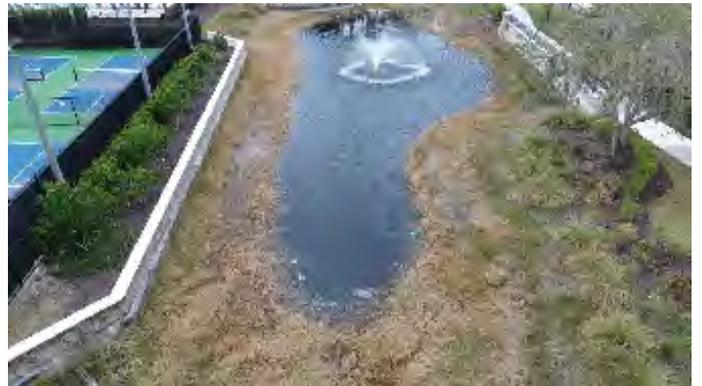
The persistence of the material on the surface is leading me to believe it is not algae, rather some kind of detritus. Heavy, prolonged rain will be the only thing that can clear it.
Other previous algal growth has been cleared. No other nuisance growth observed.

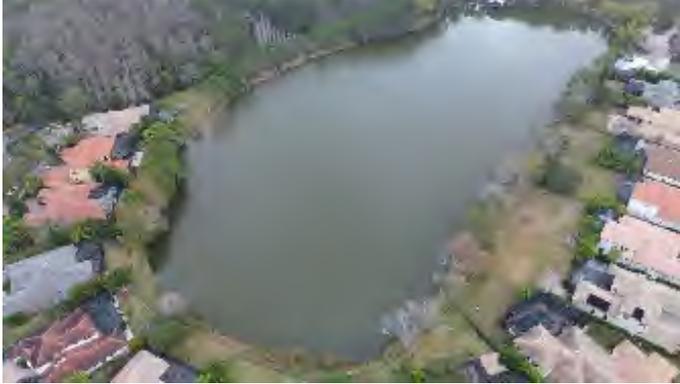
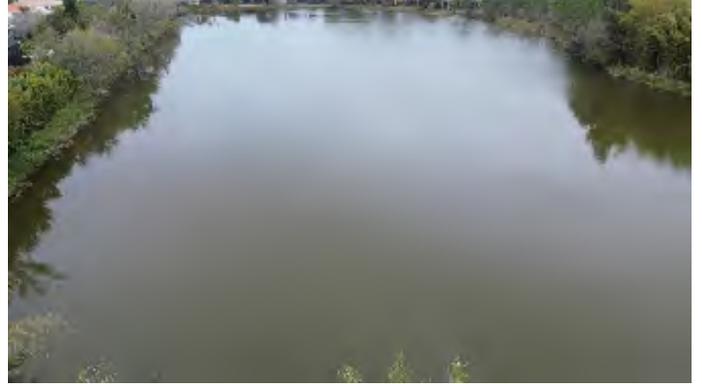
SITE: 22

No algae or nuisance grasses observed. Routine monitoring and treatment as needed will continue.

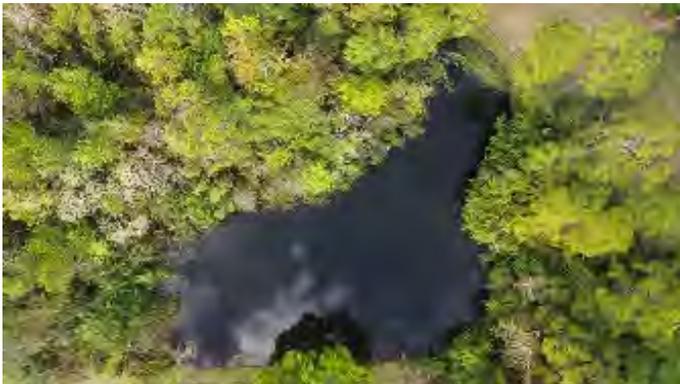
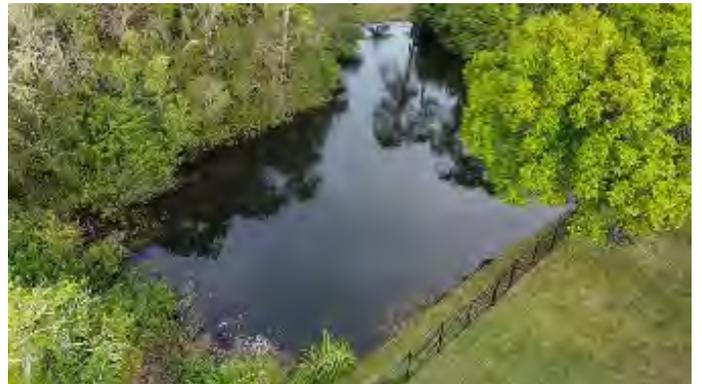
Prior herbicide treatments have started to take effect on the clusters of shoreline grasses. Technicians will continue to monitor and re-treat if decay does not progress. No algae observed.

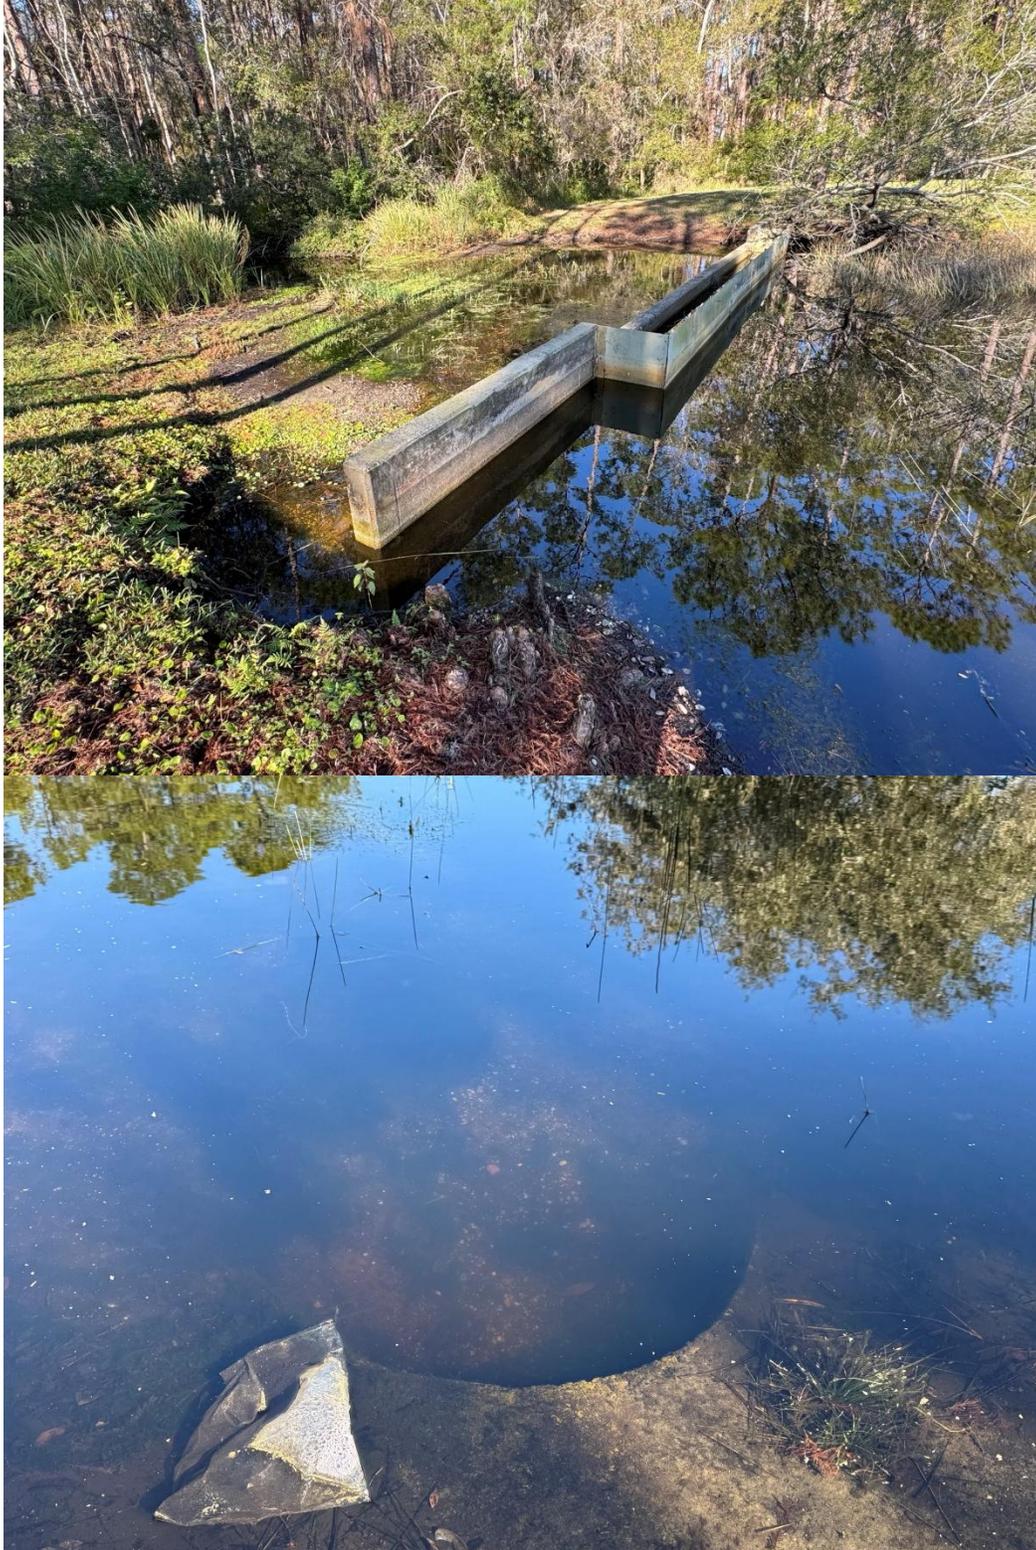
Photo 1- Displays **Pond 2** weir structure left side washout and sediment build up at the drain inlet. Sediment deposit did not appear to affect water flow.

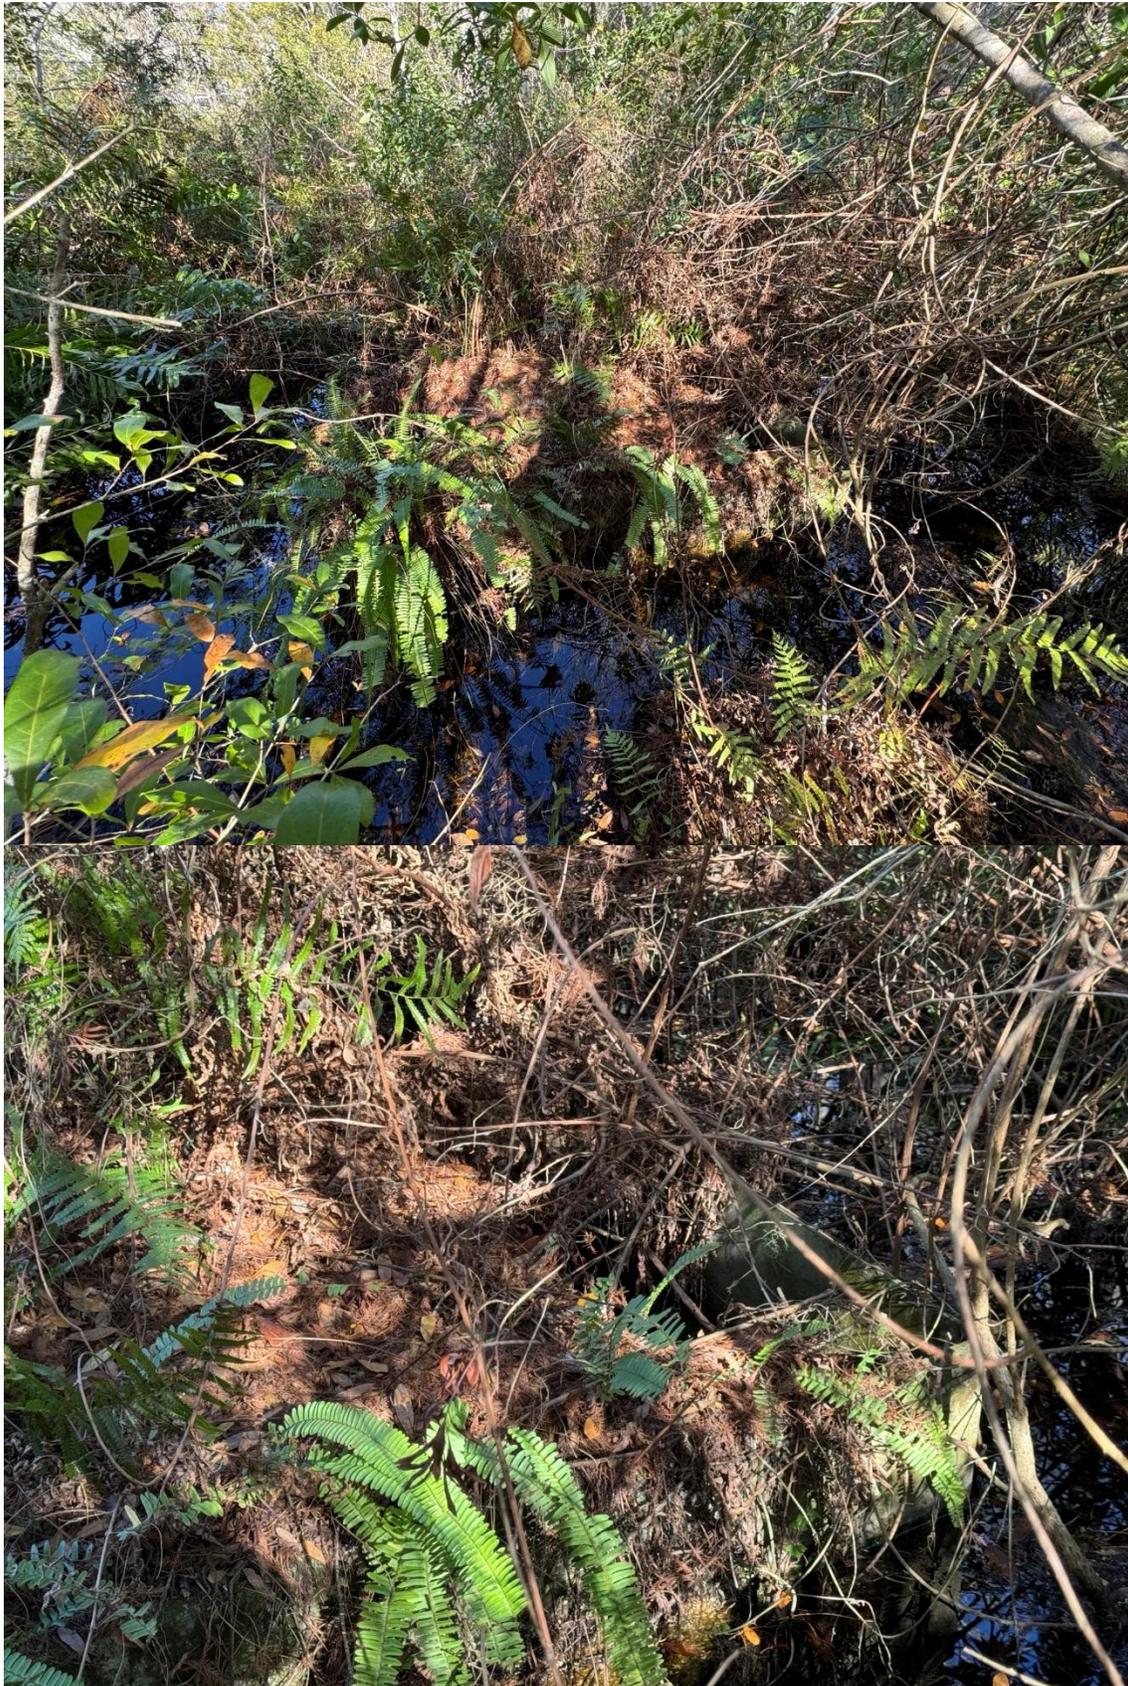
- At **Pond 4** the outfall control structure is overgrown and requires clearing and maintenance.
- At **Pond 6** the outfall weir structure is overgrown on the back side and requires clearing and maintenance. The skimmer mounting poles are broken and requires repair.

Photo 2 – Displays **Pond 4** control structure overgrown and requires maintenance.
