Waterchase Community Development District

March 9, 2026

Agenda Package

Field Inspection Report - February 2026

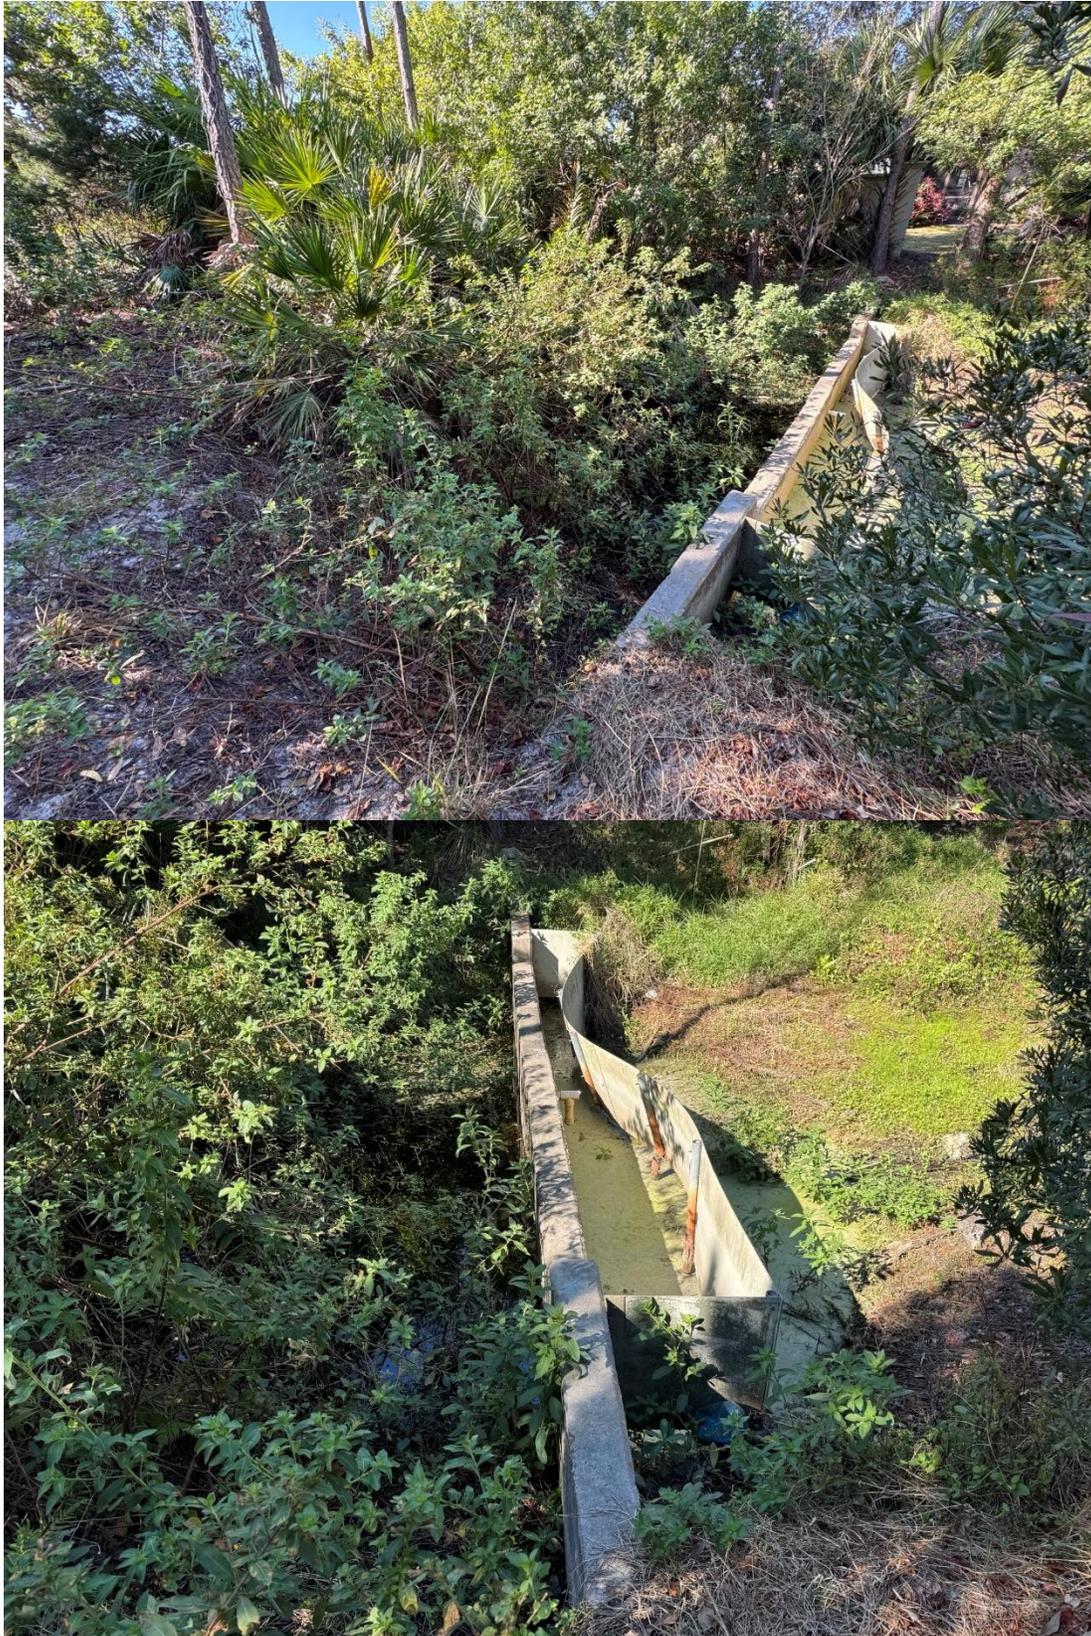
- At **Pond 4** the outfall control structure is overgrown and requires clearing and maintenance.
- At **Pond 6** the outfall weir structure is overgrown on the back side and requires clearing and maintenance. The skimmer mounting poles are broken and requires repair.

Photo 3 – Displays **Pond 6** overgrowth on the back side of the weir structure and the broken skimmer (poles broken, skimmer blade still useable).

3. That the Board seek a proposal for the skimmer repair at Pond 6 and discuss the concern with overgrowth on the back side of the weir structure.
4. That the Board seek a proposal for the skimmer repair at Pond 8 and to monitor erosion concerns.

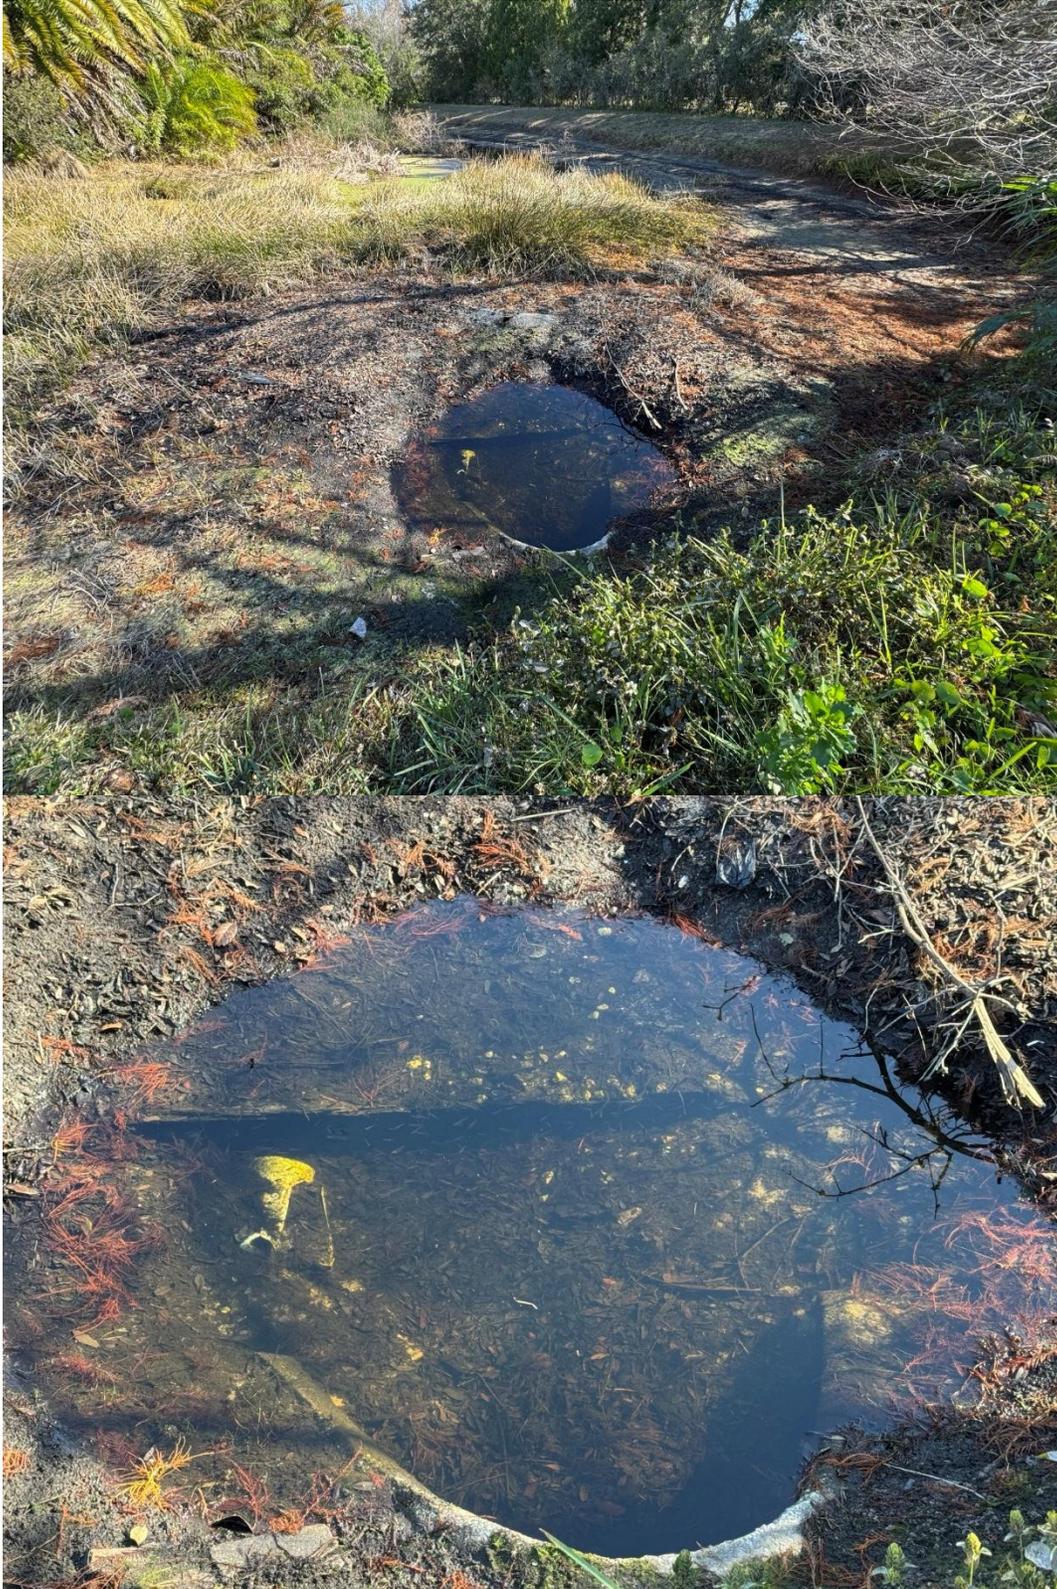
Photo 4 – Displays **Pond 7** sediment build up at the drainage inlet. Silt build up does not appear to be impeding flow.

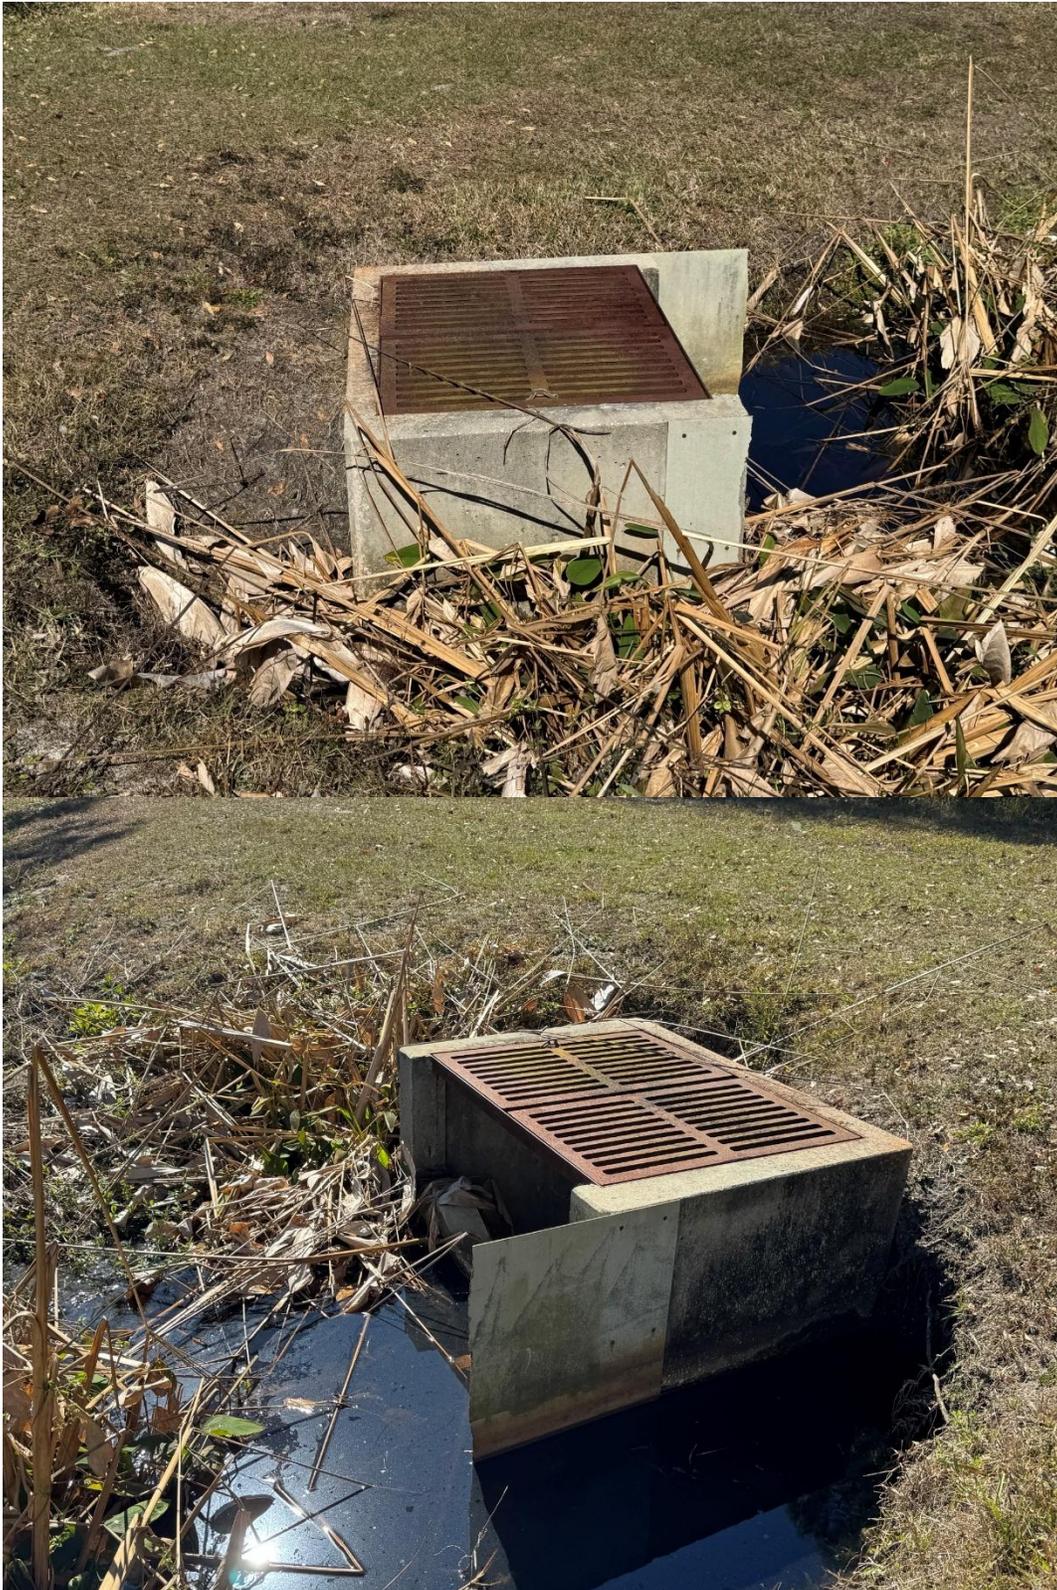
- At **Pond 8** there is minor erosion at the control structure and the skimmer is broken.
- At **Pond 9** there is minor erosion on the back side of the control structure. At the Northwest corner of the pond, it appears a resident installed a French drain that discharges near the top of the pond bank on CDD property.

Photo 5 – Displays **Pond 8** control structure with a broken skimmer and minor erosion on the back side of the structure. The pond equatic plants are greatly helping reduce erosional issues.

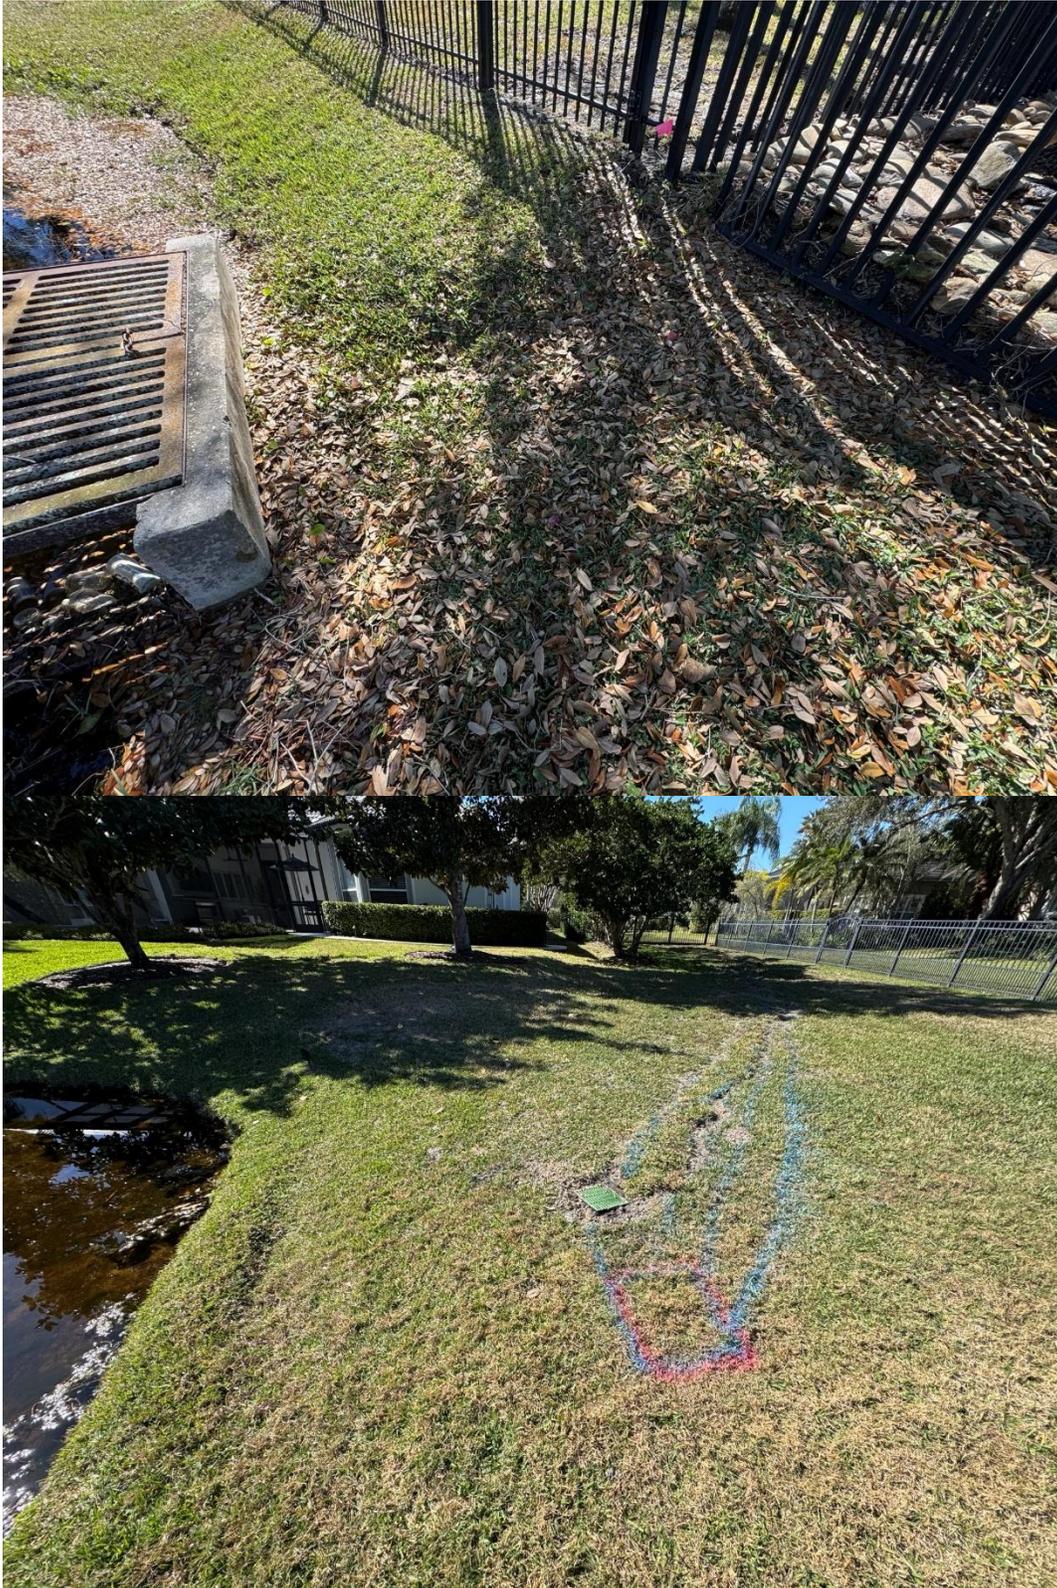
Photo 6 – Displays **Pond 9** control structure with minor erosion on the back side of the structure and the french drain installed on CDD property at the NW corner of the pond. The french drain appeared to be coming from 12046 Royce Waterford Cir

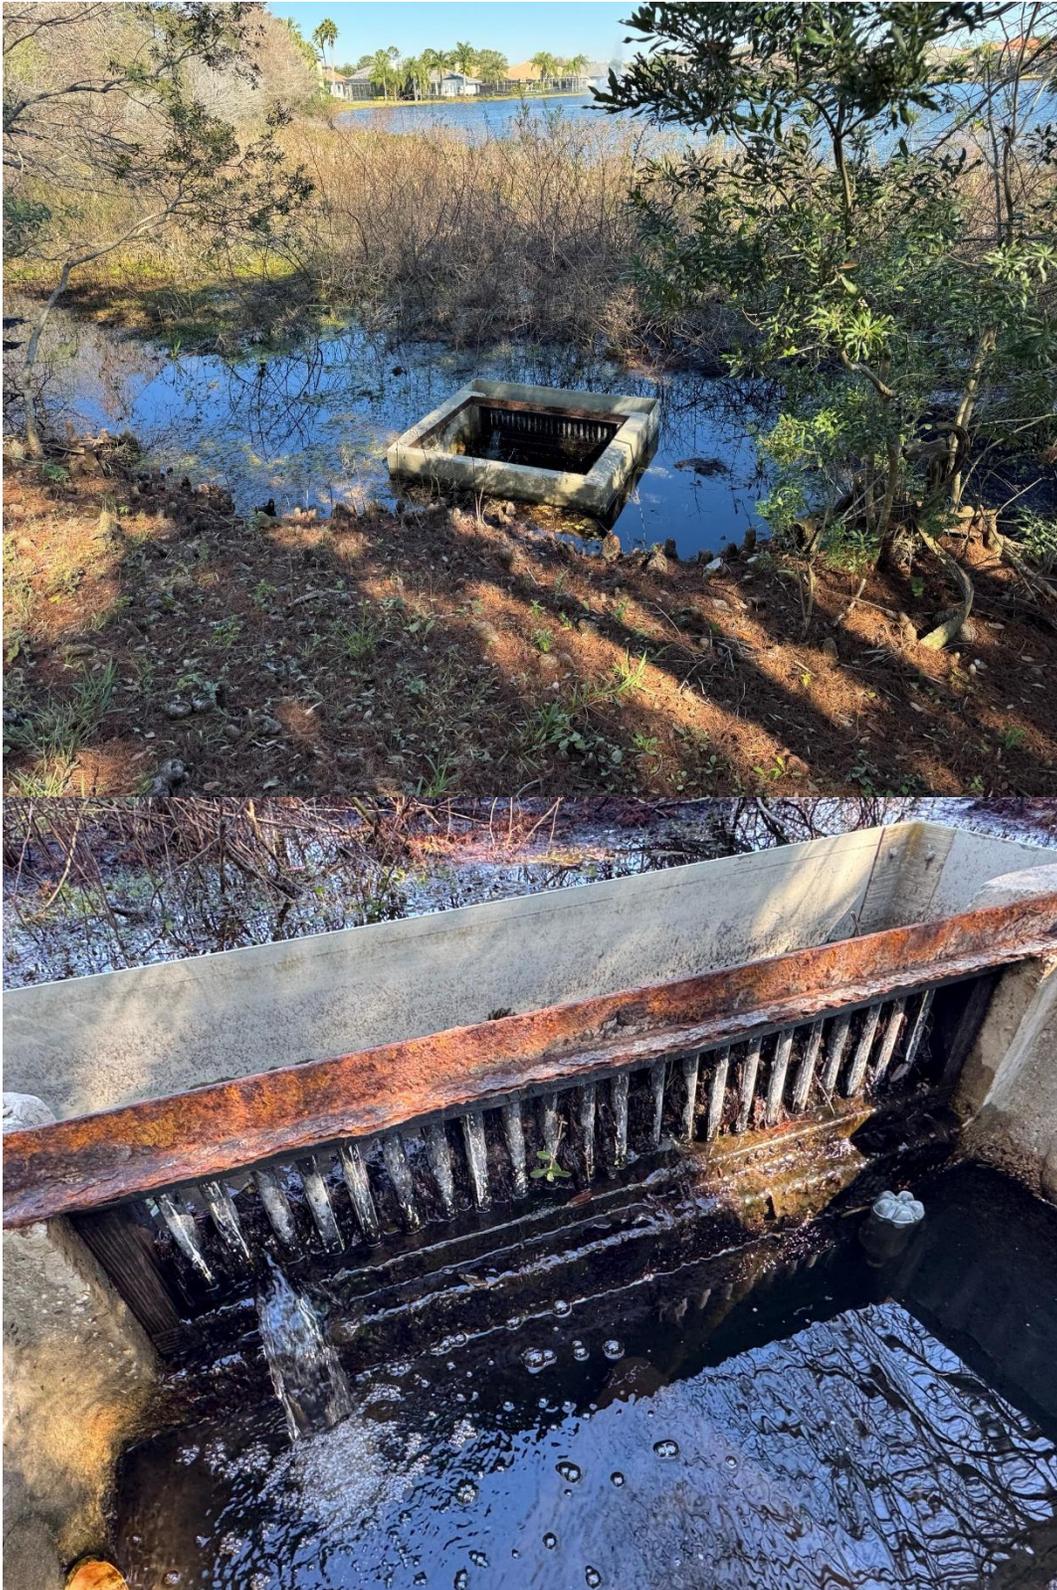
Photo 7 – Displays **Pond 11** outfall control structures' clogged weir opening and displaced top grates. The two halves of the grate have fallen into the structure.

6. That the Board discuss cleaning the fish grate on the Pond 11 control structure and seek a proposal to reset the control structure top grate.
7. That the Board consider seeking a proposal to repair the settling curb on Waterchase Blvd between 14711 and 14715. This is not considered a priority.

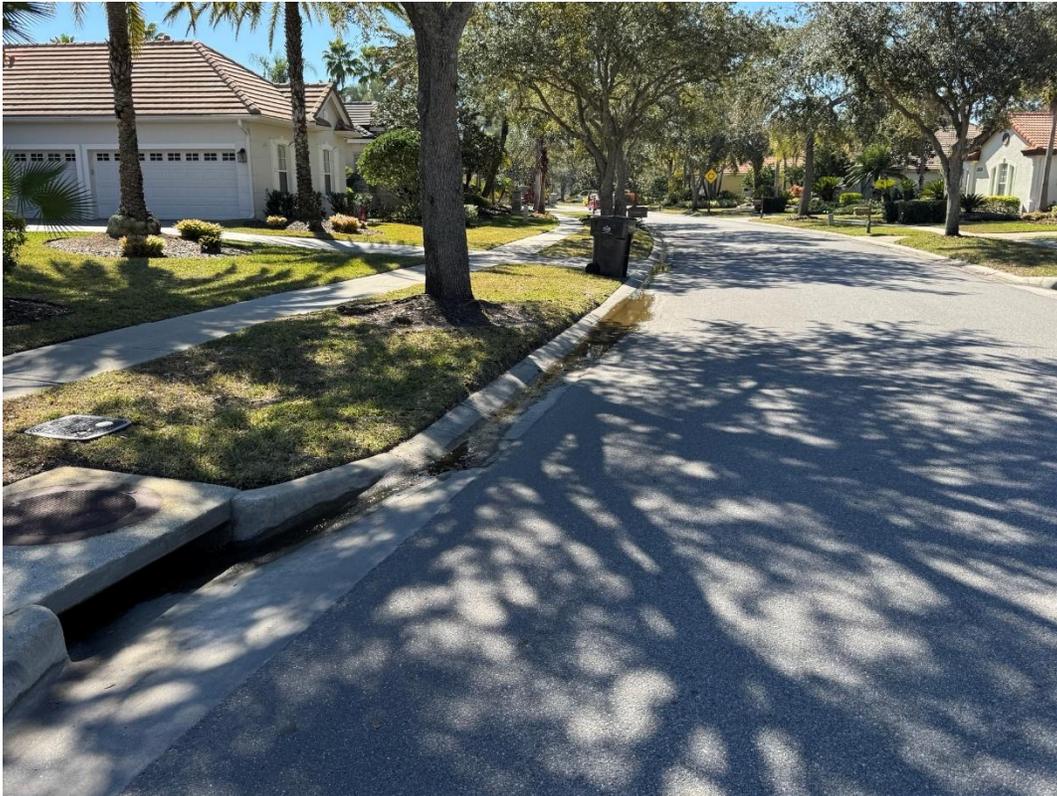
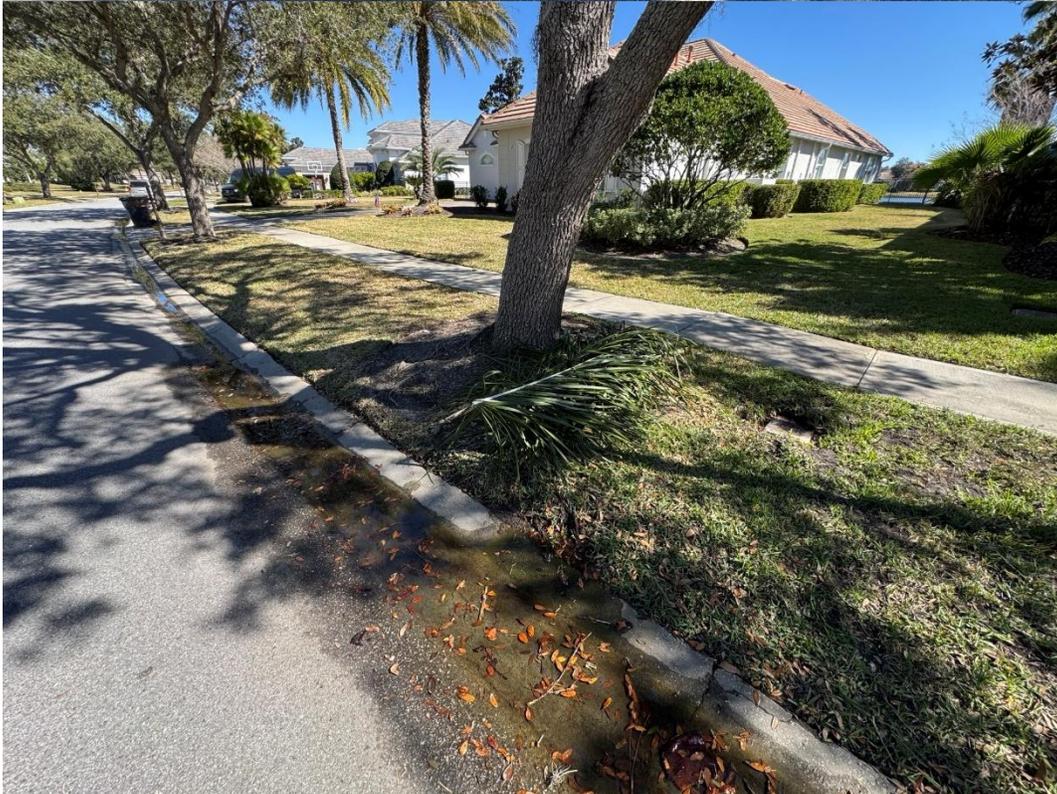
Photo 8 – In association with **Pond 11**, near a drainage inlet on Waterchase Blvd between 14711 and 14715, pooling water was observed along the curb. Water appeared to be supplied by clogged underdrain near community tree (second photo).

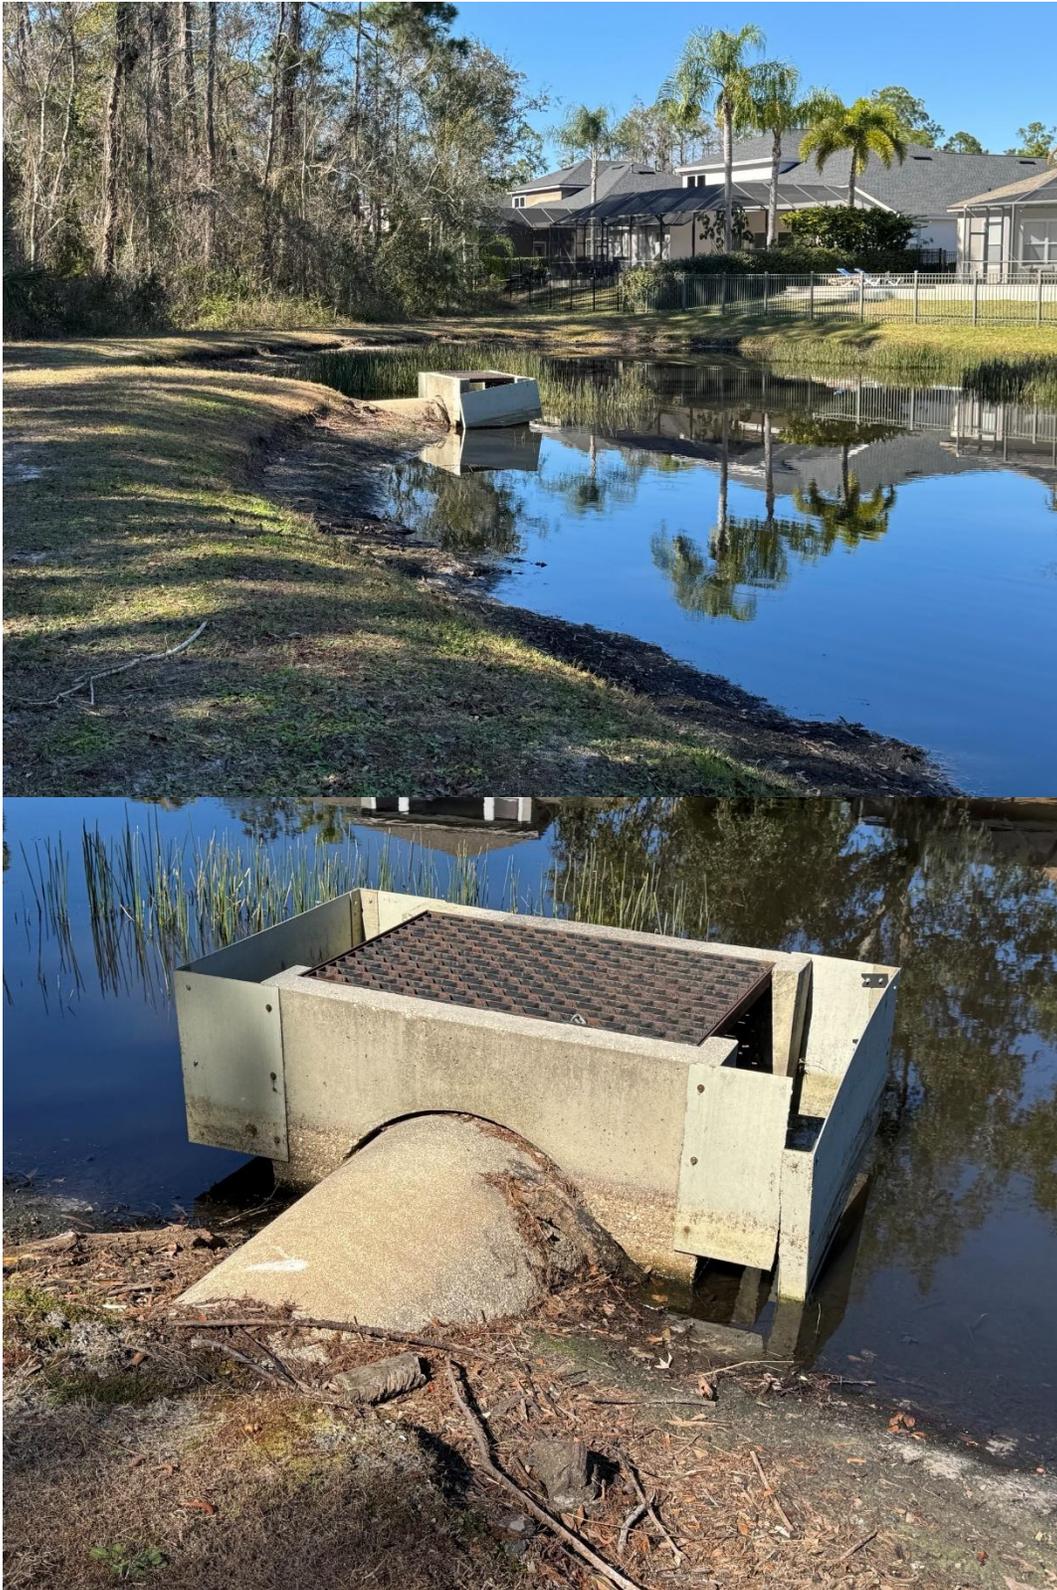
- At **Pond 16** the skimmer is broken on one side and there is minor erosion around the back side of the structure. The erosion is not affecting the operation of the structure.

Photo 9 – Displays **Pond 16** outfall control structure with the skimmer broken on one side. Structure pipe has experienced some erosion but it does not affect the operation of the structure.

8. That the Board seek a proposal for the skimmer repair at Pond 16 and to monitor erosion concerns.
9. That the Board seek proposals for the erosional concerns at Pond 18 and to discuss downspout erosion and community education.

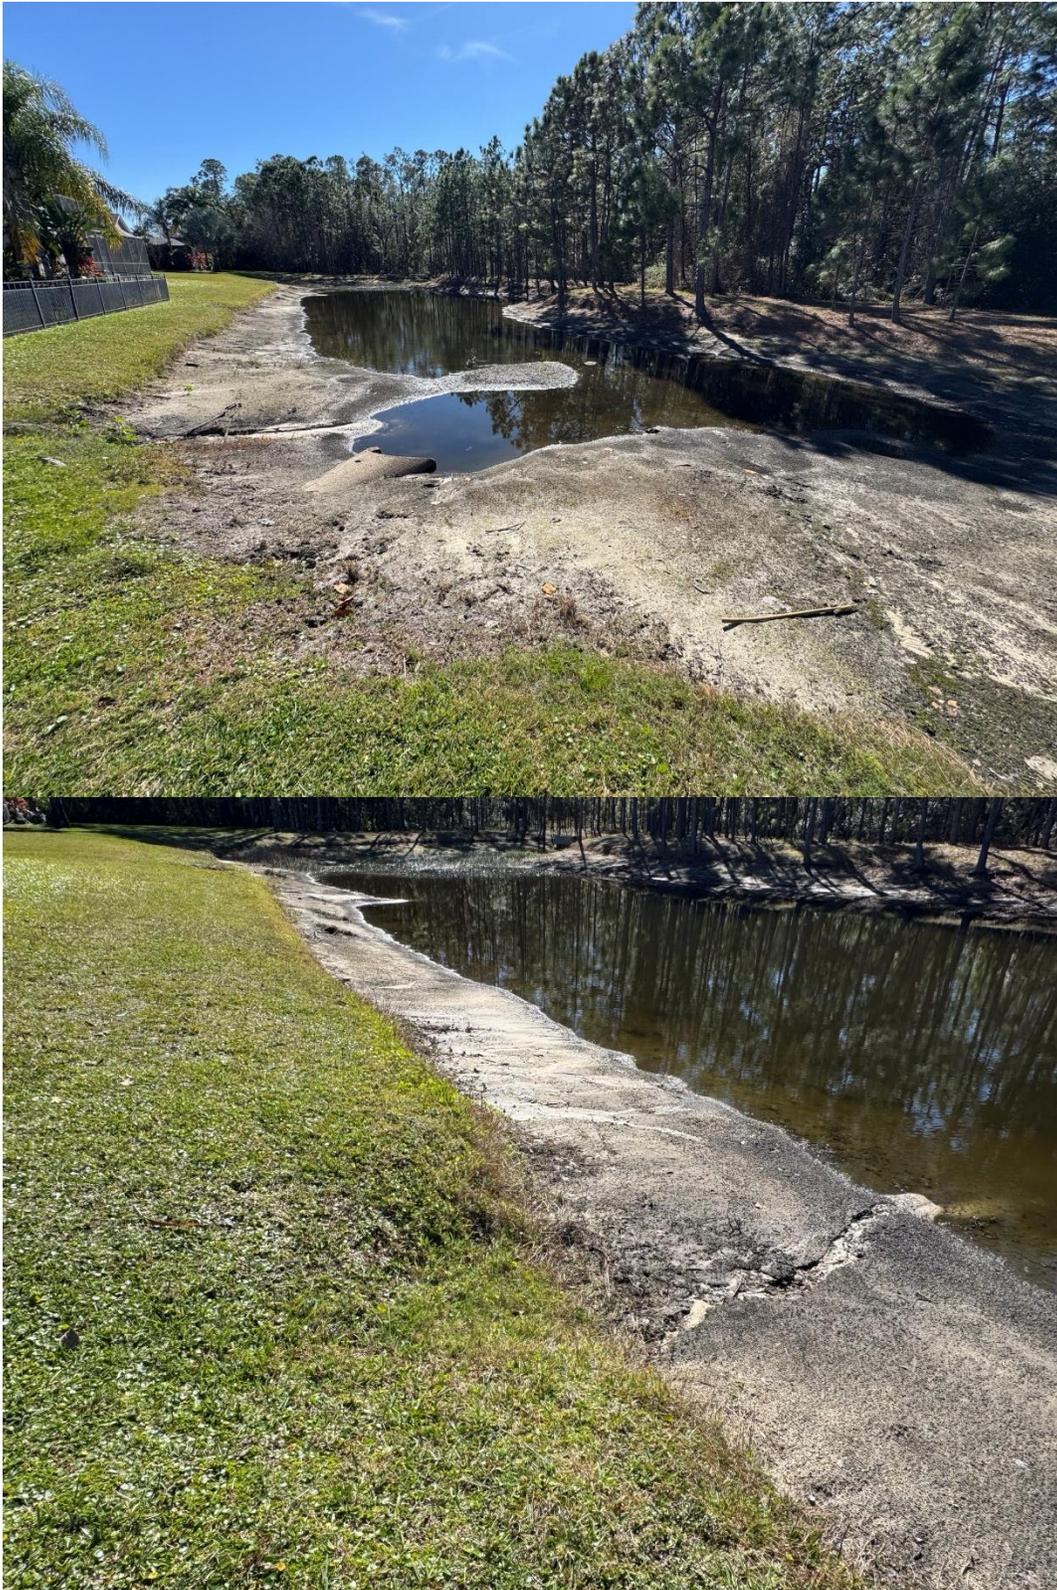
Photo 10 – Displays **Pond 18** areas of pond band erosion in the NE corner of the pond. Erosion appears to be caused by point sources from downspouts on the corner of the pond.

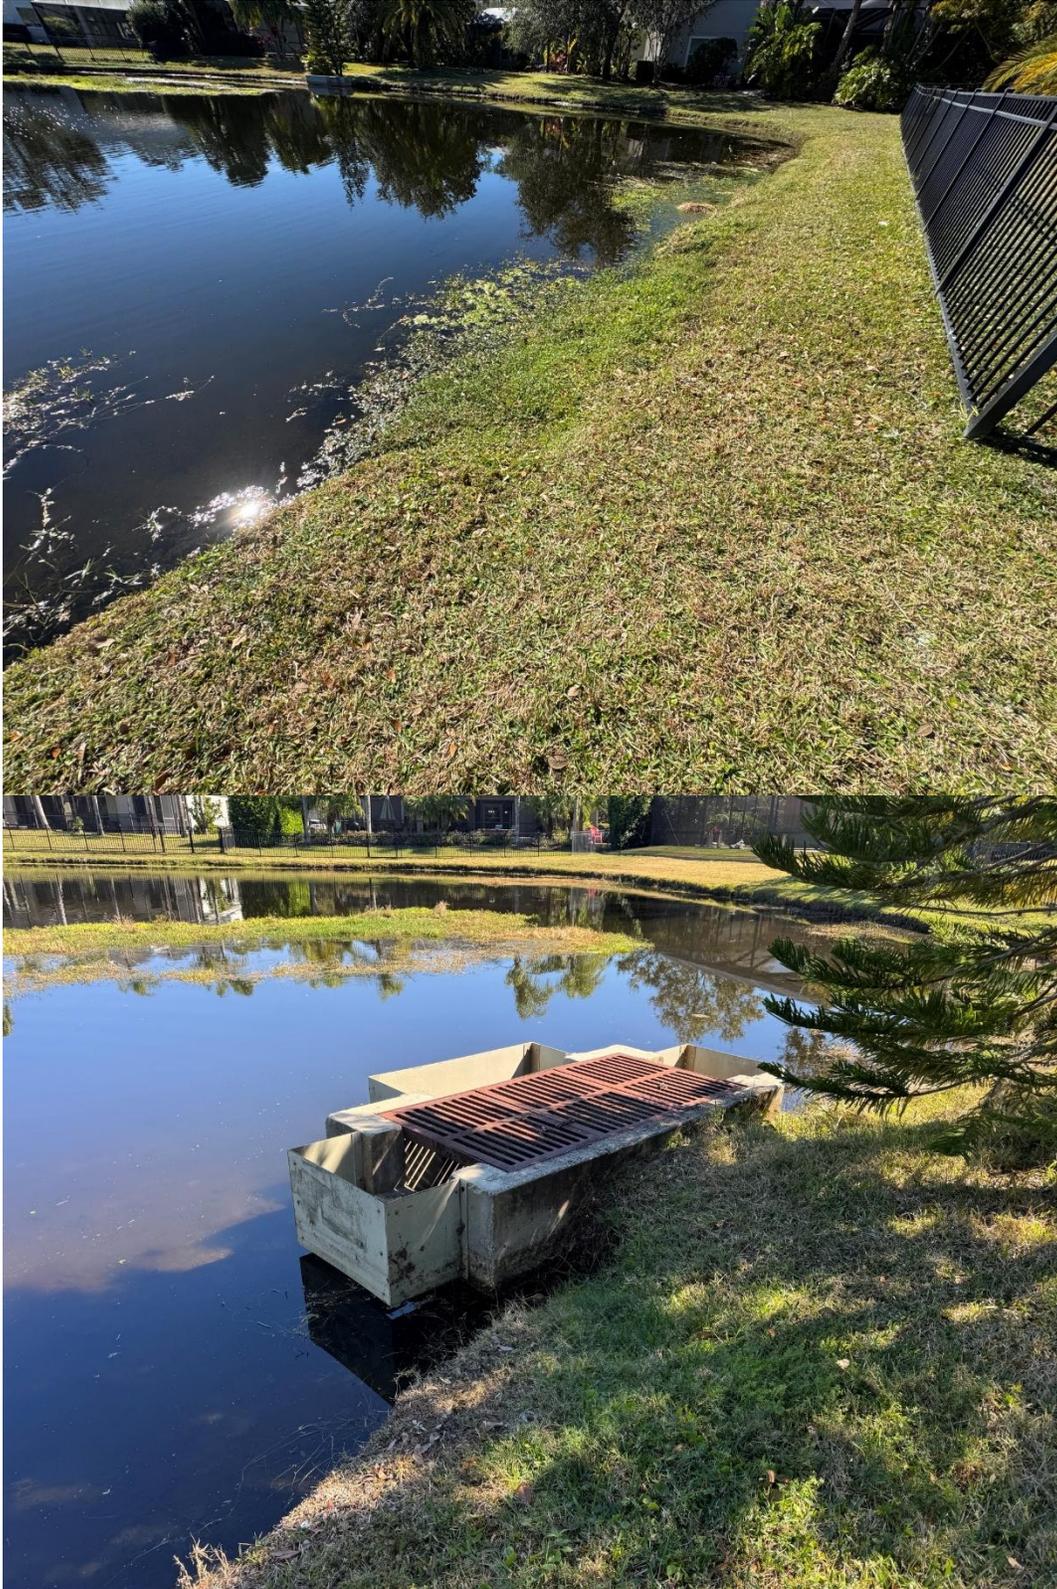
Photo 11 – Displays **Pond 19** area of minor pond band erosion and minor erosion on the back side of the control structure.

10. That the Board monitor the erosion concerns at Pond 19
11. That the Board consider repairing the erosion occurring at Pond 20. Erosion has worsened since last being mentioned in April 2024.

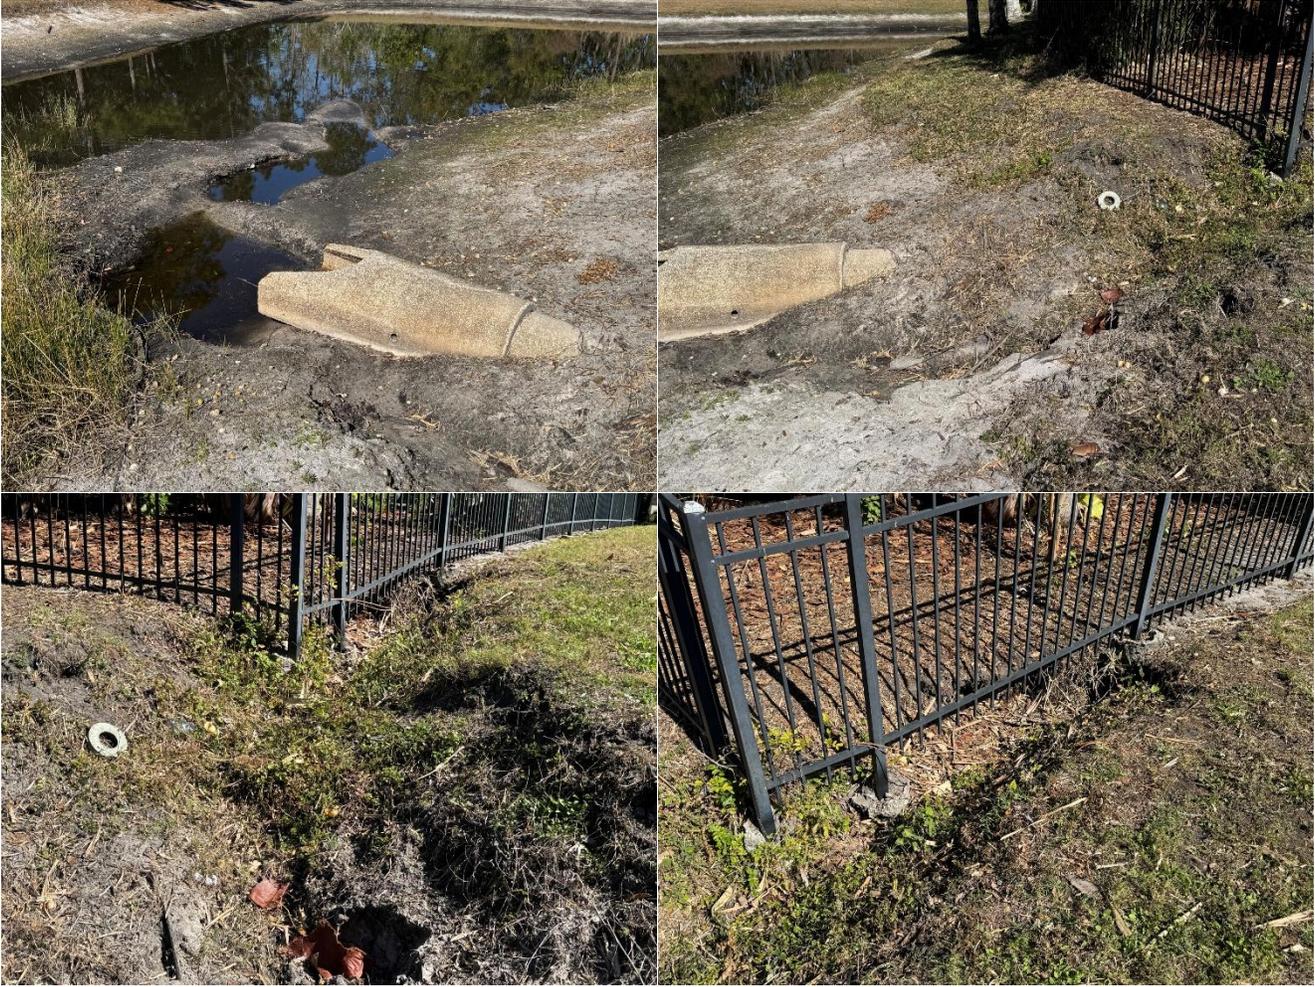
Photo 12 – Displays **Pond 20** pond bank erosion around drain inlet. Erosion is affecting CDD and private property. Water source appears to come from resident irrigation.

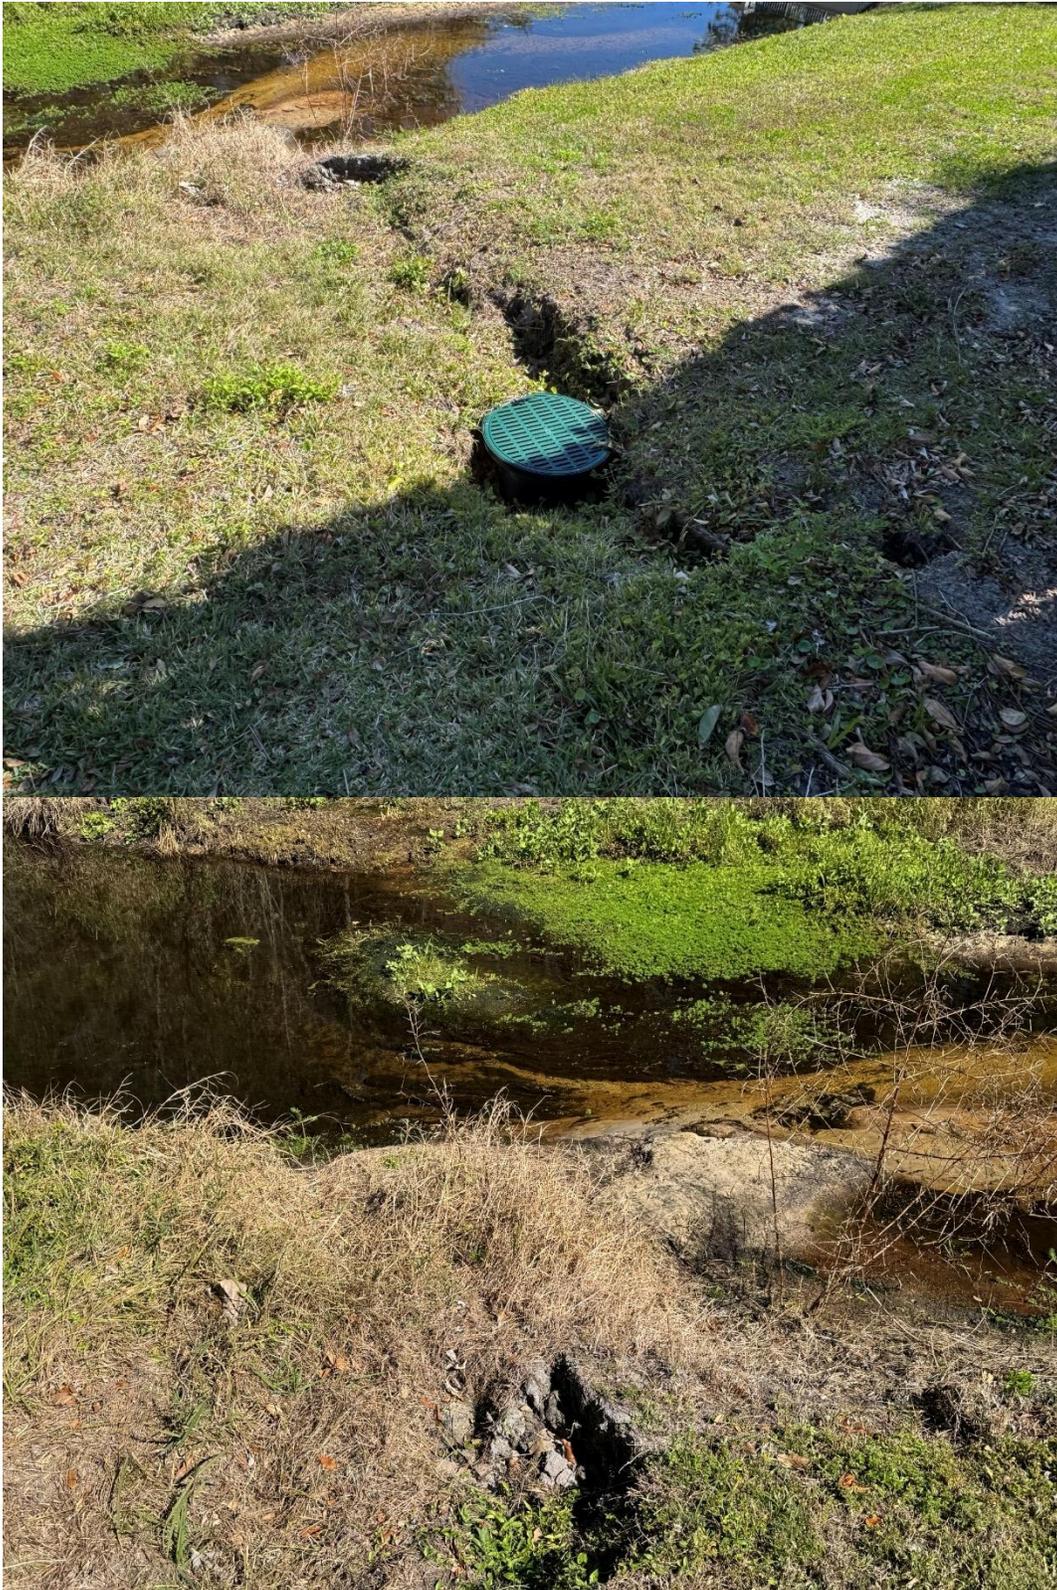
- The erosion repair with the catch basin at Double Branch Canal and Meridan Point Dr bridge has experienced further erosion, and sediment has deposited in the canal.

Photo 13 – Displays current condition of the erosion repair with catch basin at Double Branch Canal and Meridan Point Dr. Area around catch basin has eroded and erosional channel has formed. Sediment has deposited in Double Branch Canal.

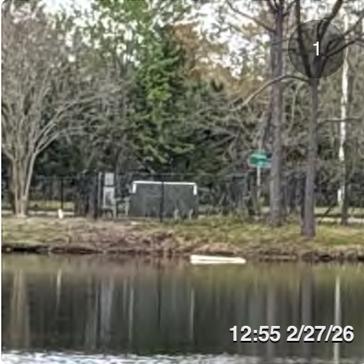
Possibly lake bank renovation on pond #5.

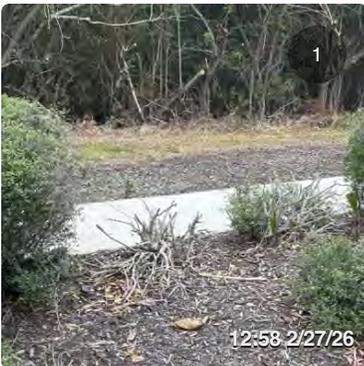
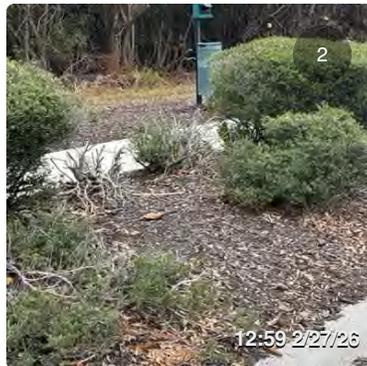
Item 2

Diagnose and treat Ilex Shillings on Meridian Point Dr. ROW located between Chatsworth Manor Cir. and Turning Leaf Ct.

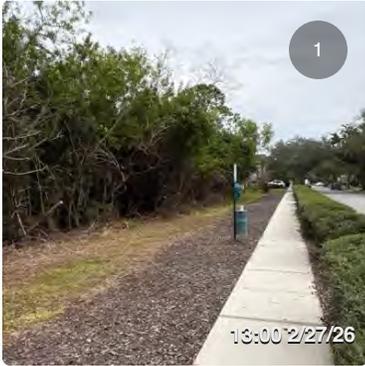
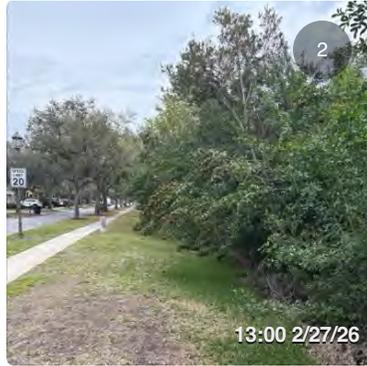
Item 3

Noting Brazilian Peppers were cut back on Meridian Point Dr. North ROW but still needs to be pushed back where over growing CDD turf on South ROW. This is located between Chatsworth Manor Cir. and Turning Leaf Ct.

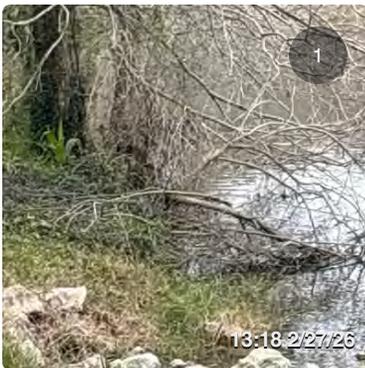
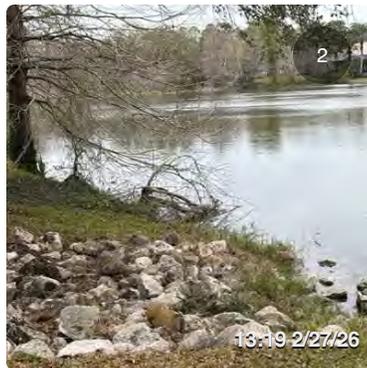
Item 4

Dead Bald Cypress in pond 11 that should be removed. This is on the portion of Meridian Point Dr. ROW.

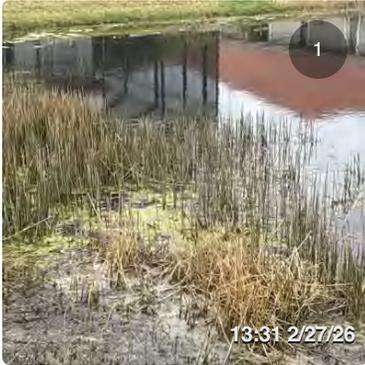
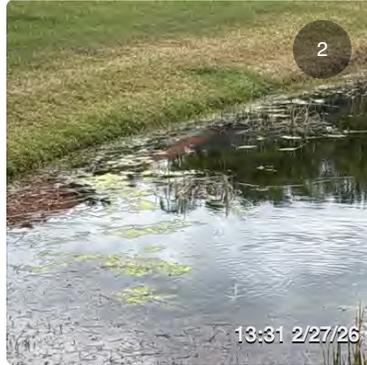
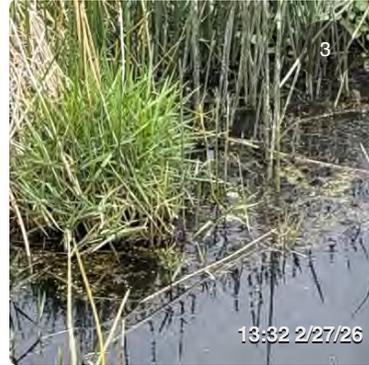
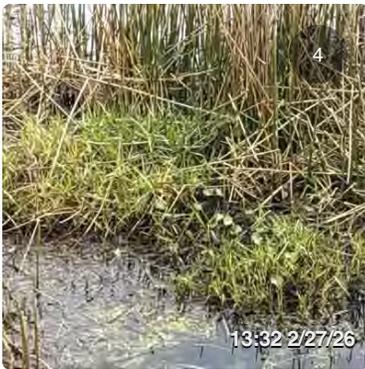
Item 5

Treat algae and non-desirable grassy weeds along the edge of pond 14.

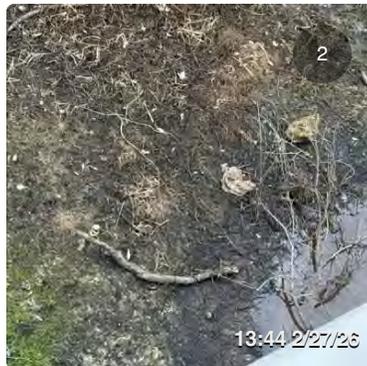
Item 6

There are a couple branches that should be picked up underneath the bridge on Meridian point Drive to ensure proper flow when rainy season comes. This is on the Eastside of bridge.

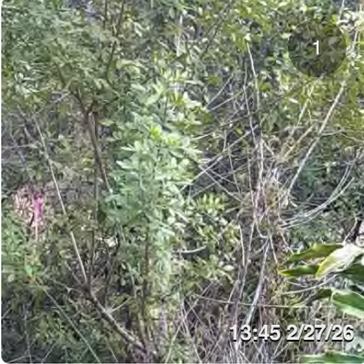
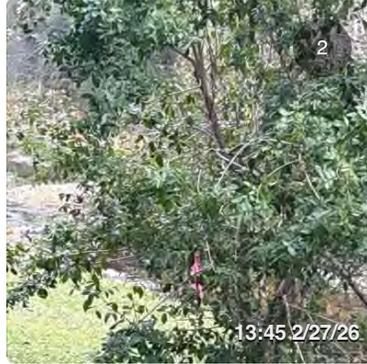
Item 7

There appears to be a couple Brazilian Peppers flagged along the top edge of this riverbank. Are these scheduled to be removed? This is at the Northeast end of the bridge on Meridian Point Dr.

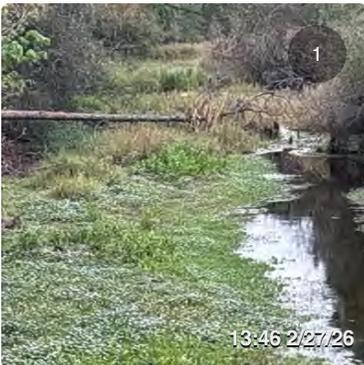
Item 8

On the other side of the bridge, there is a dead Pine tree fallen on the bank of the creek. Asking if we should have this removed before the rainy season for proper flow? This is Westside of bridge.

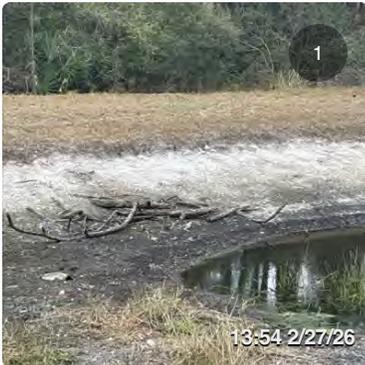
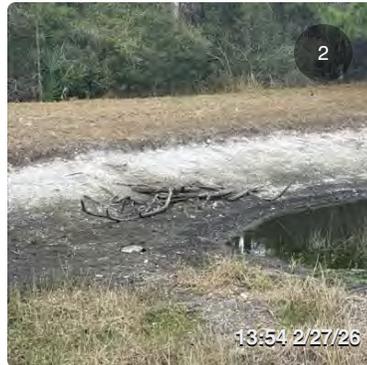
Item 10

Pick up debris in pond 20 before rainy season begins.

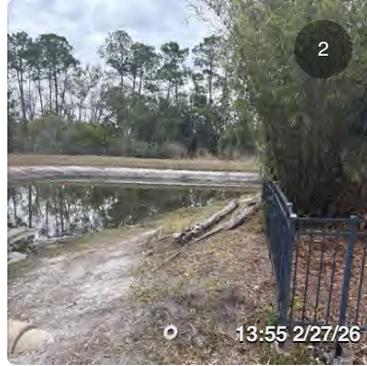
Item 11

Noting a dead downed palm tree behind the house on Lake 20 that could roll into the lake if not removed.

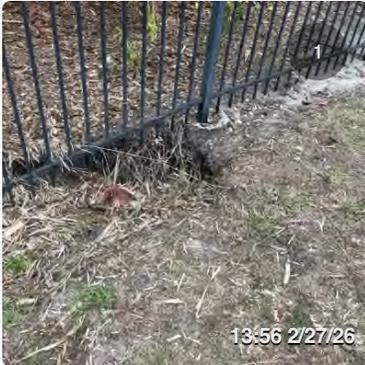
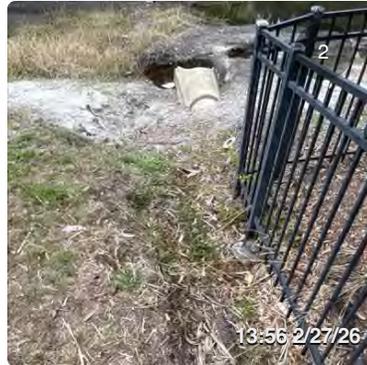
Noting a possible irrigation break for the house behind pond 20, 14835 Tudor Chase Dr. that is starting to cause erosion issues.

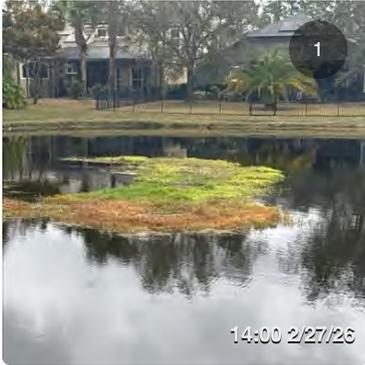
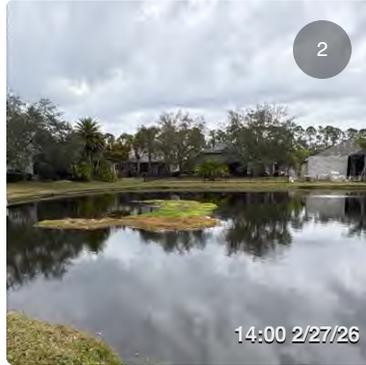
Treat non-desirable grassy weeds in pond 19.

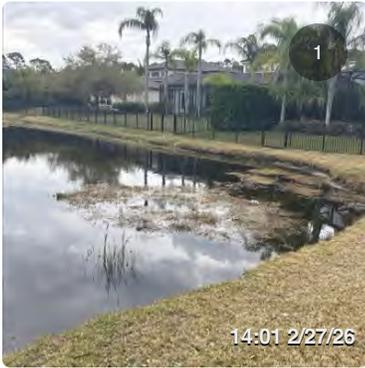
Item 14

Treat algae growing in pond #19.

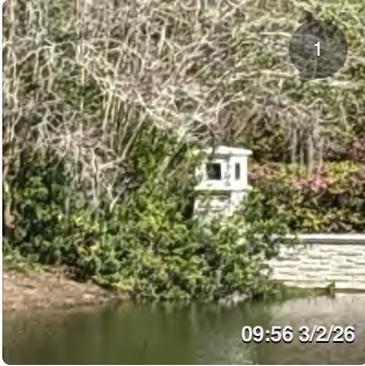
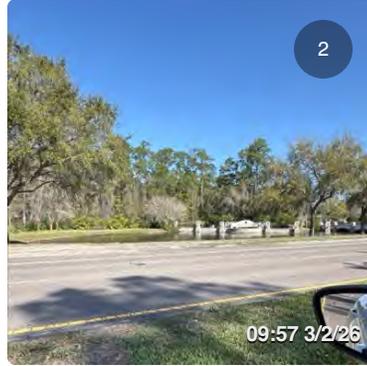
Item 15

Need a proposal to remove a Brazilian Pepper growing under the Crepe Myrtle's at pond 1 on exit corner of Racetrack Road and Waterchase Boulevard.
