Waterchase Community Development District

March 9, 2026

Agenda Package

Field Inspection Report - February 2026

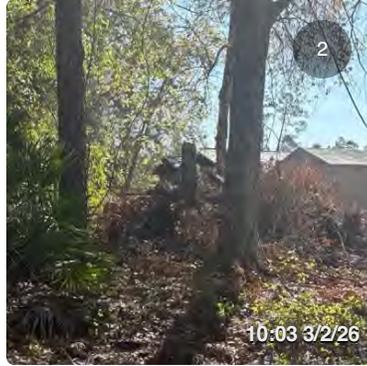
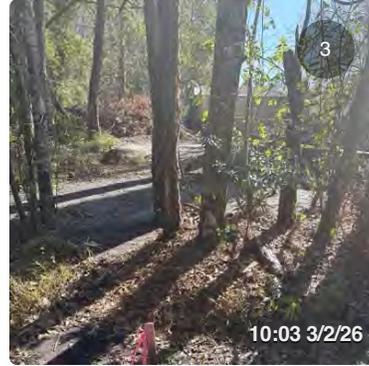
Pile of debris that needs to be removed from construction at the Philippine Cultural Center on 9 Eagles Dr.

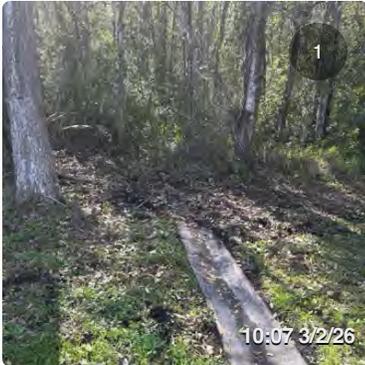
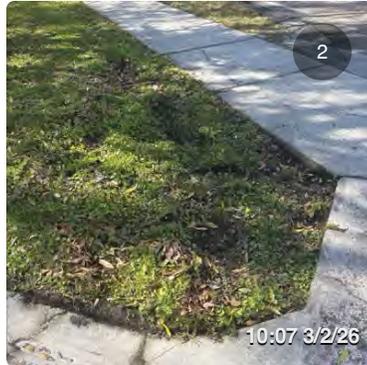
Noting need to clear a little bit of dirt in concrete swales at the entrance and exit corners of 9 Eagles Dr. Also, need a proposal to repair ruts.

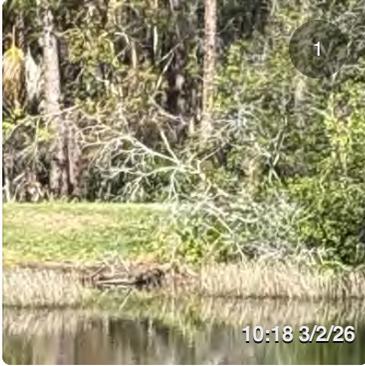
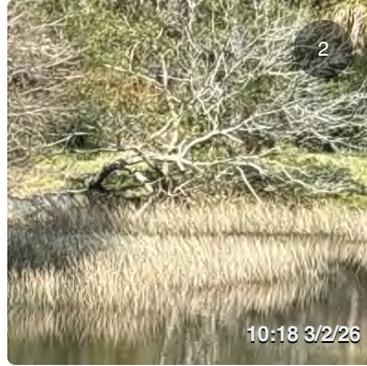
Noting a downed tree and broken dead branches that should be considered for removal on pond bank 2.

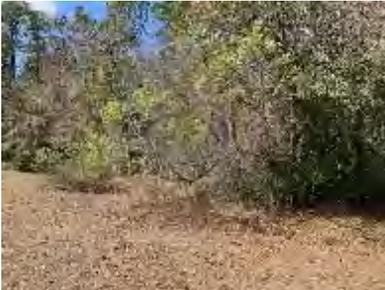
Cutback two trees that have fallen in conservation area into CDD area on San Chaliford by pond 16.
