Facilities Assessment of School Buildings

Oyster River Cooperative School District

December 6, 2024

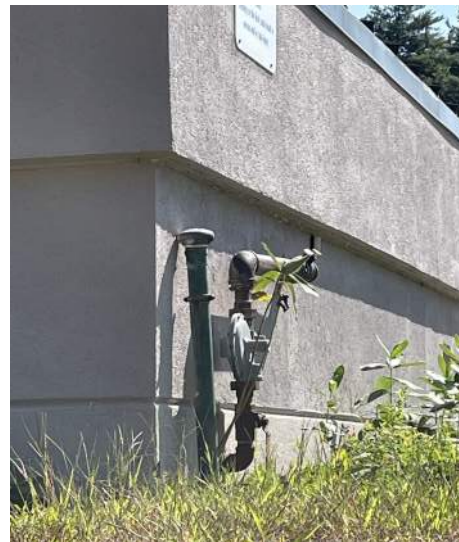
Berm Provides Easy Access to Roof, Gas Service, and Top of Transformer.

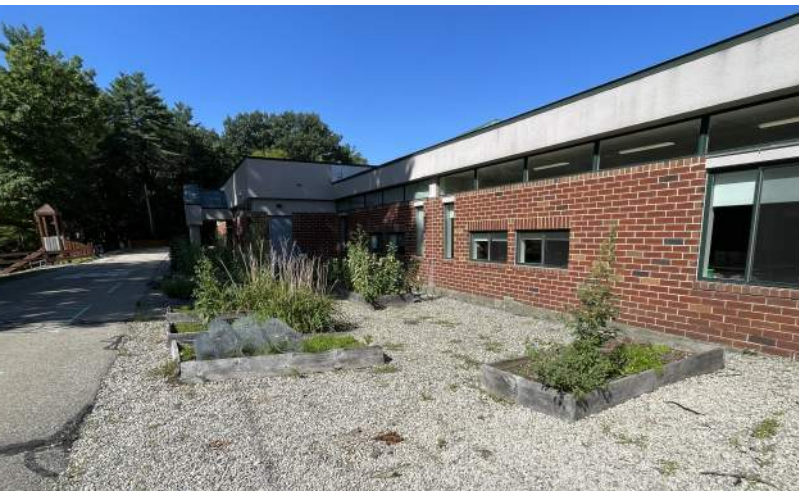
Area Susceptible to Ponding.

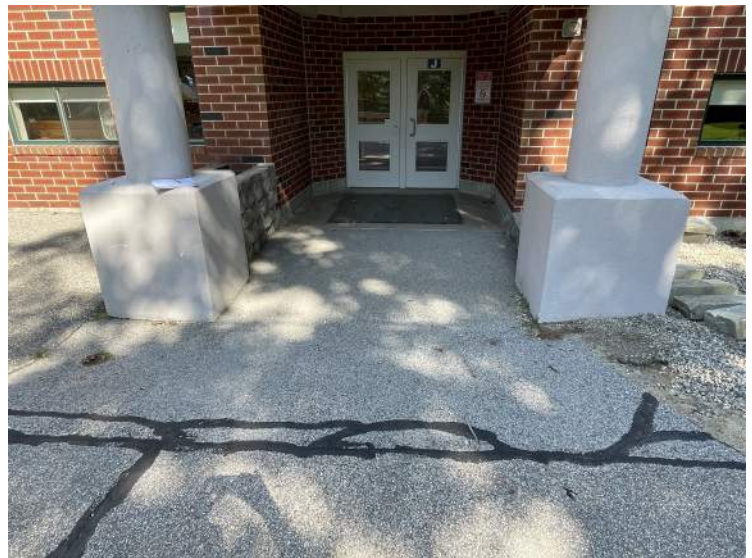
Area Susceptible to Ponding.

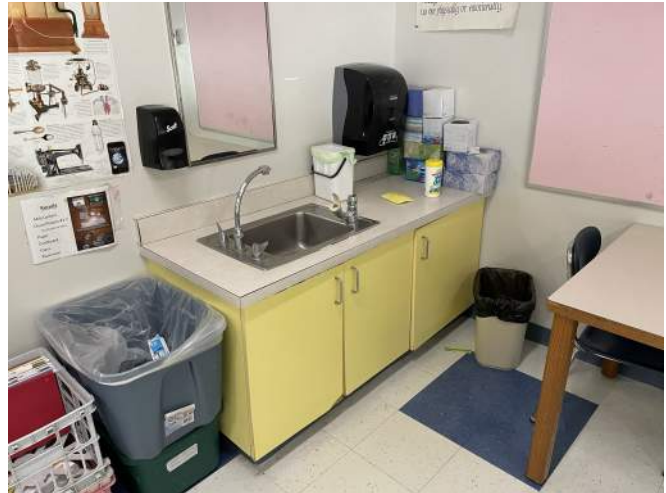
Typical Classroom Casework.

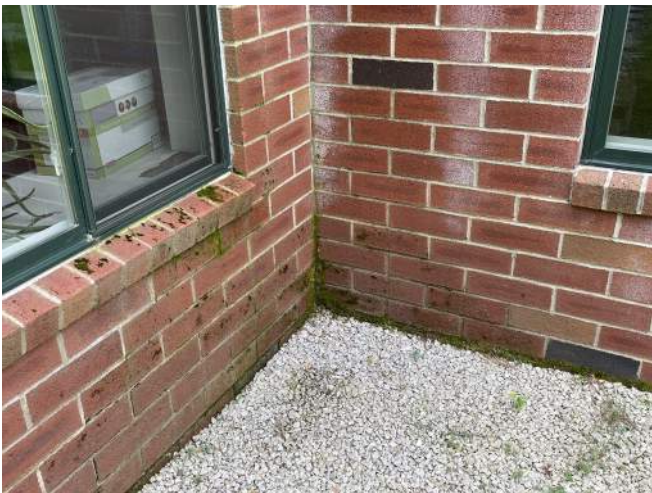
Moss Growth on Brick Veneer.

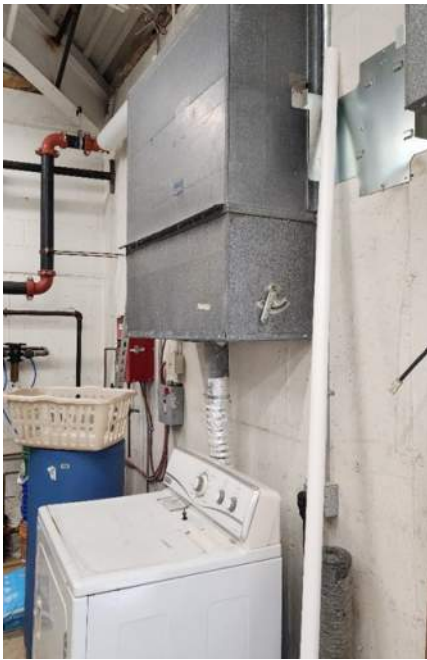
Non-Compliant Dryer Vent.

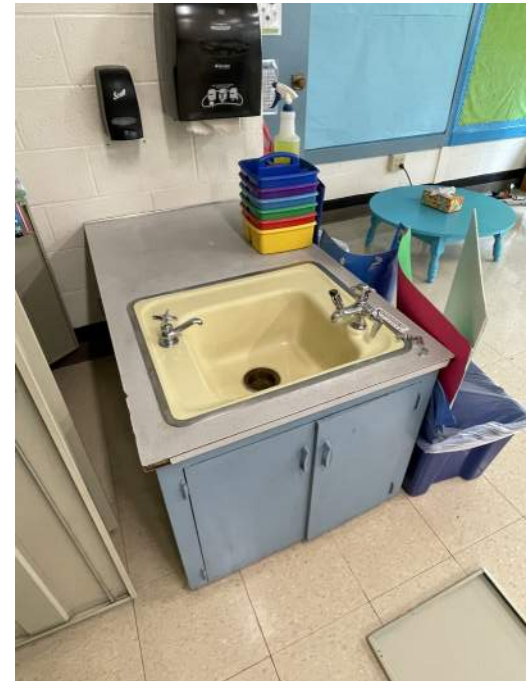
Typical Classroom Casework.

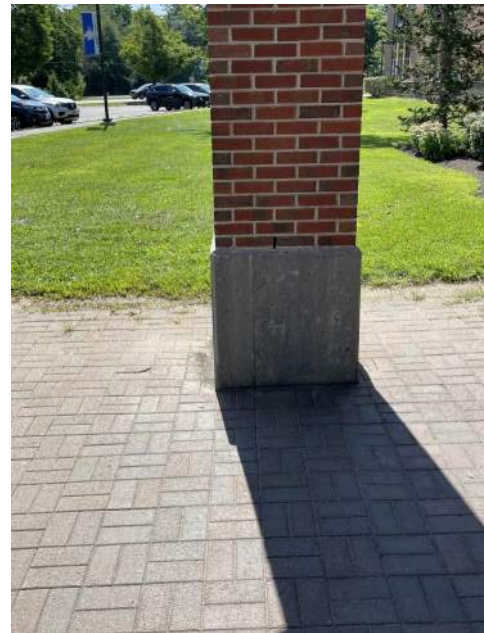
Main Entry Area Susceptible to Ponding.

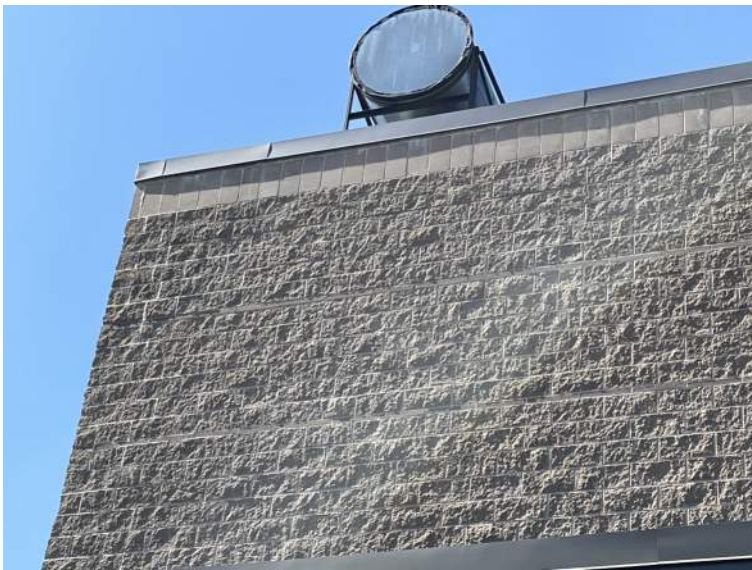
- CMU efflorescence was observed on the CMU along roof edge of Auditorium.
- Cafeteria wood fascia is wood and is peeling badly.

One non-roofing item that should be noted is the condition of the split face concrete block. These walls appear to hold moisture and are showing indications of efflorescence. Efflorescence is the result of salts within the block migrating to the surface in a salt and water solution. As the water evaporates, the salts form a white residue on the outside of the block. This may result in loss of integrity and spalling of the block as the moisture migrates in and out the block. It is recommended that the block be reserved with a siloxane based waterproofing.

Efflorescence at Auditorium Roof Edge.

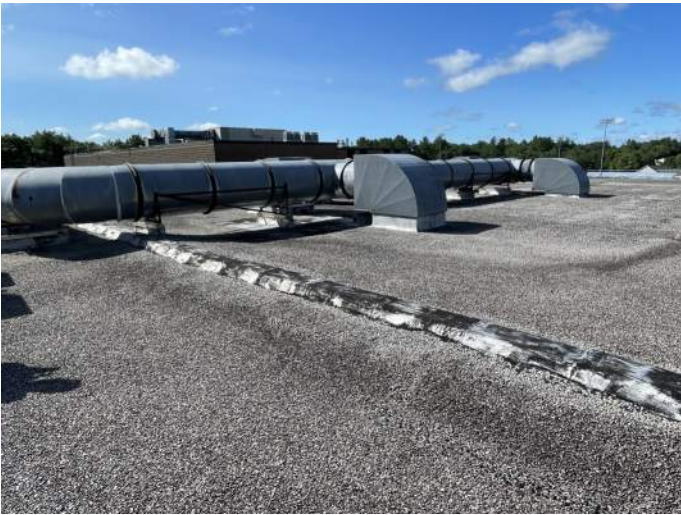
The overall condition of the existing roofing is fair to good. While there have been numerous roof leaks since the installation of the roof in 2004, many of these have been related to walls and flashings, including flashings around ductwork and through-wall flashing installed after construction.

Deficiencies include deterioration of the seam sealants, deterioration of field seams and flashings, and remedial repairs and patches.

View of Roof.

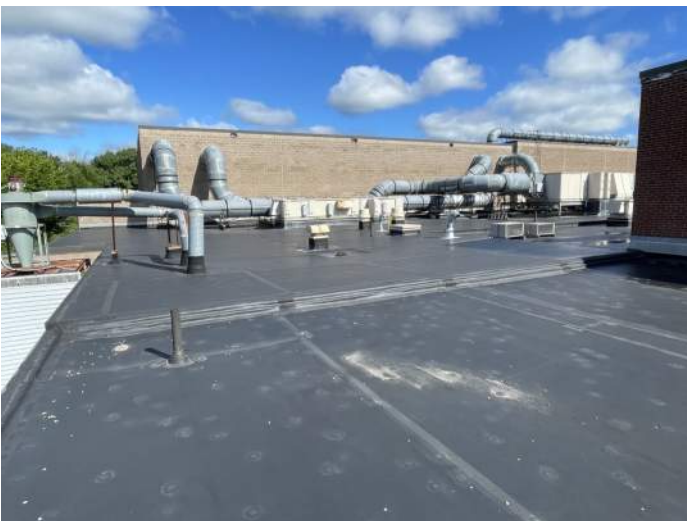
View of Roof.

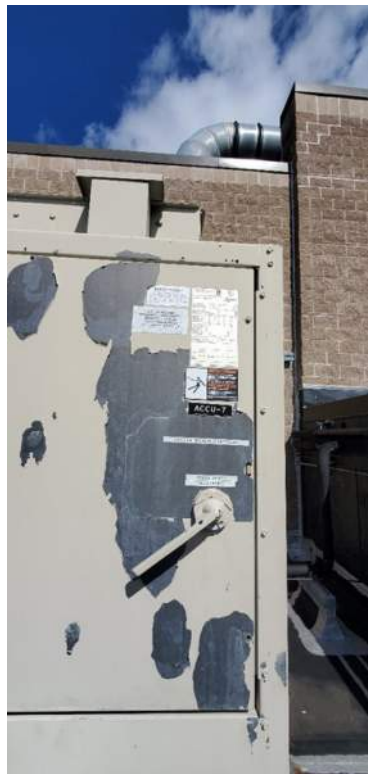
ACCU-7.

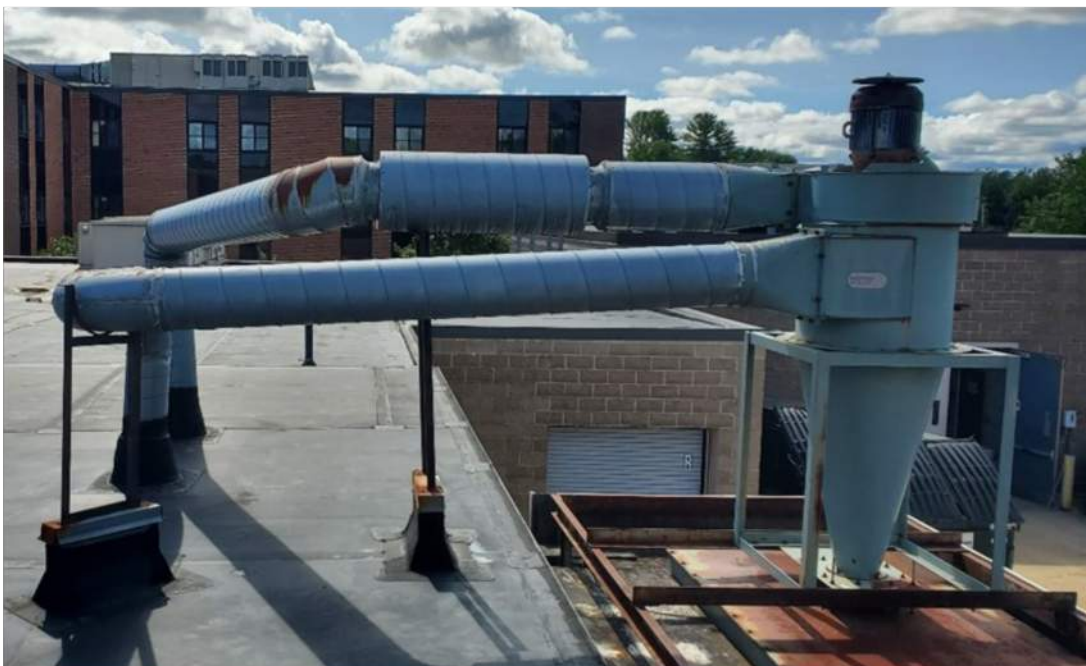
Dust Collection System.

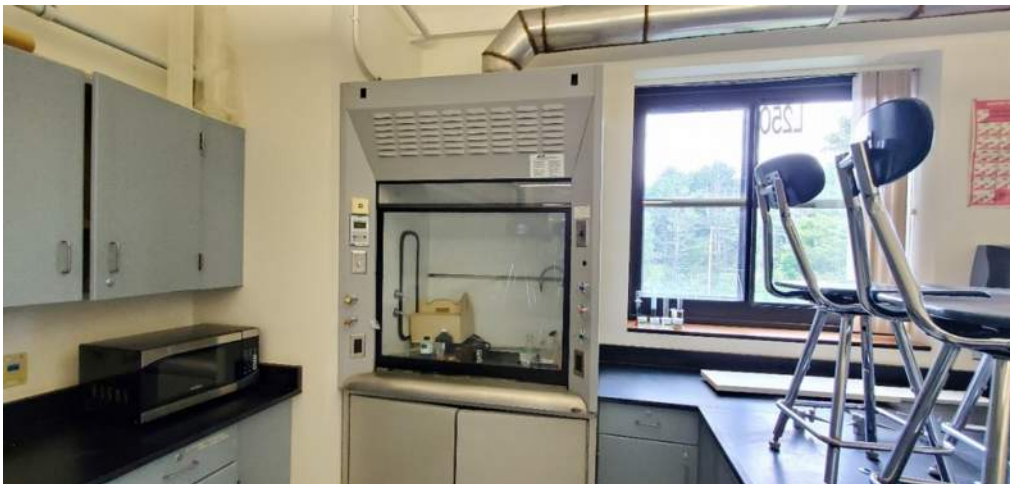
Laboratory Fume Hoods.

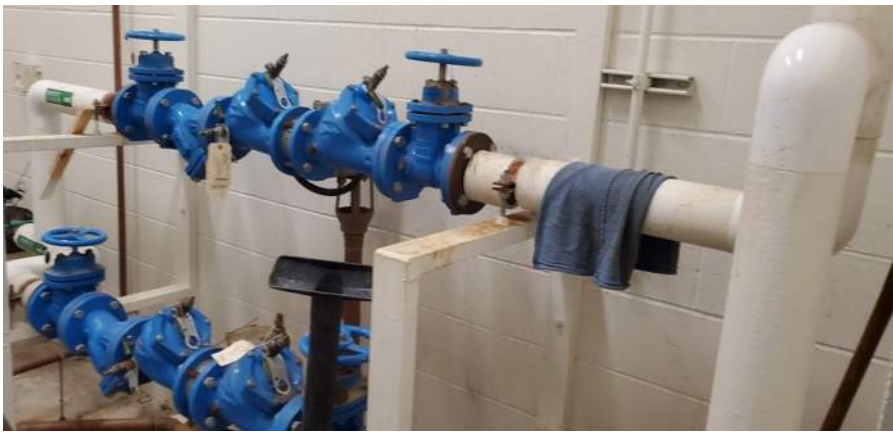
Water Service.

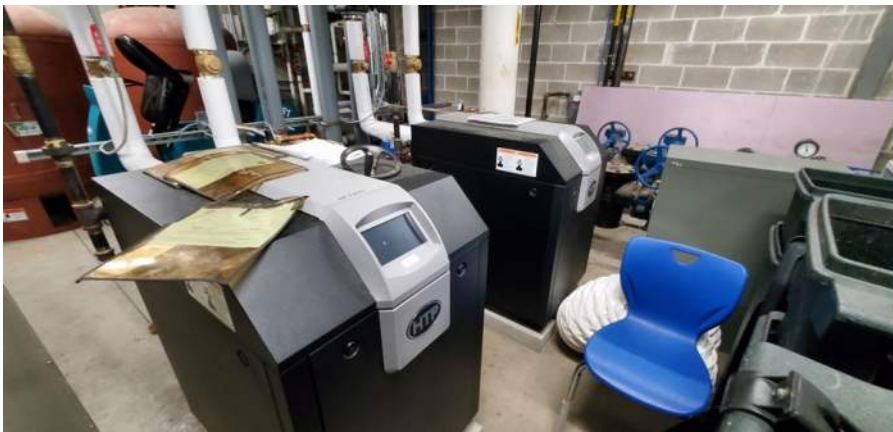
Instantaneous Domestic Hot Water Heaters.

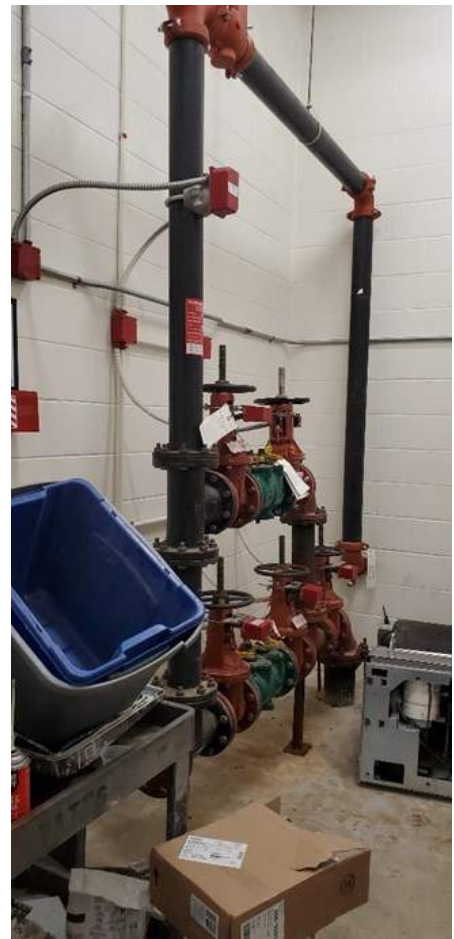
Fire Service.

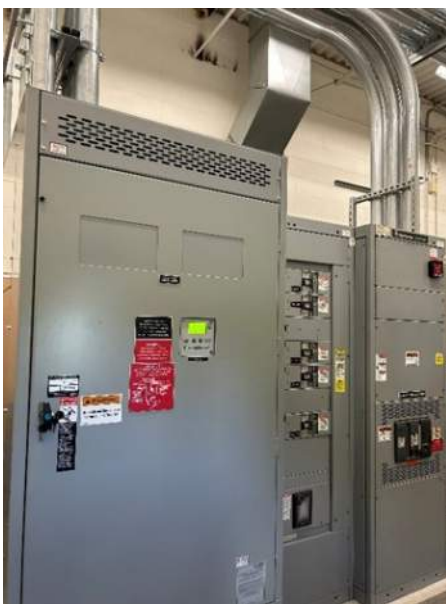
Main Switchboard.

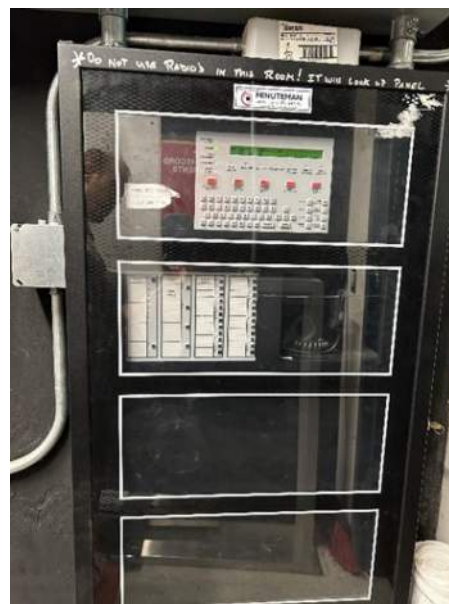
Fire Alarm Control Panel.

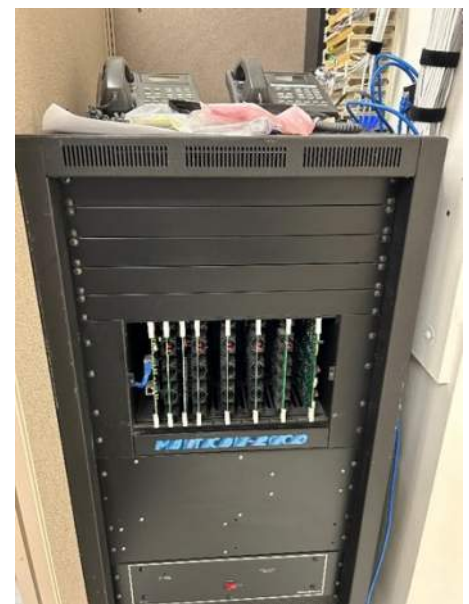
Public Address System.

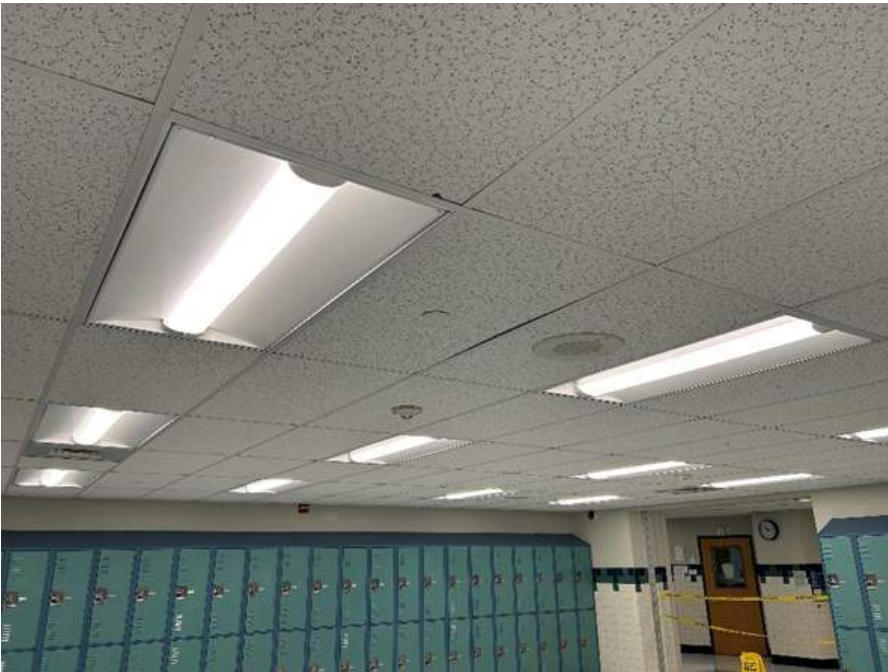
Common Area Lighting.

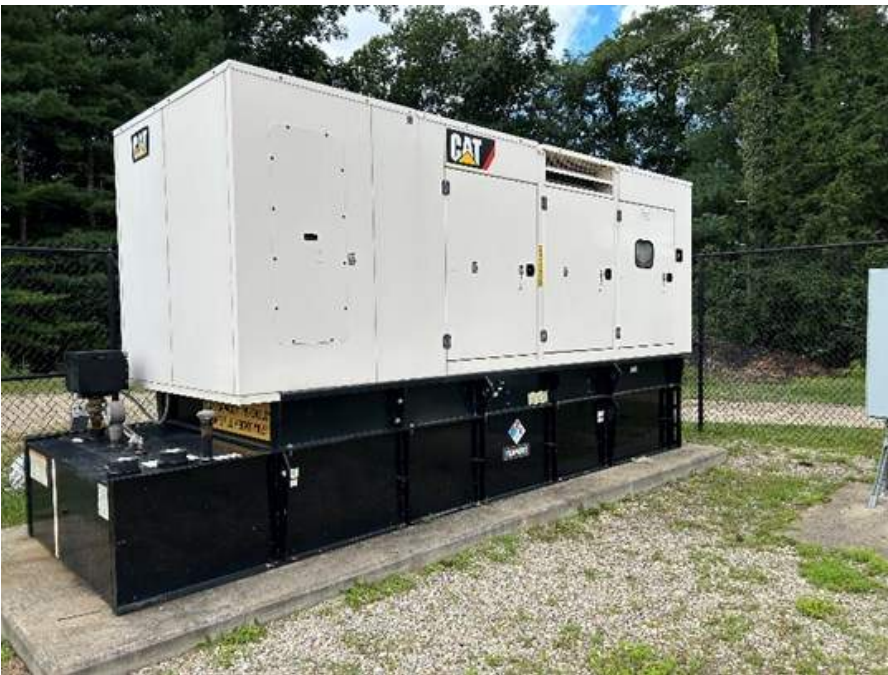
Generator.
